GRETA VIEW BARN

Low Road, Bowes
County Durham

Historic Building Recording

Project 250-19-HBR | August 2019

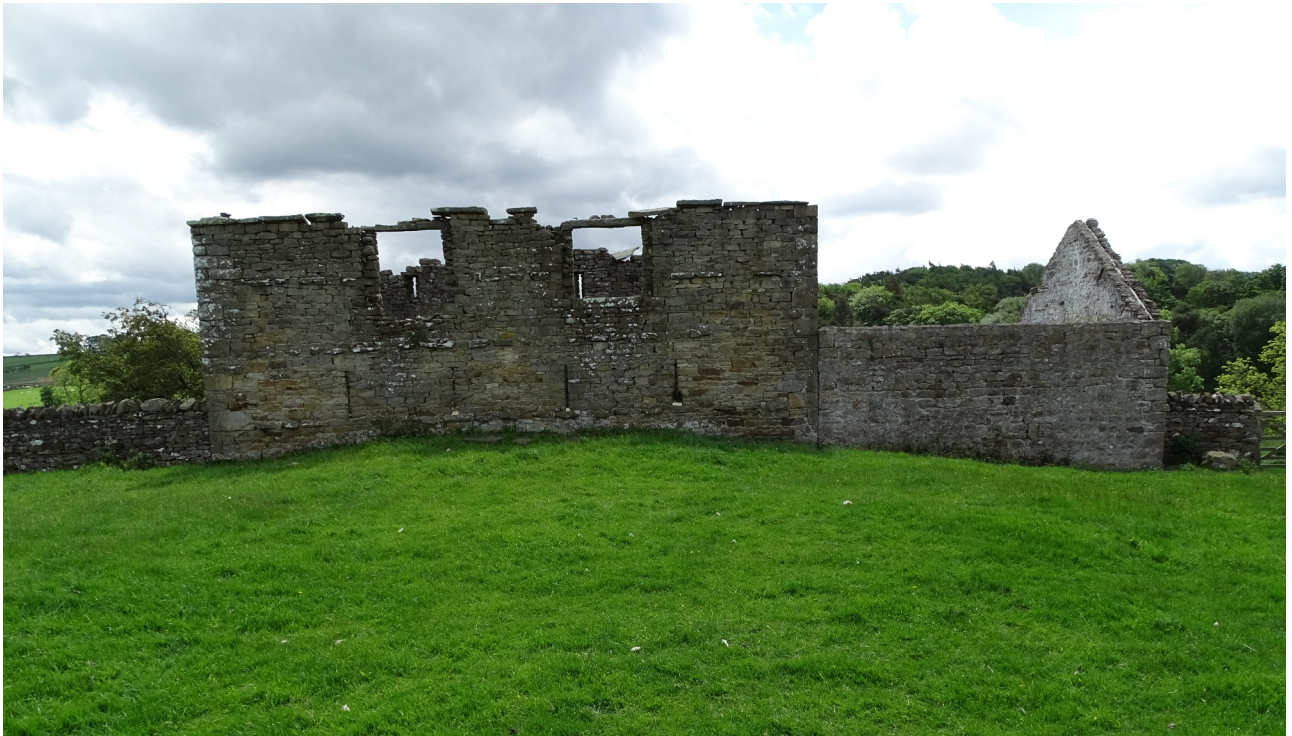
Plate 5. The northern elevation of the overall building (frame GVB19002)

- 3.2.1 **Northern elevation:** The northern elevation of Greta View Barn is constructed of dressed sandstone blocks presented and built in a random un-coursed fashion with mortared joints, the corners being built with stressed quoins. There are four vertical arrow loops within the northern elevation located on its lower level and positioned equidistant to each other on an east-west axis. There are three prominent string courses on the northern elevation with a string course below and above the arrow loops and a further string course central to the two large window bays: these window bays are unframed and in a dilapidated condition, with the eastern window in a state of collapse. There are coping stones on the uppermost course of the northern elevation but these appear random as there is no roof or framework attached.

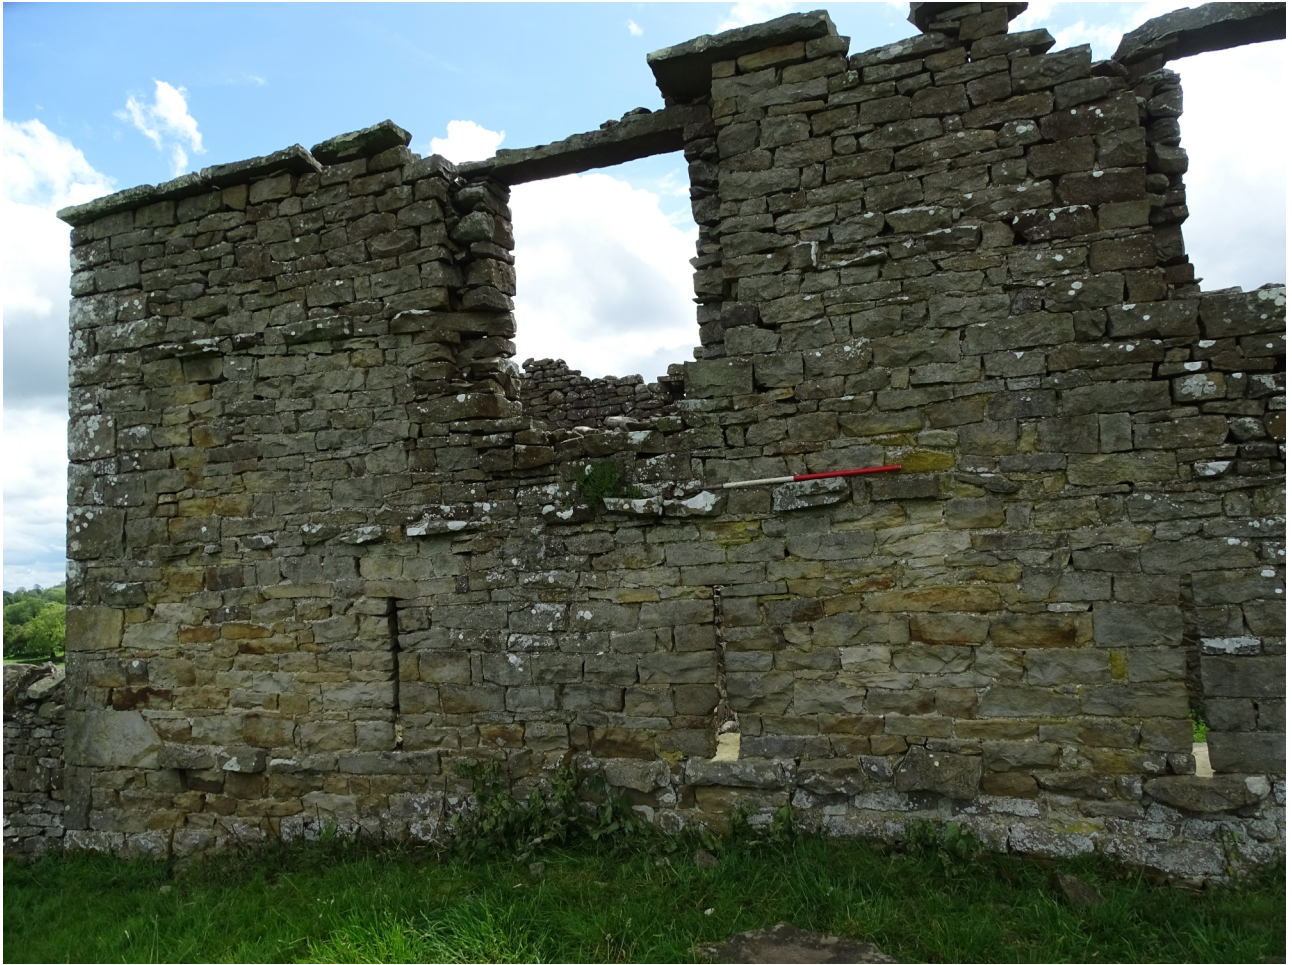
Plate 6. The northern elevation of the original barn (frame GVB19005)

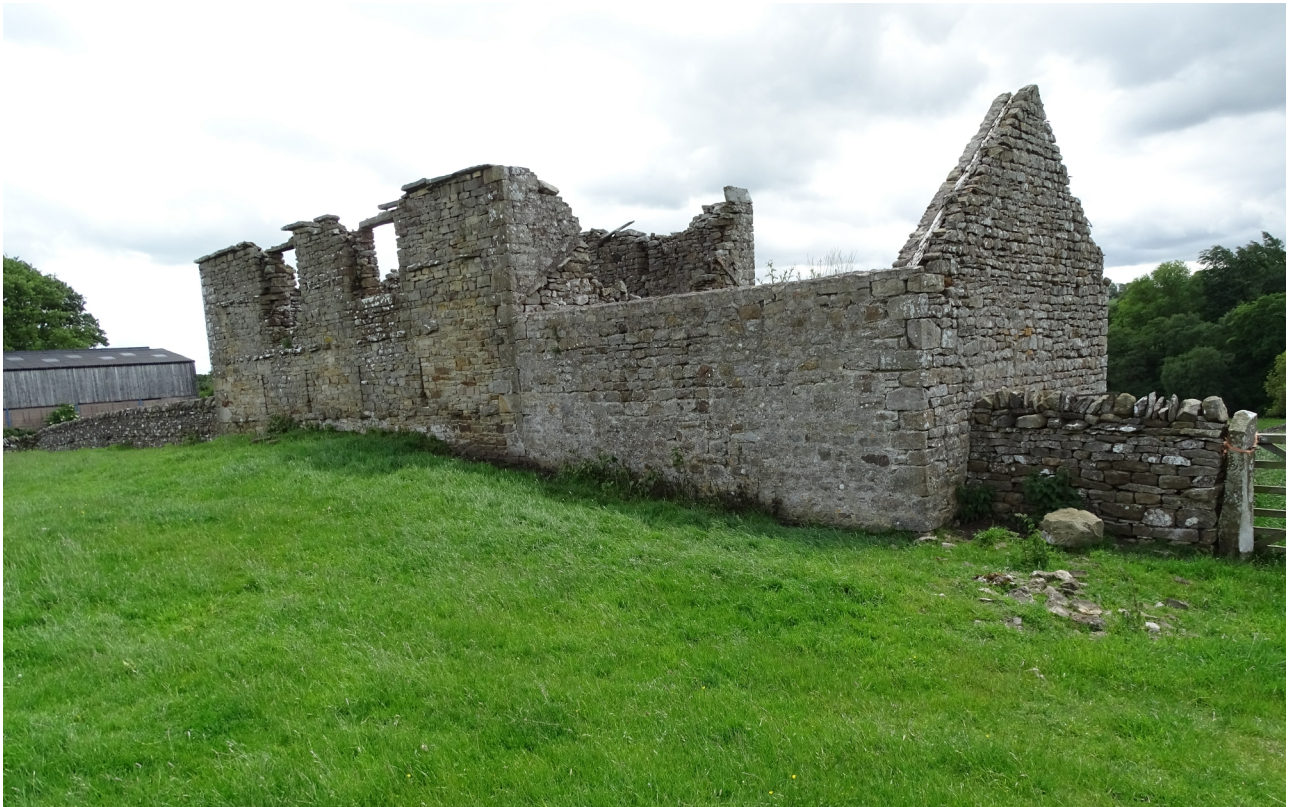
- 3.2.2 There is an extension built against the main barn's western side, not tied to the original structure. The extension is stone built with square blocks and lain to courses with mortared joints. There is no surviving roof associated with the extension. However the pitch of the stone roof-slates associated with the western extension are still visible against the western gable of the original barn.

Plate 7. The northern elevation from the northwest with the extension in the foreground (frame GVB19001)

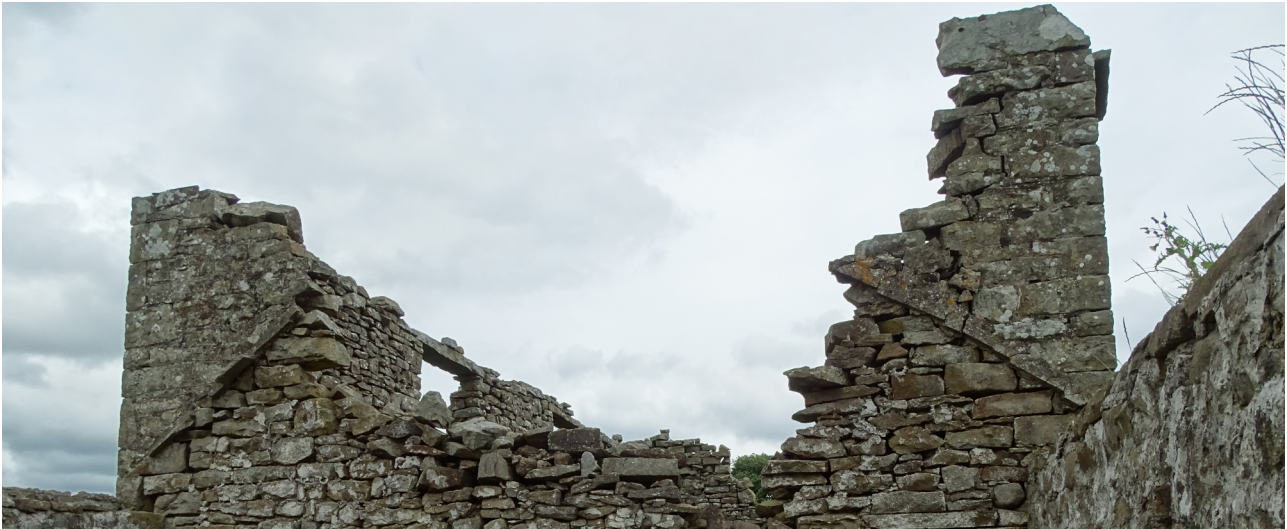
Plate 8. The remains of the original barn western gable end, obscured by the roofline from the extension (frame GVB19017)

- 3.2.3 **Western elevation, original barn:** The western gable of Greta View Barn is mainly in a state of disrepair. It has been constructed from roughly coursed sandstone with stressed quoins. The elevation was mostly masked by the eastern wall of the later extension.
- 3.2.4 **Western elevation, extension:** The western elevation of the extension appears to be in a fair condition and is almost complete with just the eave stones missing. It is constructed of large dressed sandstones which are squared and lain to courses, with the corners being stressed quoins. The joints have patches of mortar but the majority has been weathered out. The western side of the east-west aligned dry stone wall that Greta View Barn is situated within is constructed against the western side of the west gable extension and continues from this point in a westerly direction down to Bowes Sewerage Works.

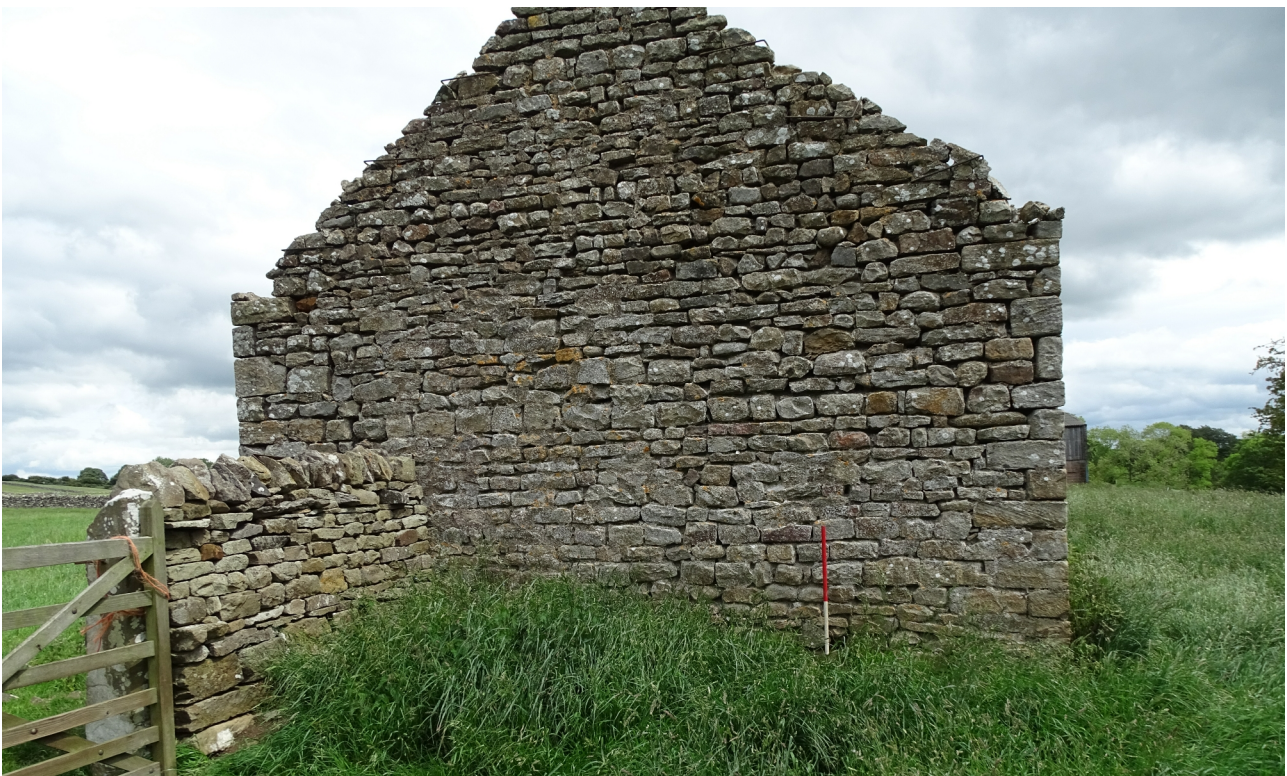
Plate 9. The western elevation of the extension (frame GVB19008)

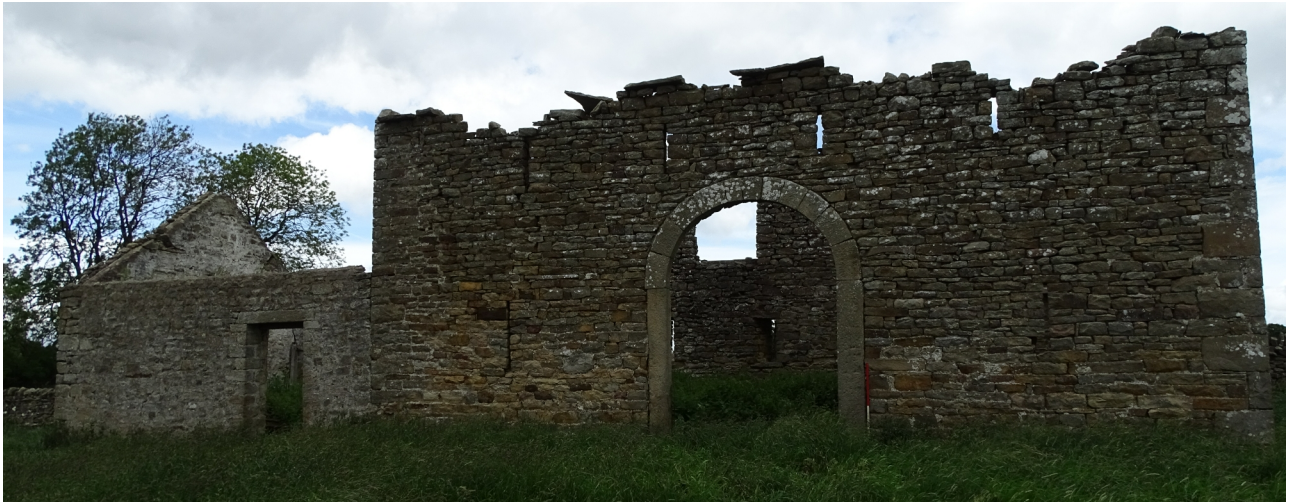
Plate 10. The southern elevation of the building (frame GVB19048)

- 3.2.5 **Southern elevation:** The southern elevation of the building is constructed of dressed sandstones which are squared and lain to courses with stressed quoins. The entrance way within the southern elevation allows access into **Area A** which is the central part of the existing barn. This entrance is an impressive archway and has a span of 2.33m, with ten *voussoirs* and a central keystone that form the arch; the upper portion of the arch is sprung from two vertical single stone piers that form the east and western side of the entrance. The arch has no impost and the piers have no base plinth. There are a total of six arrow loops within the southern elevation, two are located on the lower side of the elevation (either side of the arched entrance) and a further four which are equidistant from each other on the upper section of the southern elevation above the arched entrance. The joints of the southern elevation have mortared remnants but these are sporadic and patchy at best with the vast majority having been weathered out.

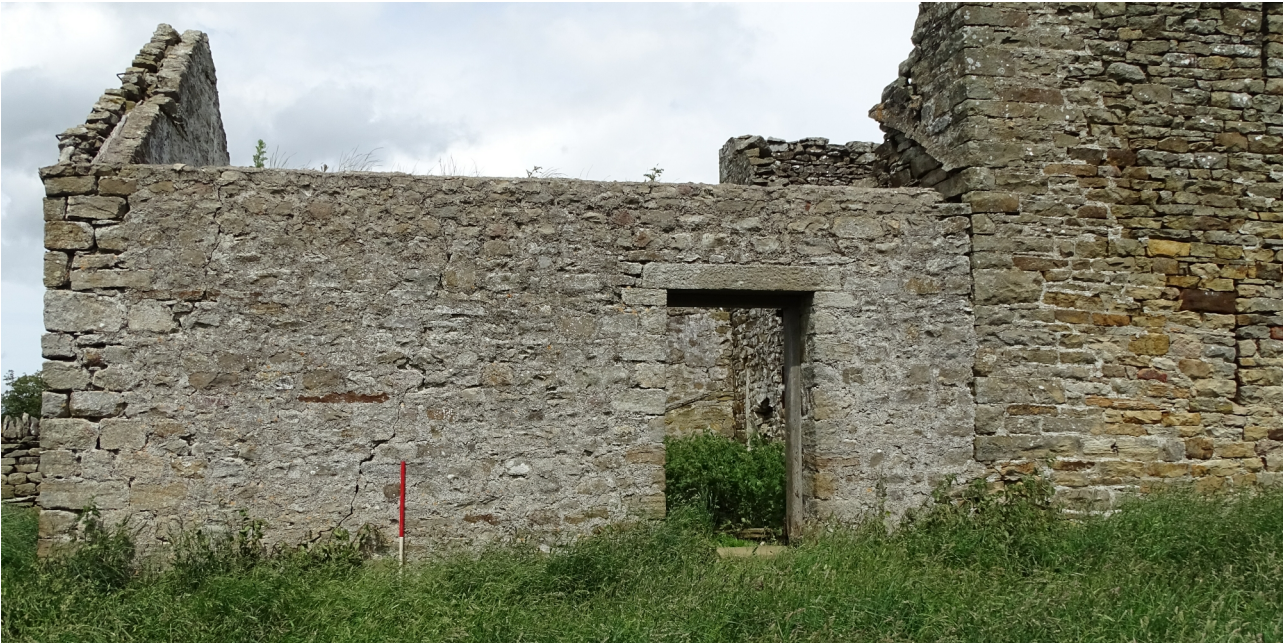
Plate 12. The southern elevation of the extension (frame GVB19011)

mortared joints are also weathered and degrading. The roof of the southern extension is missing. There is an access doorway within the southern elevation's extension, located on the east side. This doorway has a single dressed sandstone lintel and the sides of the doorway are squared stressed quoins. Two single sandstone steps adorn the entrance and allow access to the interior of the extension.

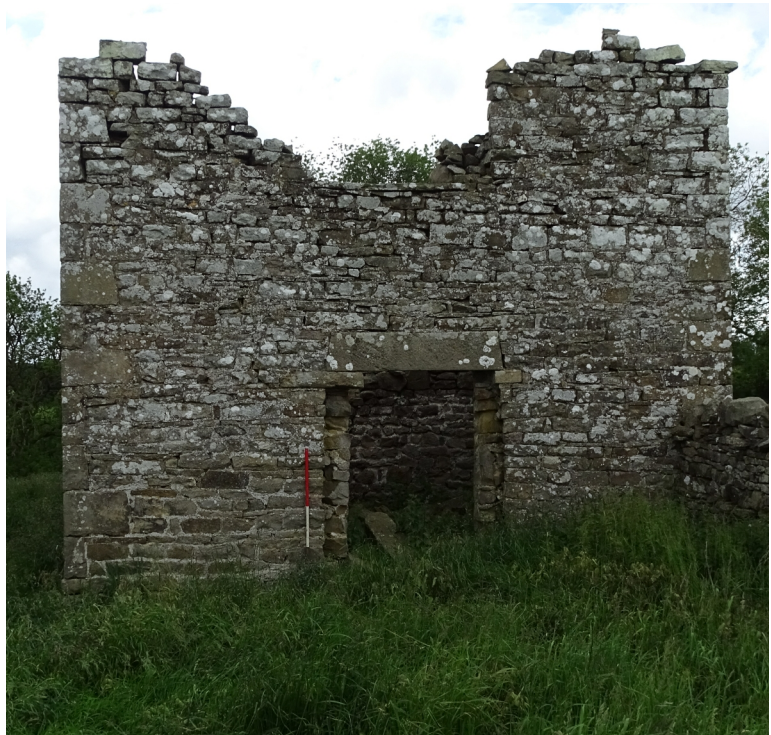
- 3.2.7 **Eastern elevation:** The eastern gable of Greta View Barn is in a generally poor state, constructed of dressed sandstones, squared and lain to courses. The corners of the east gable are stressed quoins, and the exposed mortared joints have heavily weathered and are badly degraded. There has been external rendering applied to the east gable's façade, but again this is brittle and in places missing. The central upper portion of the eastern gable has collapsed, leaving only lower remnants of the upper window visible, including the stone sill and the northern side of the window. The doorway within the eastern gable is recessed (rebated jamb) for a door frame but this frame is missing; the lintel above the doorway is a single dressed sandstone, trapezoidal in shape, and is sprung from two engaged impostes either side of the upper portion of the door aperture. The eastern side of the east-west aligned dry stone wall that Greta View Barn lies between is abutted against the eastern gable's northern side and runs east to West Low Fields Farm.

Plate 13. The eastern elevation (frame GVB19050)

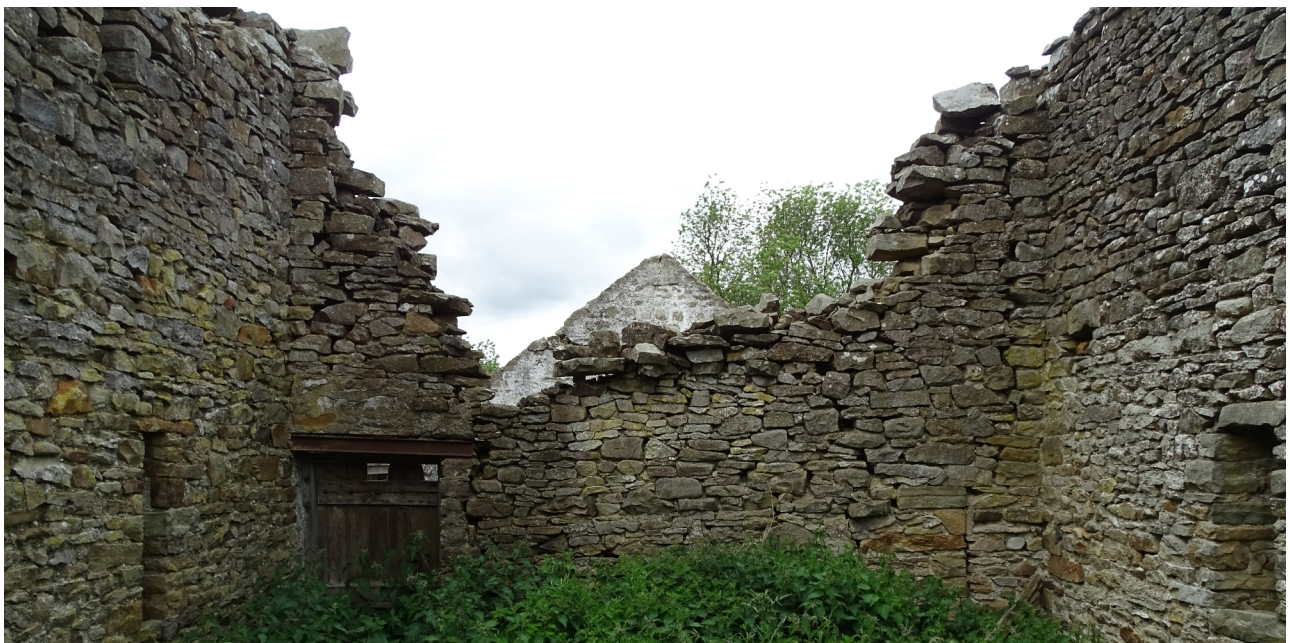
- 3.3.1 **Area A:** The western elevation of **Area A** is in a bad state of collapse, especially the central section. Constructed of randomly un-coursed partially dressed sandstone and limestone sub-angular

Plate 14. Area A, western wall (frame GVB19024)

blocks, the mortared joints have suffered heavy weathering and the remaining mortar is degraded and patchy. There is a large vertical fissure within the internal western elevation's northern side, possibly due to subsidence. The doorway set within the internal western elevation corresponds to the doorway described in Section 3.3.13 and allows access between the two areas.

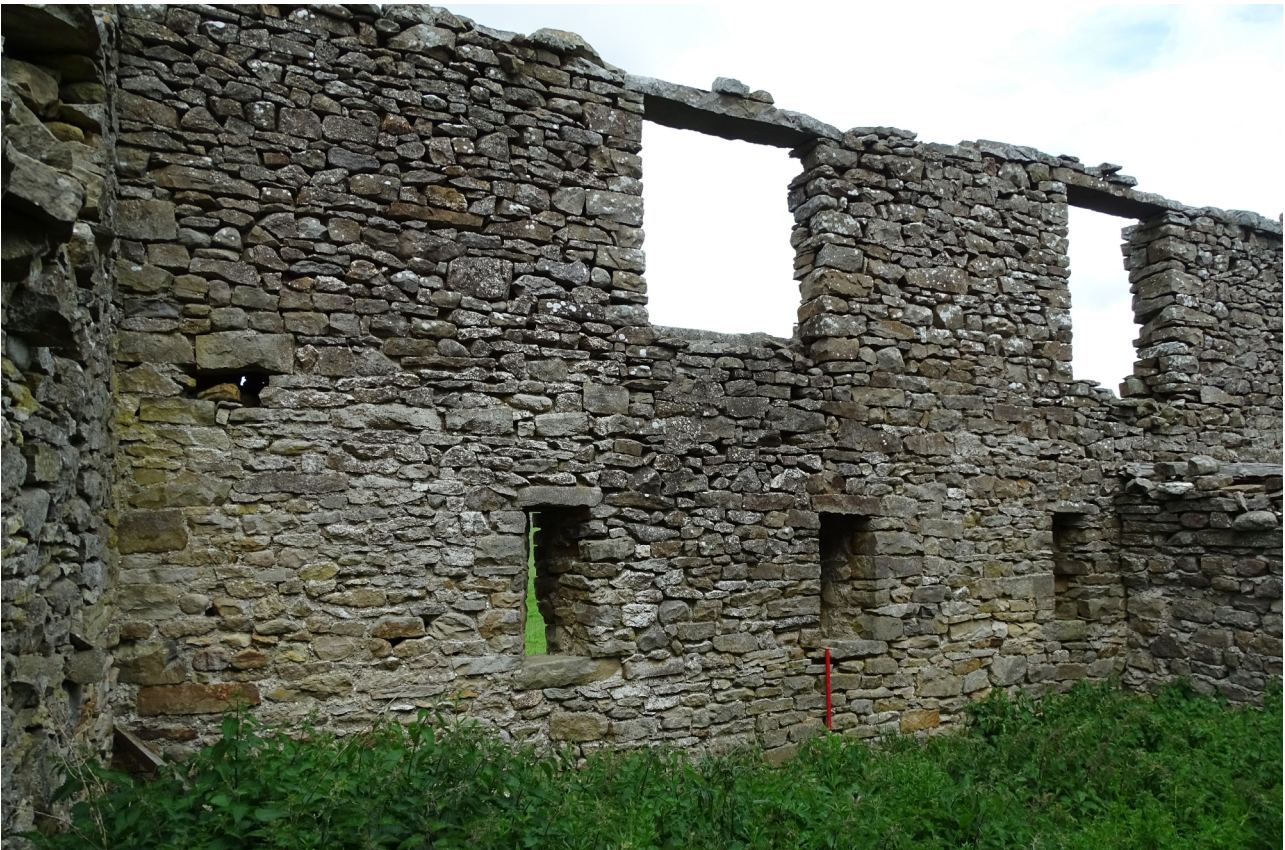
Plate 15. Area A, northern wall (frame GVB19030)

- 3.3.2 The northern elevation is in a poor state overall, the two large upper window apertures remain squared but frameless and the lintels attached to these windows are *in situ* but on the point of collapse. Of the four arrow loops viewed externally within the northern elevation three are internal to this room, the other being internal to **Area B**. The internal aspects of these arrow loops differ to the external views, with an apparent widening internally that incorporates a single sandstone sill and a

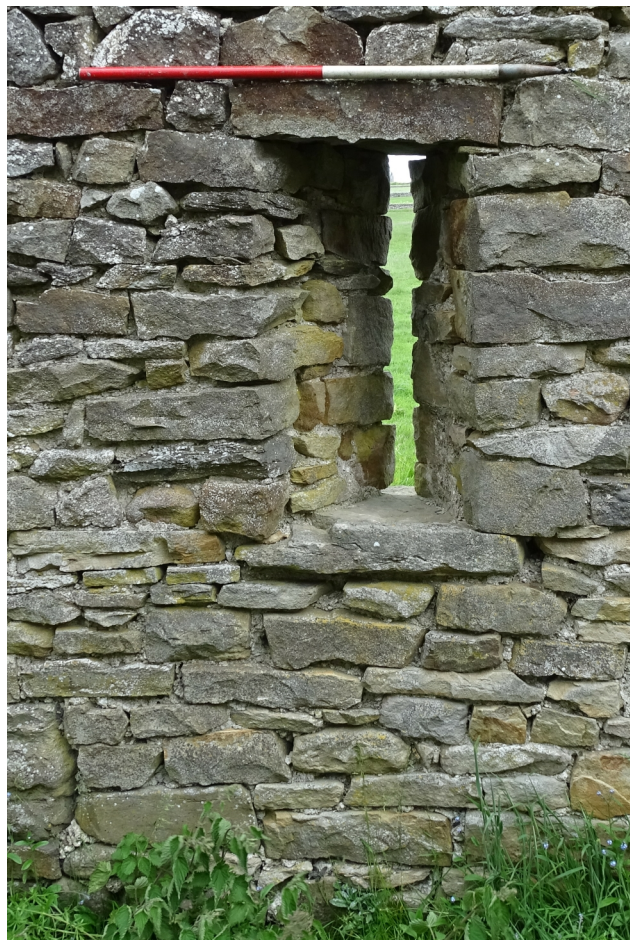
Plate 16. Area A, arrow loop window detail (frame GVB19032)

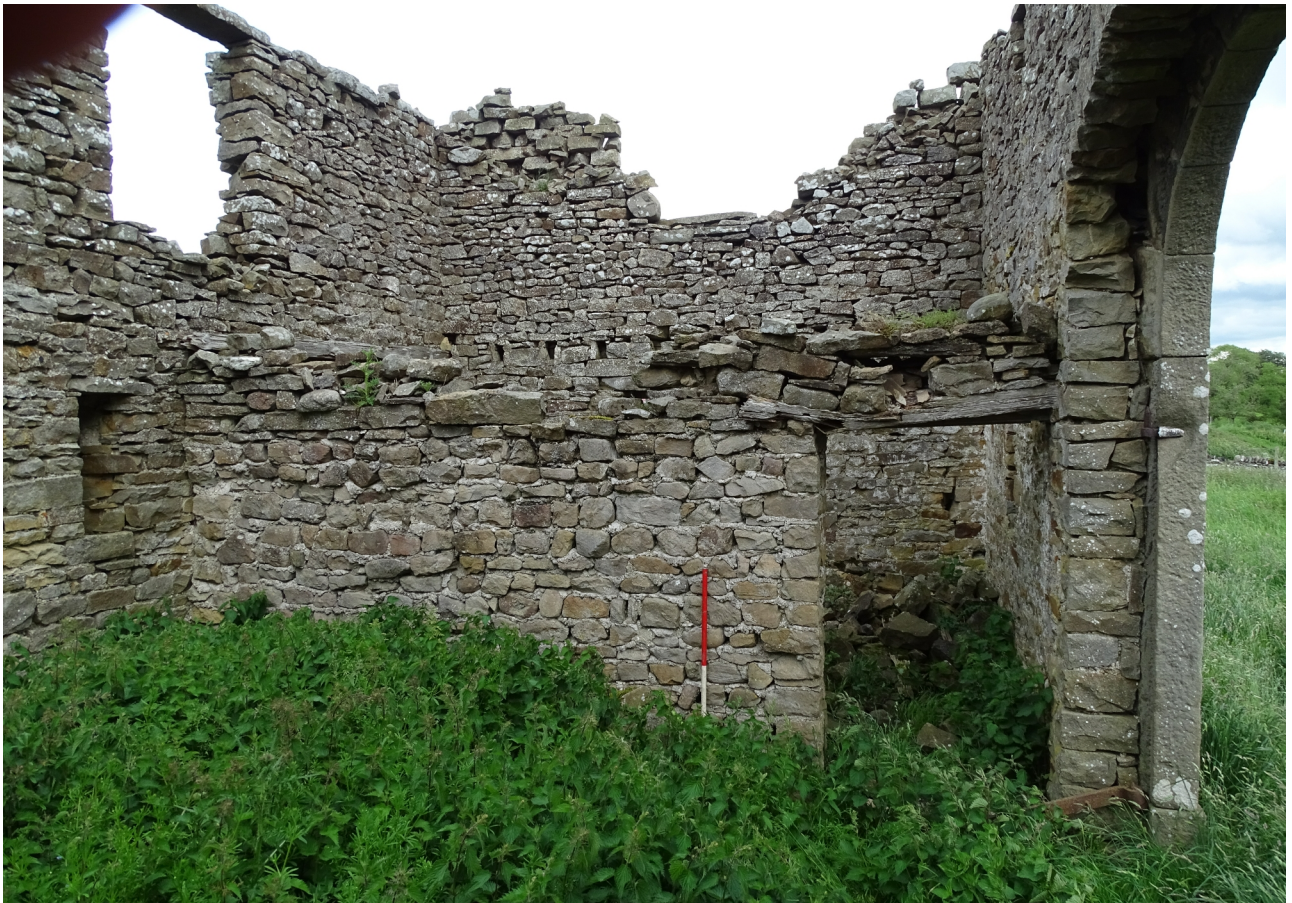
Plate 17. The eastern wall of Area A, with Area B beyond (frame GVB19028)

- 3.3.3 The eastern elevation is constructed of partially dressed sandstone and limestone blocks, squared and randomly laid to courses. There is no roof attached and it is basically acting as a partition wall with **Area B** beyond. The door to the southern extent of the elevation has quoins on its northern side, and a collapsed wooden lintel with the south side of the lintel being tied into the internal southern elevation above the door immediately east of the arched entrance way.

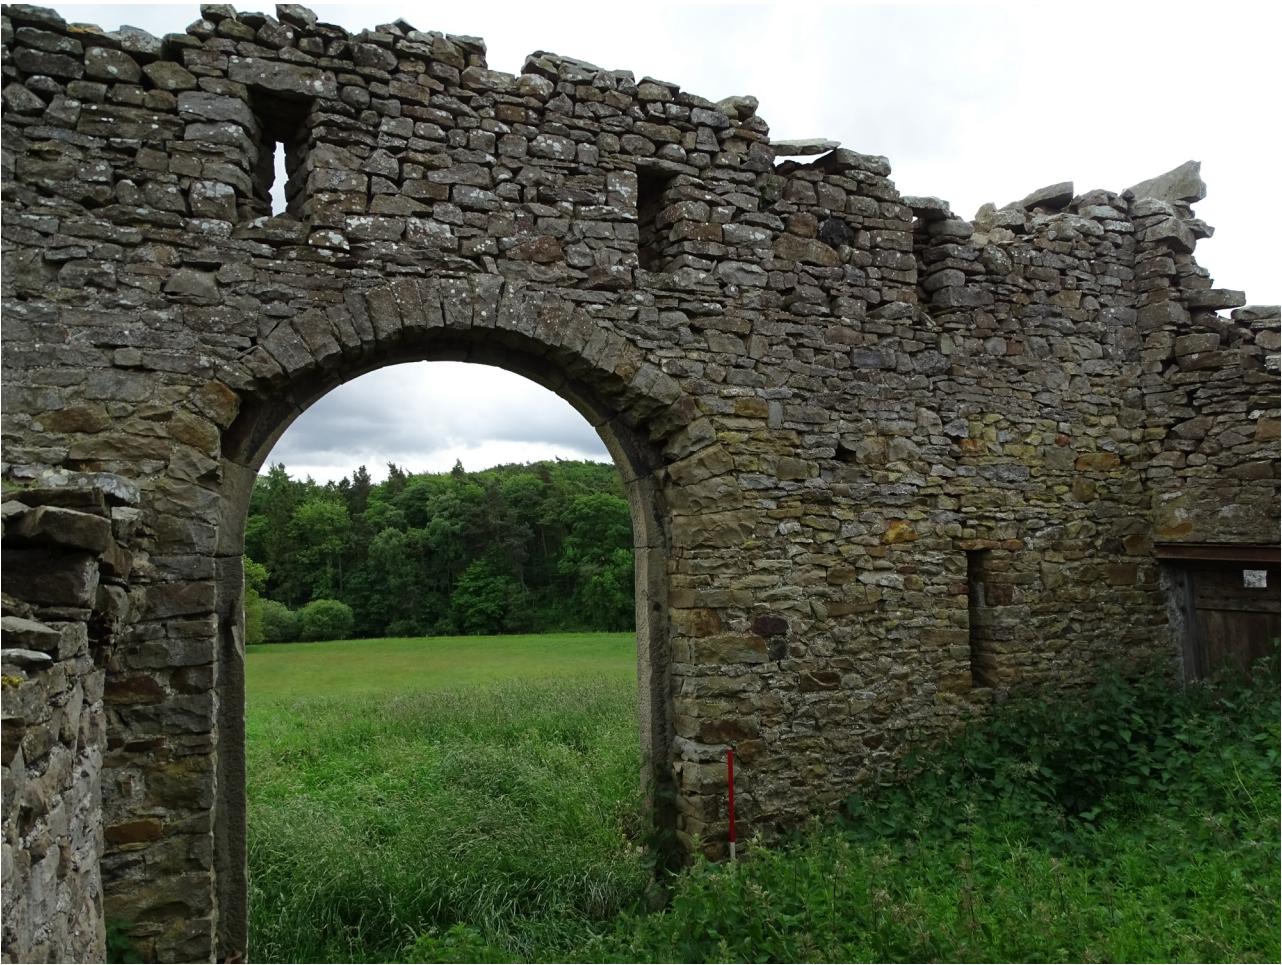
- 3.3.4 The southern elevation is constructed of coarsely dressed sandstone and limestone which are laid random and partially coursed. The joints have been mortared and in some places appear pointed. Of the two lower level arrow loops viewed externally, only the western arrow loop appears internally to this room, with the external eastern arrow loop appearing internally to **Area B**. The internal aspects of these arrow loops differ to the external view, with an apparent widening possibly to allow more light into **Area A**, as noted with those in the northern elevation. Internally the arrow loops all have stone lintels and sills. Of the four upper arrow loops three are within **Area A** with the easternmost being within **Area B**. The archway within the elevation differs to its external appearance, mainly by differing construction materials in the form of roughly hewn sandstone blocks. Partially dressed and mortared, the mortar is heavily degraded and weathered. The westernmost upper and lower arrow loops show a large vertical fissure between the upper lintel of the lower arrow loop and the lower sill of the upper arrow loop: this adds generally to the overall degraded and poor condition of the internal southern elevation.

Plate 18. The south wall of Area A, showing detail of the arch and arrow loop windows (frame GVB19025)

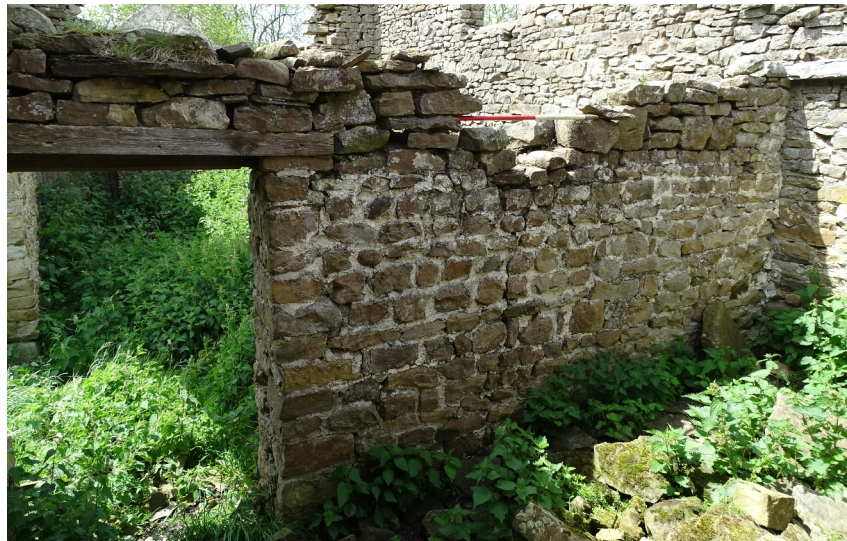
3.3.6 **Area B:** The western partition wall of **Area B** is in a very poor condition and in a state of collapse in places. The upper portion and internal roof are missing with the remaining upper courses un-mortared. An attempt to re-point the internal western elevation on its lower portion is evident, however this mortar has now weathered and degraded. There are two apparent vertical fissures within the Western elevation, located centrally and running from the base to the surviving upper courses. The doorway at the south side of the partition wall corresponds to the doorway within the internal east elevation of **Area A** and allows access between **Areas A** and **B**. This access contains the wooden lintel above the doorway that is tied into the internal face of the southern elevation wall immediately east of the main arched entrance. The block work associated with the internal western partition wall elevation is constructed of roughly hewn, partially dressed coursed sandstone and limestone.

Plate 19. The west wall of Area B, (frame GVB19040)

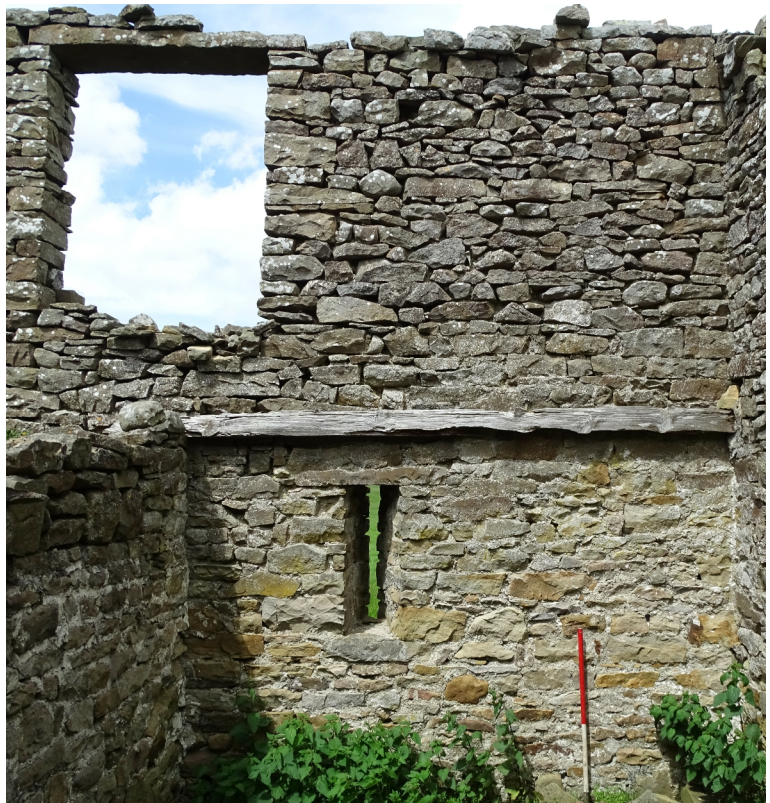
Plate 21. The east wall of Area B, showing detail of upper floor joist sockets (frame GVB19043)

- 3.3.8 The internal eastern elevation of the room is constructed of partially dressed sandstone and limestone, squared and randomly coursed. The lower portion has been mortared and pointed in places although this is sporadic. There are eight recessed joist sockets visible within the elevation located midway within the elevation immediately above the access door to **Area A**. These recessed joist sockets are integral supports for the missing/collapsed roof associated internally with the room. The external access doorway within the elevation has an impressive single limestone lintel but has no frame; the sides of the doorway have been pointed. The central portion of the elevation has collapsed above and around the centrally located single window aperture within the wall, leaving only remnants visible. There are no frame, sill or lintel remaining. The internal eastern elevation is generally in a very poor condition.

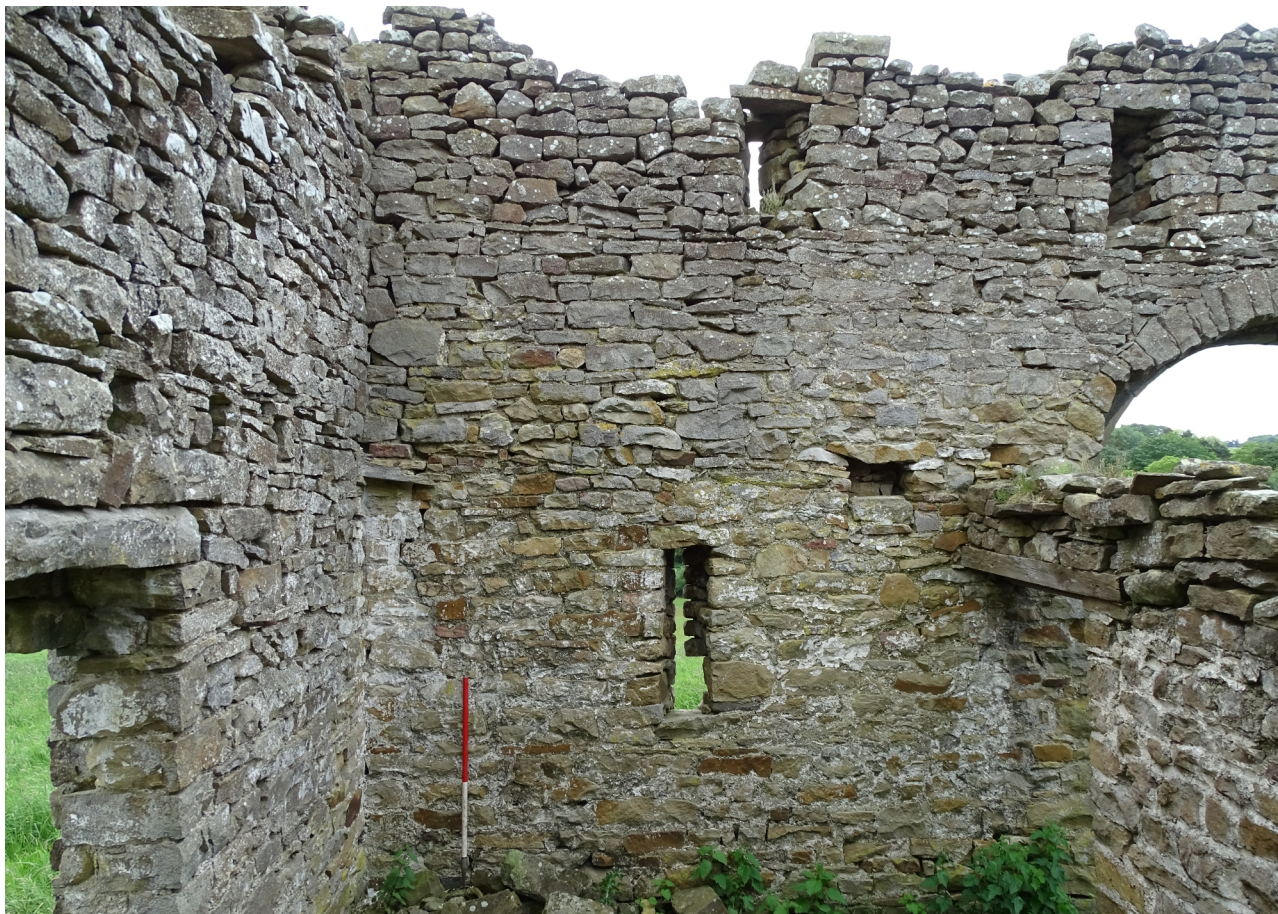
- 3.3.9 The internal southern elevation is constructed from roughly hewn, partially dressed un-coursed sandstone and limestone blocks, mainly mortared and pointed on its lower section with the upper portion randomly coursed and un-mortared. The upper courses are in a state of collapse. Of the two window arrow loops visible within the wall the lower has been mortared and pointed and still contains its stone sill and stone lintel, with the upper window loop in a state of collapse and disrepair with no lower sill and a displaced lintel. The wooden door lintel located within the western partition wall elevation at its south side, immediately east of the arched entrance is tied into the

Plate 22. The south wall of Area B (frame GVB19039)

internal southern elevation at this point. Overall the southern elevation of the room is in a poor state.

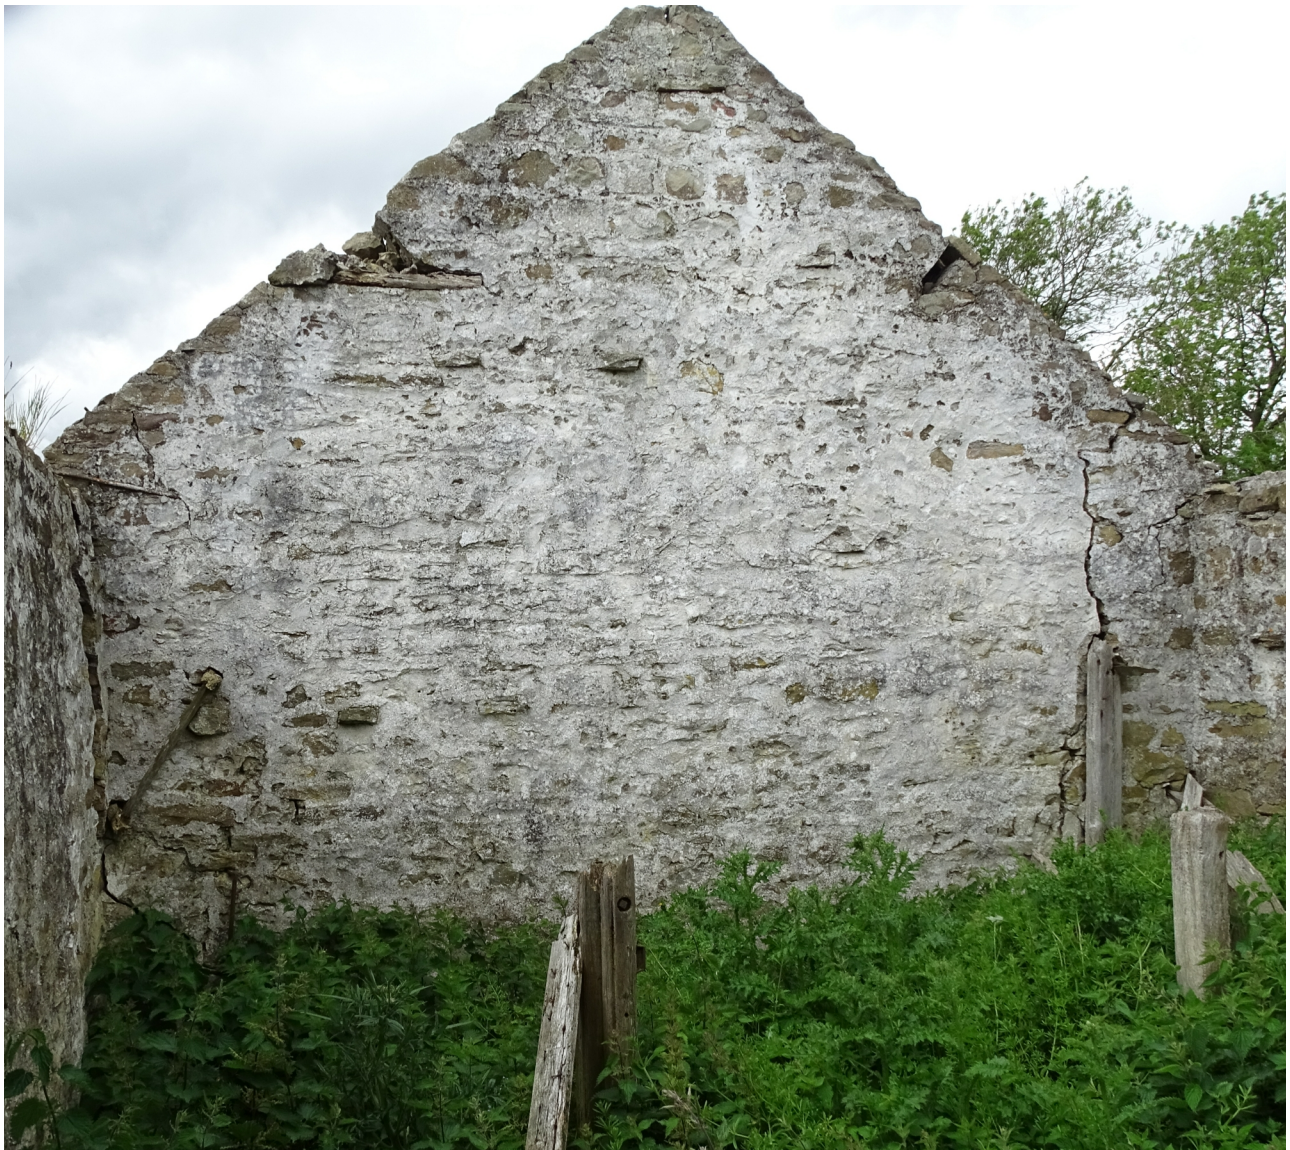
- 3.3.10 The internal floor surface within the room is completely carpeted with a dense layer of thick vegetation and debris.
- 3.3.11 **Area C:** The internal west elevation of the extension is constructed of randomly coursed, partially dressed sandstone with heavily mortared joints. A lime whitewash has been applied to this internal elevation and there is a small fissure on the northern side of the wall (this fissure is not visible on the external side of the elevation).

Plate 23. The west wall of Area C (frame GVB19015)

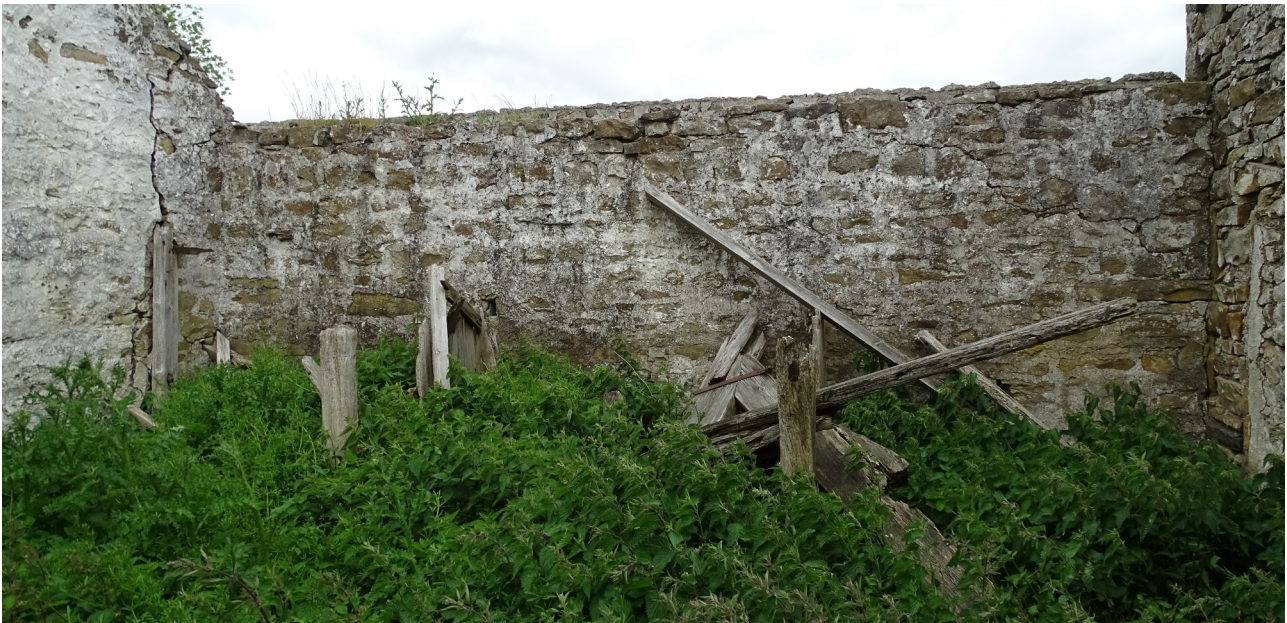
- 3.3.12 The north elevation of the extension is constructed of roughly hewn, randomly coursed sandstone blocks; the joints are heavily mortared and a lime whitewash has been applied. Heavy vegetation and collapsed roof beams mask the lower portion of the internal Northern elevation.

Plate 24. The north wall of Area C (frame GVB19016)

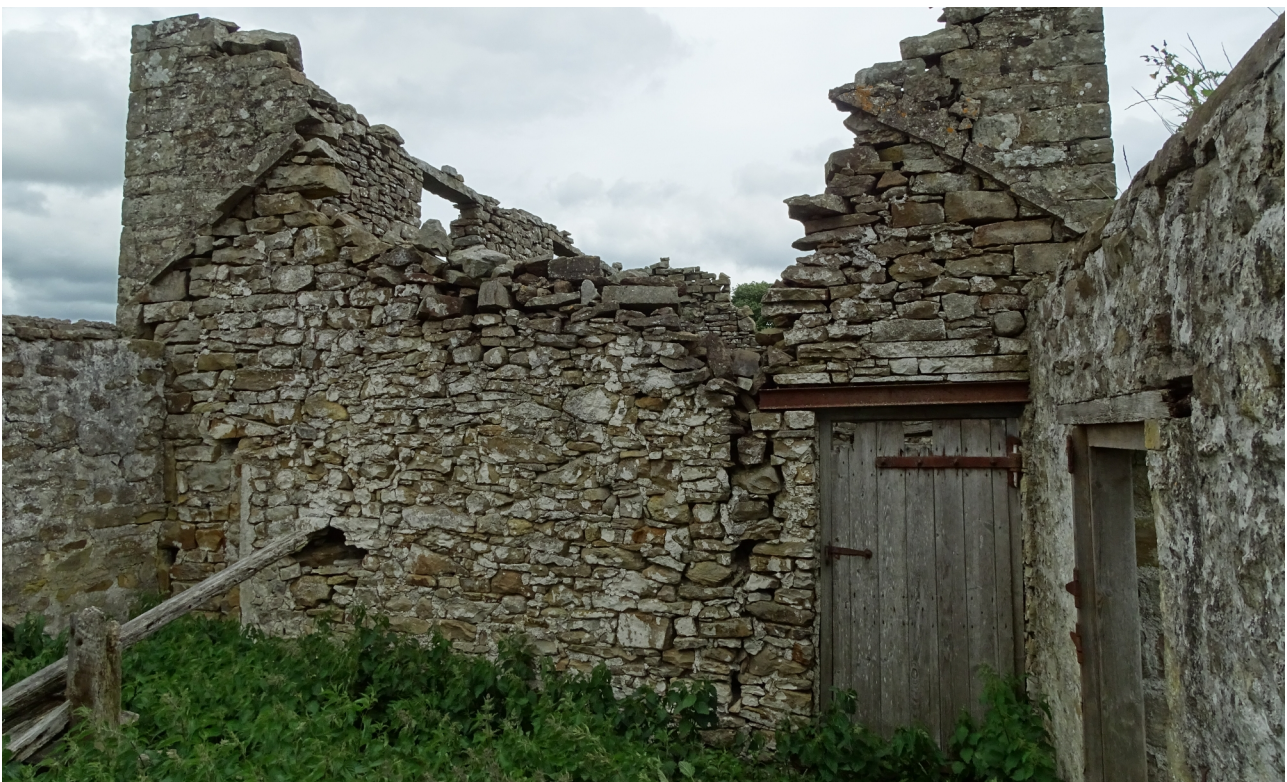
- 3.3.13 The eastern elevation of the extension is mainly in a state of disrepair. It has been constructed from random and un-coursed partially dressed sandstone with remnants of badly degraded plaster between the joints. Remnants of white washed patches are still visible on the stone. The central portion of the wall has collapsed with a large vertical fissure splitting the wall on the central southern side, and also a patched repair on the lower northern quadrant, likely to be the remains

of a blocked door. There is a wooden door within the wall's south side, which allows access between the original barn (**Area A**) and the western extension (**Area C**). The door is composed of vertical wooden slats and braces with two strap hinges and is set within a wooden frame. The door also has a steel lintel which is a reused rigid supporting joist (RSJ).

Plate 25. The eastern wall of Area C (frame GVB19017)

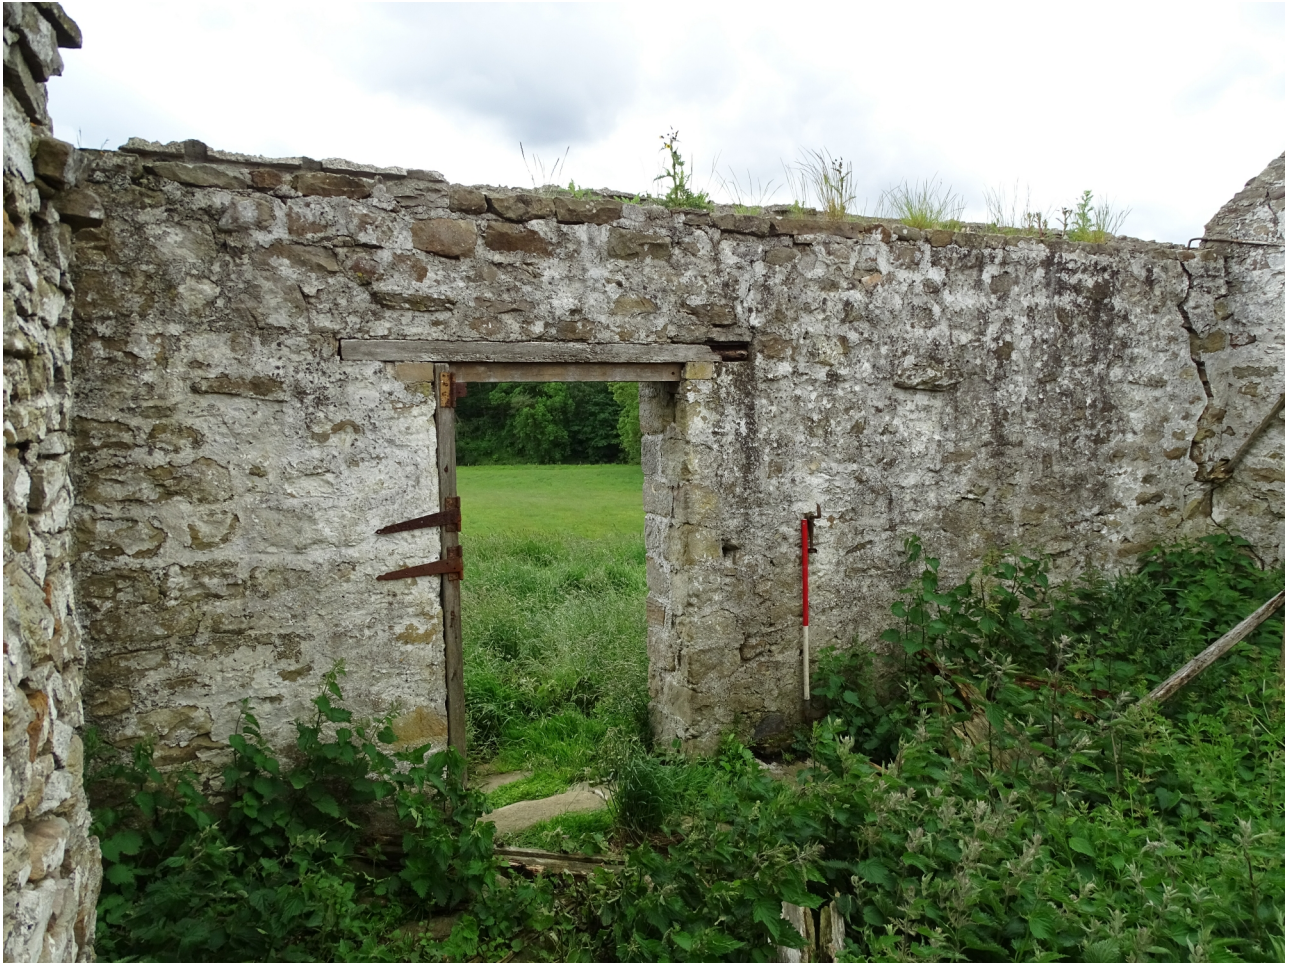
3.3.14 The southern elevation is constructed of roughly hewn sandstone blocks, partially dressed in areas with heavily mortared joints with a lime whitewash applied. There is a small fissure visible internally on the western side but not externally visible. The doorway within the elevation has a wood frame

Plate 26. The southern wall of Area C (frame GVB19018)

attached but no door. Internally there is a wooden lintel above the door which is set immediately behind the stone lintel visible externally within the external elevation (see Section 3.2.6). Two single sandstone steps spanning the width of the doorframe door allow access to this area.
