**BUILDING SOUTH OF
WHINFIELD COTTAGE**
Windy Bank Road, South Bedburn
Woodland, County Durham
NGR 406578 527310

Historic Building Recording

Project 284-19-HBR | November 2019

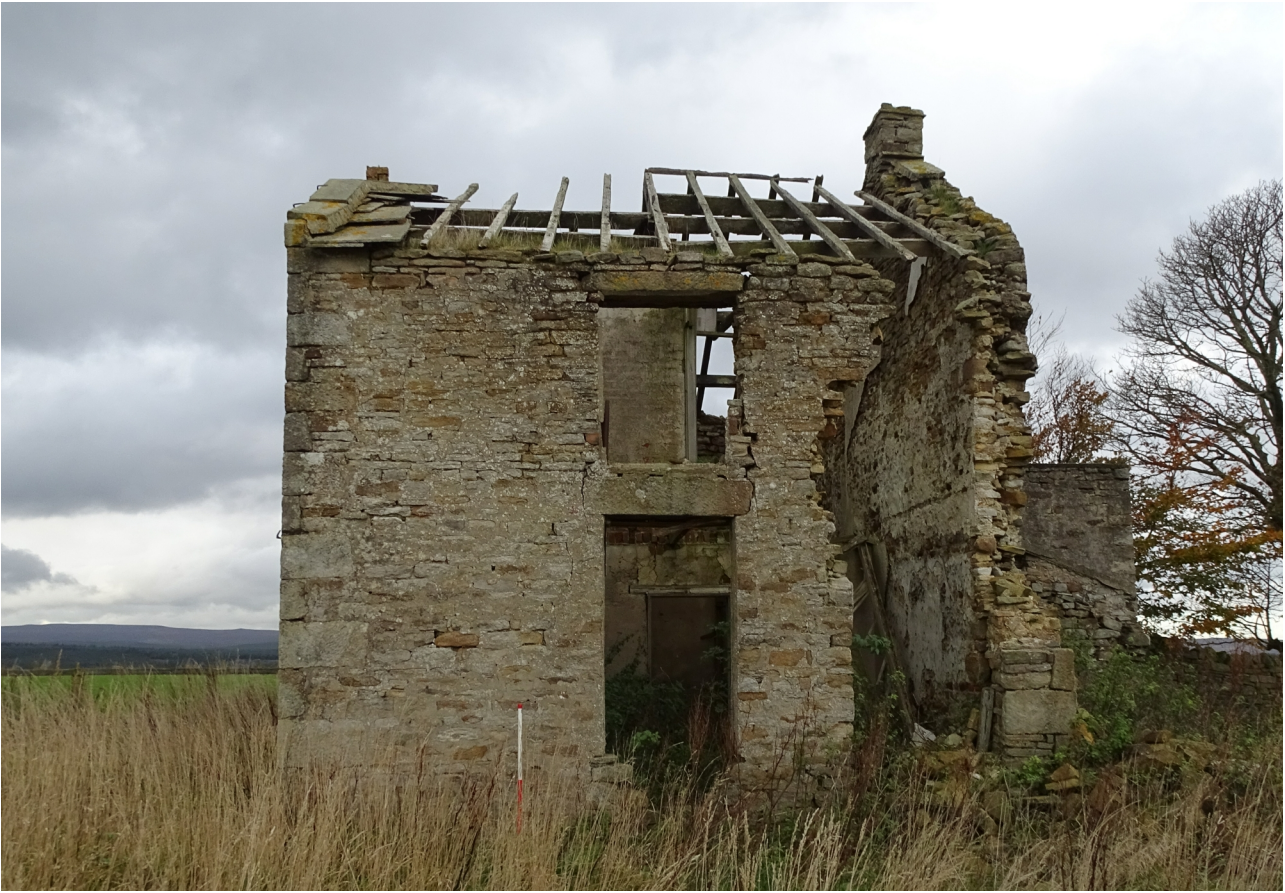
Plate 6. The primary south-eastern elevation (frame WCW002).

3.2.3 The southern corner of the building sported quoins (see *Plate 6* for reference), but the north-eastern extent of the facade had collapsed above the line of the ground floor external door to its full height (see *Plate 7* for detail). As such no evidence of a potential window on the first floor above the door remained. The partial remains of the stone door jambs could be seen. The first floor window roughly centrally located within the elevation had a stone lintel (see *Plate 8* for

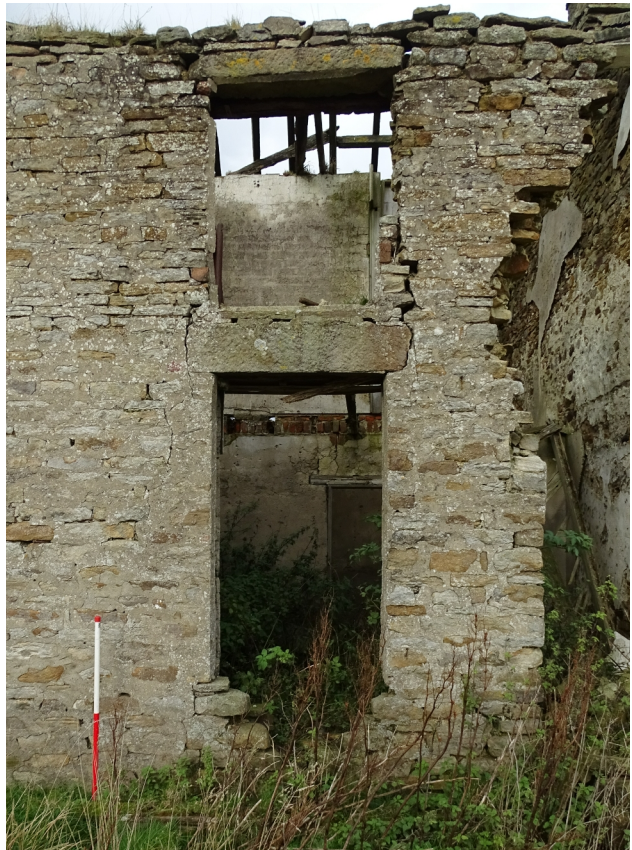
Plate 8. The windows (detail) (frame WCW005).

detail), with the sill resting atop the stone lintel for the ground floor window. The sill for the ground floor window had partially collapsed but its form was still visible.

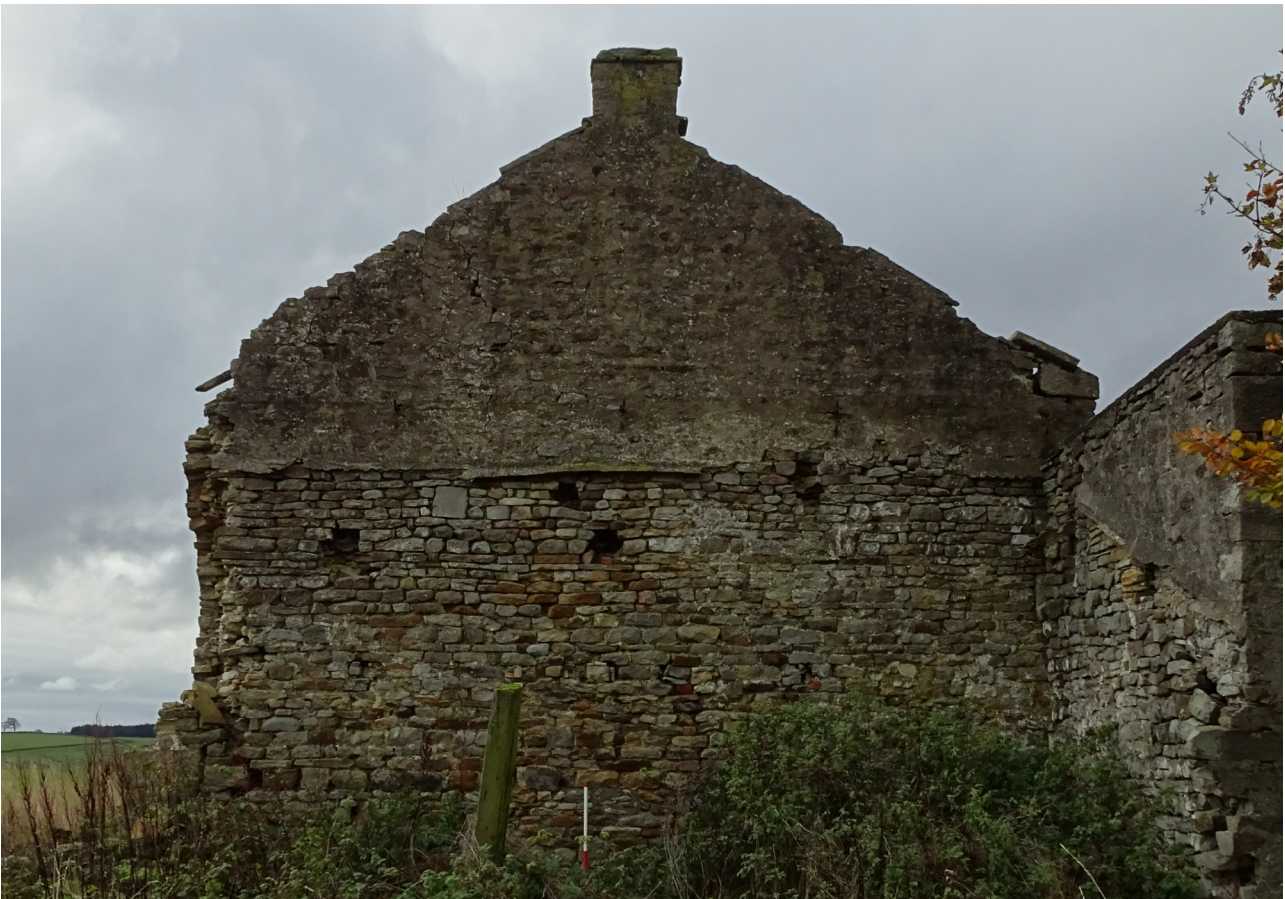
Plate 15. The north-east elevation (frame WCW015).

3.2.11 **North-west facing elevation:** The main north-eastern elevation of the main house was rendered (see Plate 15) above the roof line for the lean-to 'barn'. Historic mapping shows that the barn was derelict by at least 1978. Where the north-western elevation would have been within the 'barn' it can be seen to be constructed of rubble and slabbed stone, roughly coursed and repaired in a number of places. Voids relating to the timber structure of the lean-to can be seen within the wall, and Plate 17 shows the internal south-east facing wall of the structure, which can be seen to butt the main house and was not keyed in.

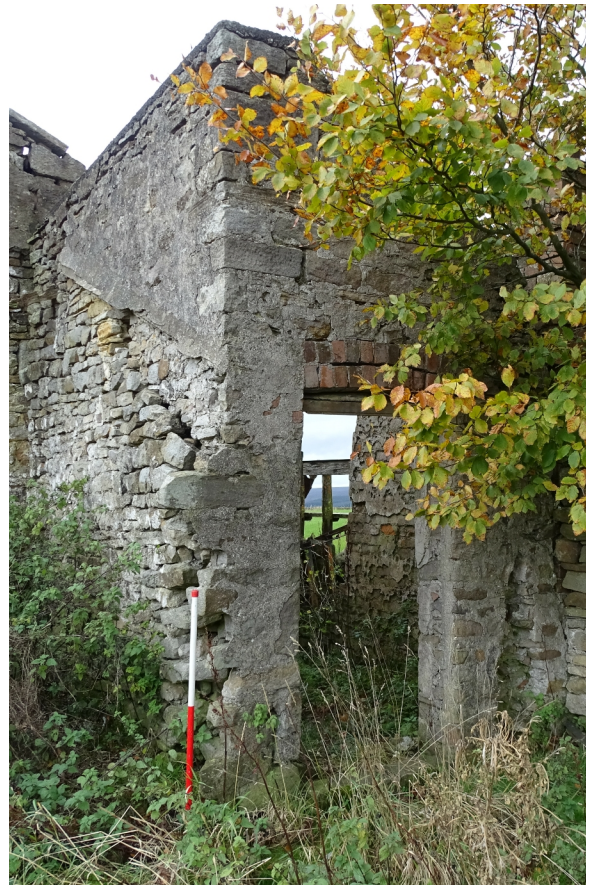
Plate 17. The north-east elevation of the extension (frame WCW014).

3.2.12 The northeastern extent of the northern extension can be seen on Plate 17. The elevation was constructed of rendered stone with a brick relieving arch over a central doorway. The rubble stub of the remains of the collapsed northeastern wall of the barn could be seen on the southeastern corner of the wall section.

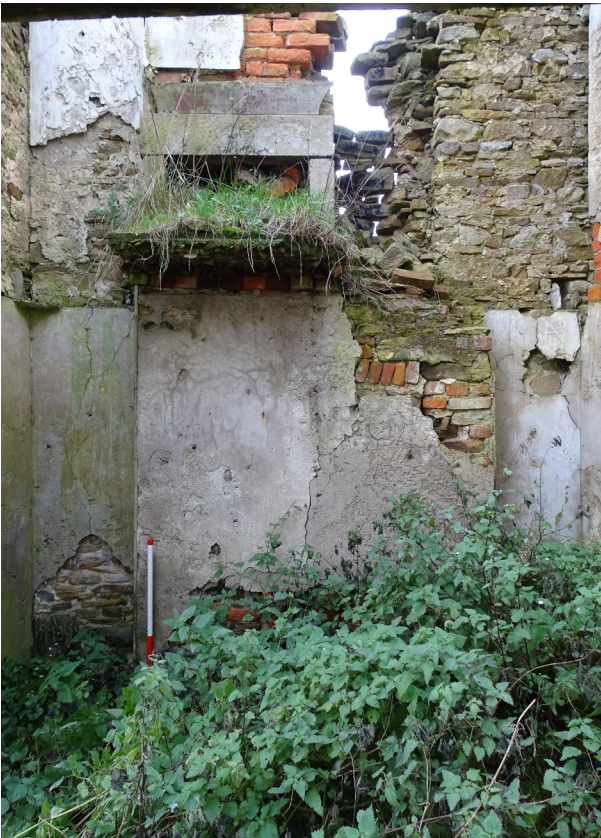
Plate 19. The chimney and suspended upper floor hearth (frame WCW018).

(blocked) as well as a fireplace on the first floor (see Plate 19). The chimney and its associated fireplaces were not original to the structure, rather they were later insertions likely put in place in the latter half of the 19th century. Now in very poor condition, the stack itself is collapsing, and the first floor fireplace with a visible stone lintel and frame could be seen to be full of fallen debris. The hearth for the first floor fireplace remains suspended on a brick plinth. The collapse noted in the outer wall (see Section 3.2.5) is aligned against the back of the brick chimney insert, suggesting that the construction of the chimney caused a weakness in the wall structure and a fault line for the collapse to follow.

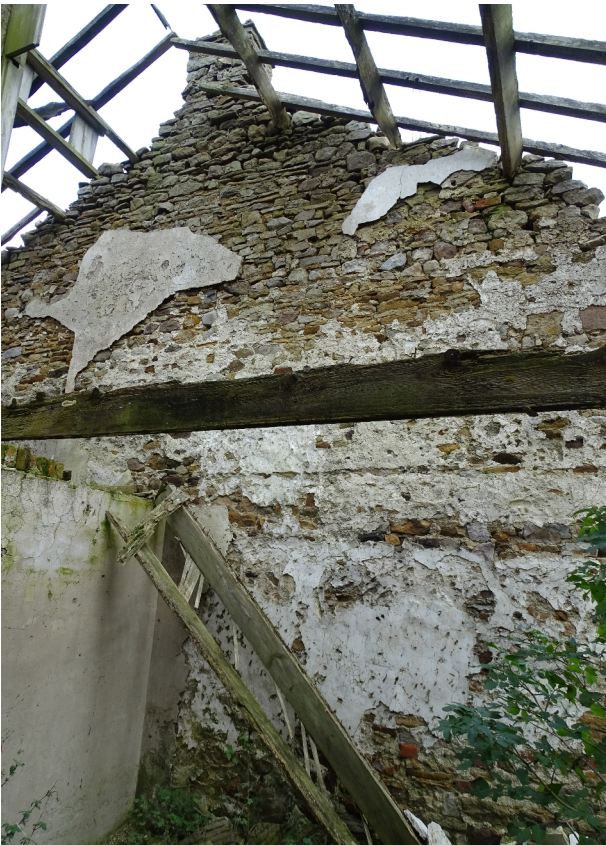
Plate 20 (left). The northeastern wall of Room A (frame WCW024).

3.3.4 The northeast wall of Room A shows little detail (see Plate 20) other than the scar of the ceiling/floor level.

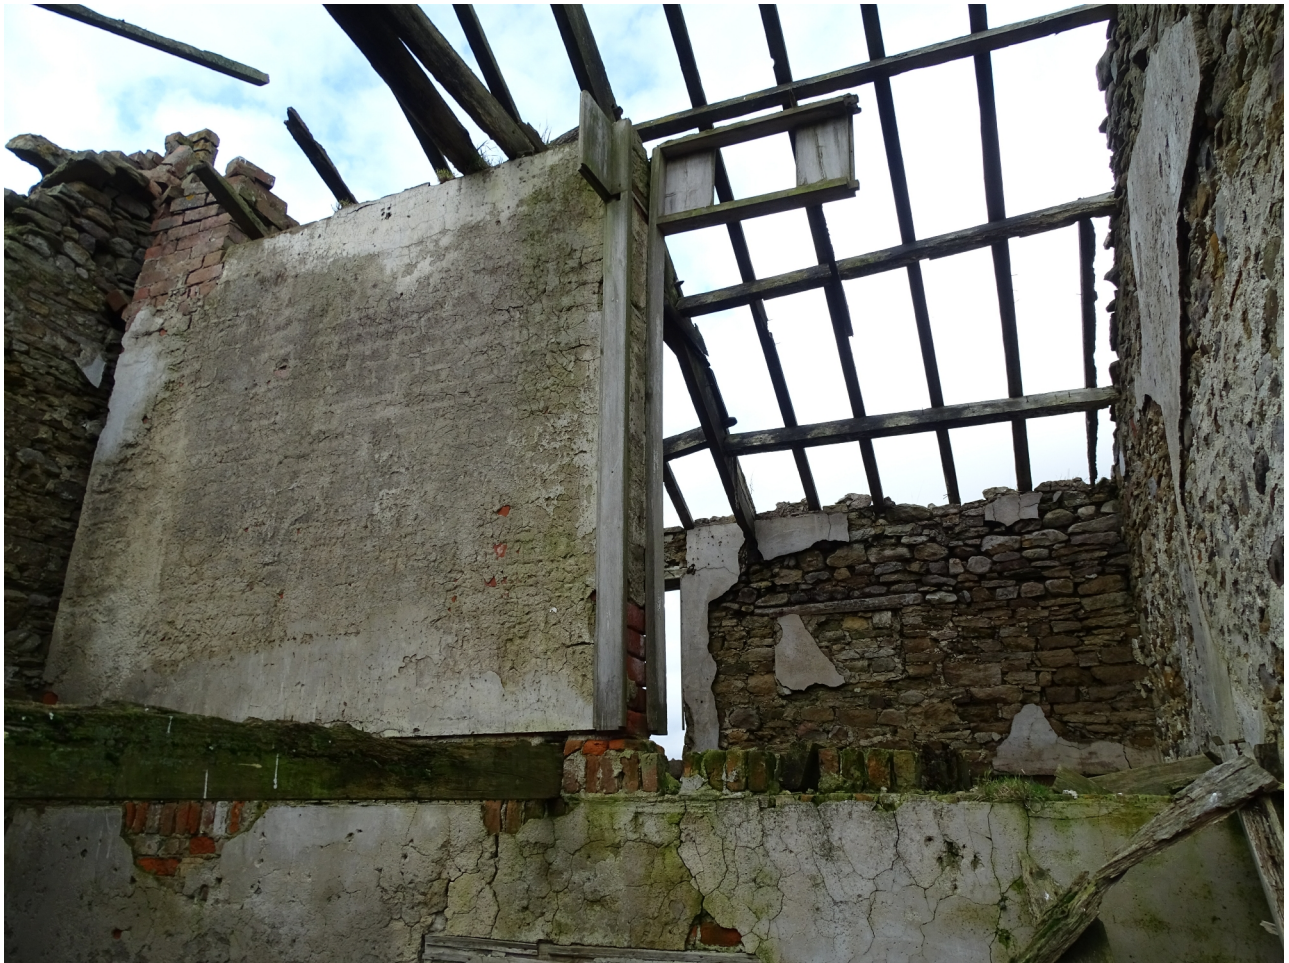
Plate 22. The northwestern wall of Room A, upper floor (frame WCW021).

3.3.5 The internal northwestern wall was constructed of brick and was a later insert, likely constructed at the same time as the chimney on the southwestern wall. Rendered at ground floor level, it contained a door with a wooden frame and lintel through into Room B. The upper floor showed that the wall only continued across half of the floorspace at that height, suggesting a large open area on the northeastern side.

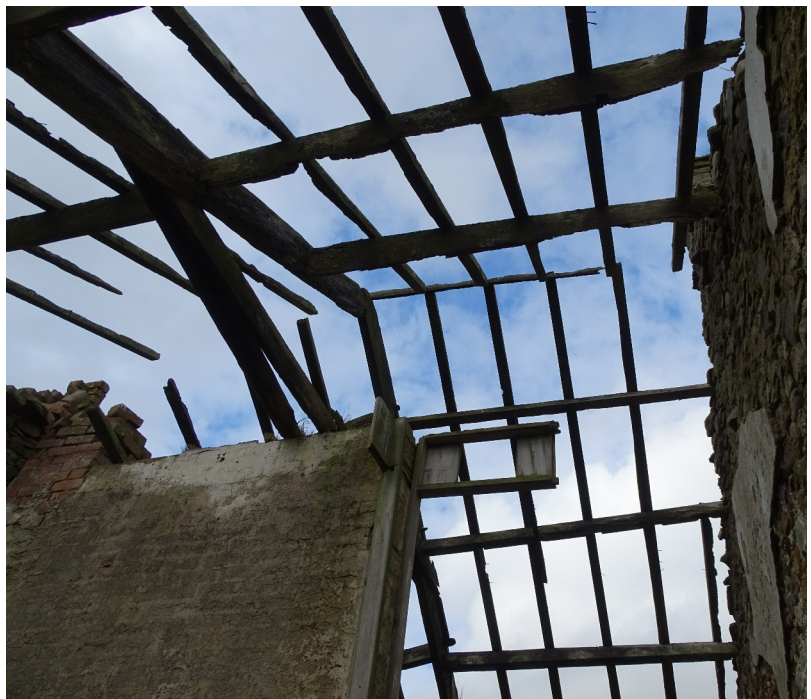
Plate 23. The roof structure from Room A (frame WCW022).

3.3.6 From the internal view of the roofing structure, the remaining timbers while relatively stable presently are likely to be easily dislodged by any strong winds or other adverse weather conditions (see Plate 23).

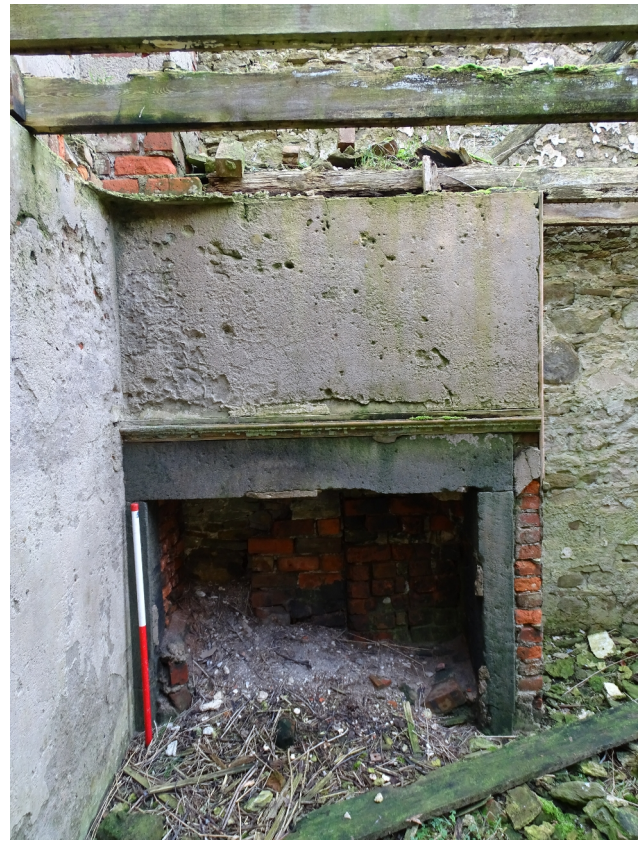
Plate 27. The fireplace in Room B (frame WCW027).

3.3.9 The southwest wall contained a chimney on the ground floor constructed of brick with a stone lintel and frame and a timber mantle (see [Plate 27](#)). The structure had fallen completely on the upper floor with no trace remaining, and it was noted that as with the other brick internal constructions this was a later addition, though in this case the chimney had not been tied into the main wall and was in the process of 'peeling' away. Further evidence of this feature being a later addition to the structure lies in the location of the blocked window noted in the outer wall (see [Section 3.2.4](#)) which lies behind the chimney.

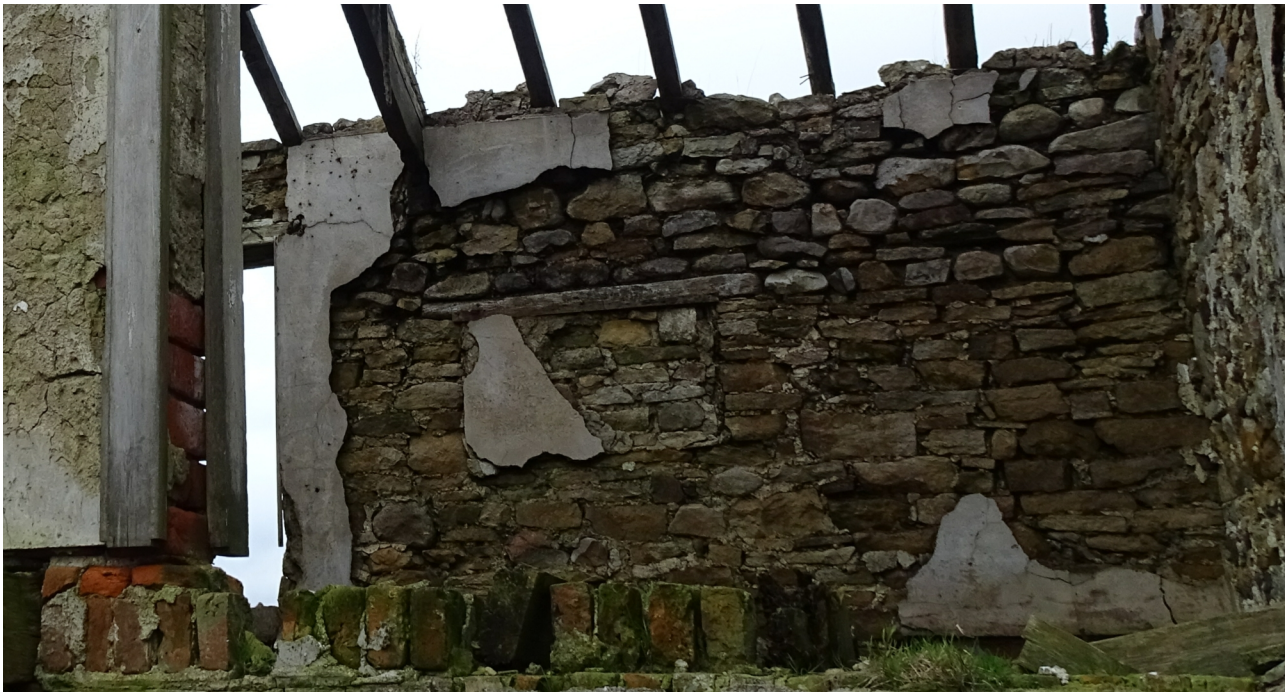
Plate 29. The blocked upper floor window in Room B, taken from Room A (frame WCW021).

beams and their slots. The upper floor also contains the remains of a further small blocked window (noted externally in Section 3.2.10) as can be seen on Plate 29.
