St. David's Church, Little Dewchurch: THE MEASURED SURVEY OF THE REMAINS OF A MEDIEVAL PREACHING CROSS

Report prepared by
Tim Hoverd

Herefordshire Archaeology Report No. 291

**NGR: SO 529 317
Event No. EHE 1840**

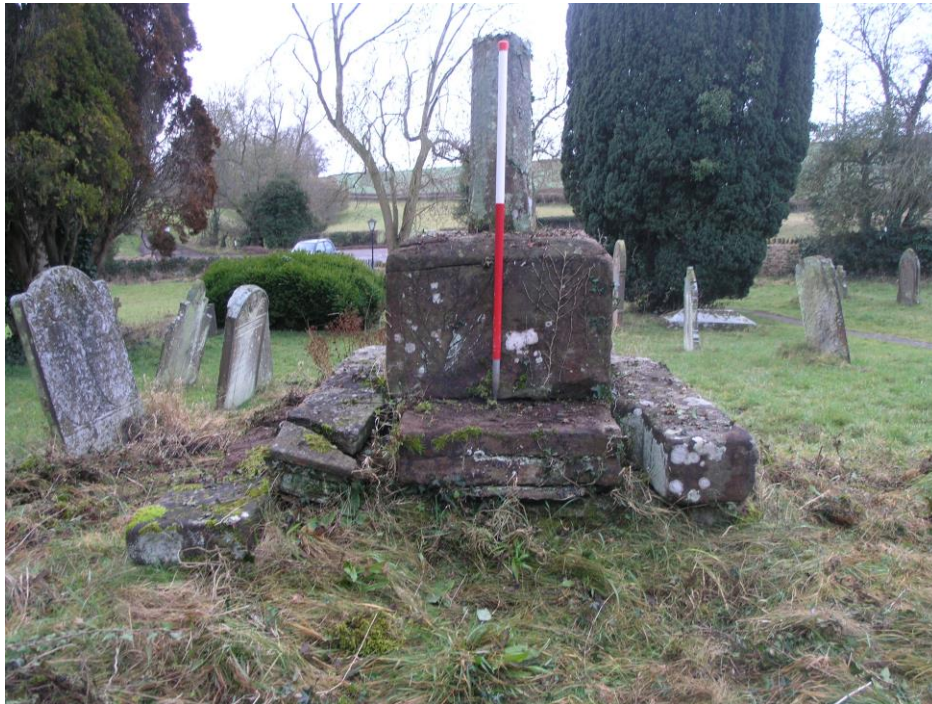
Plate 1: Northern elevation of Cross base. looking south.

The Northern elevation comprised the upslope side of the cross base and as such was originally made up of two steps rather than three. The stone (or stones) making up the lower step have been removed and this has led to the top step on the eastern elevation collapsing at its northern end.

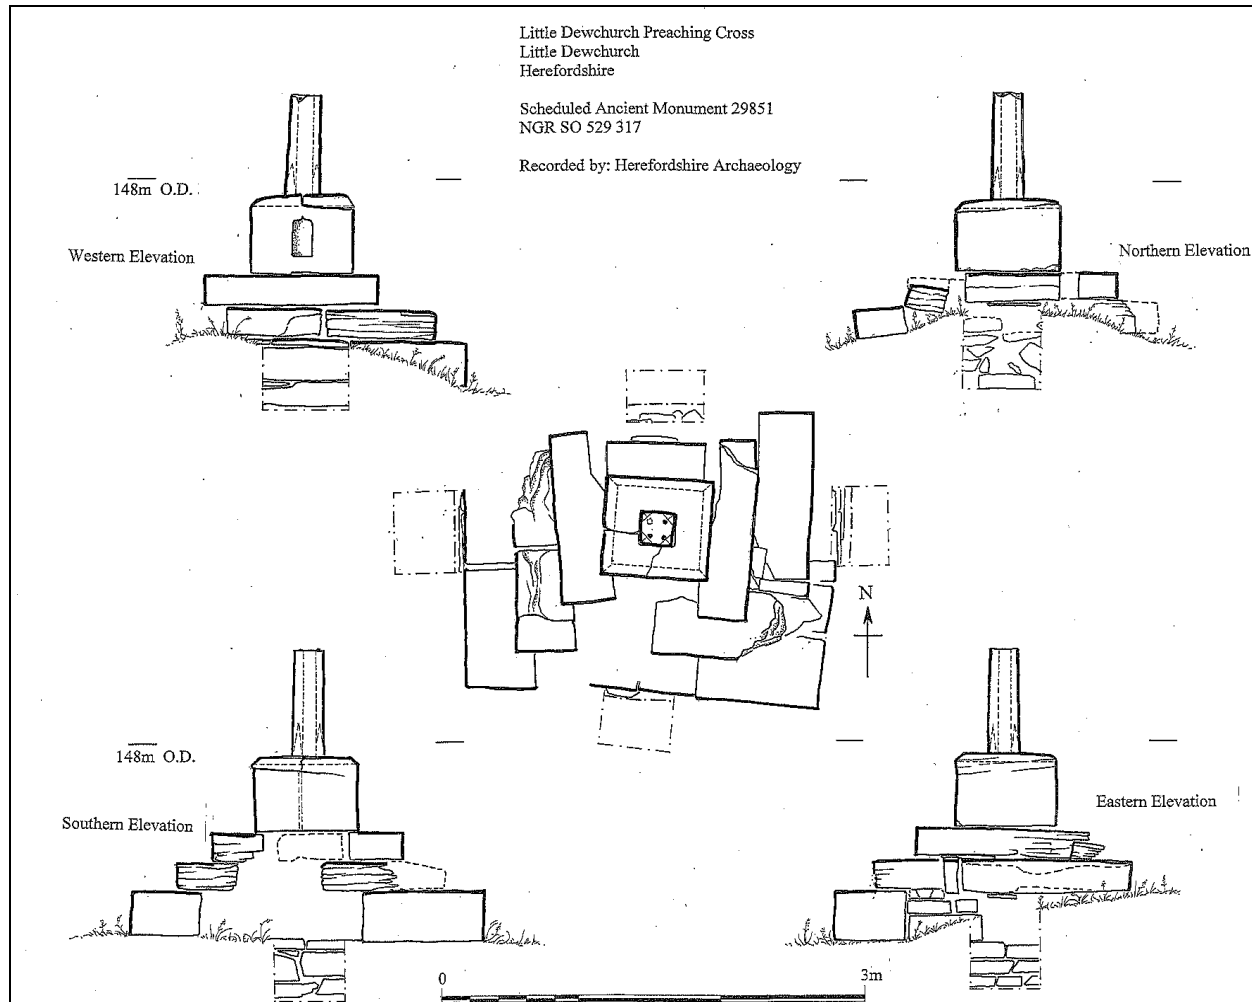
Figure 3: Plan and elevations of Little Dewchurch preaching cross base.

The results of the measured survey illustrate that the structure of the cross base is in generally poor condition. It appears that a considerable amount of damage has occurred in the past resulting in a significant loss of masonry from both the northern elevation and, in particular the southern elevation of the structure. This has resulted in the exposure of the central core of the structure on the southern side resulting in further erosion. The nature of the disturbance is characteristic of a tree having been formerly present in the southern elevation and that this displaced many of the stones, either as it grew or upon its removal. This tree growth, would also account for the side-ways displacement of the top steps on the eastern and western elevations. It was noted that whilst there has been significant side-ways movement of the eastern and western top steps, most of the large blocks of masonry are still on or close to horizontal suggesting gradual movement consistent with root pressure. The location of the missing stones has not been established. The exposed internal core work of the structure is loose and may well have been bonded with a lime mortar which has now decayed.

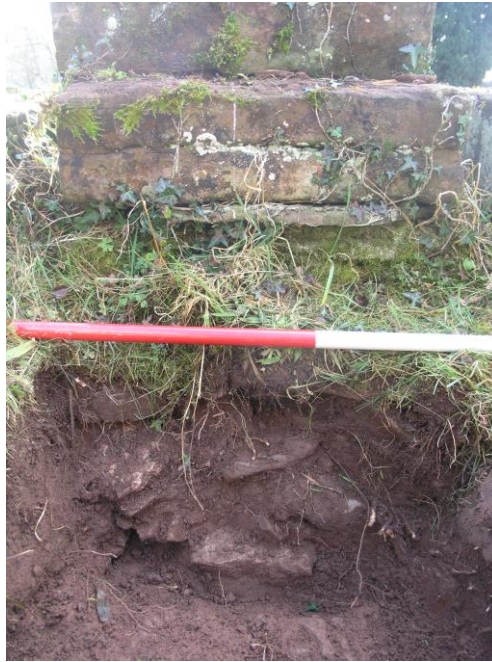
Plate 2: Northern face of cross base, looking south, showing un-coursed rubble foundation.

The foundations of the northern elevation comprised un-coursed and un-bonded rubble to a depth of 0.47m below the present ground surface. A vertical cut for this material was recorded approximately 0.35m below present ground surface.

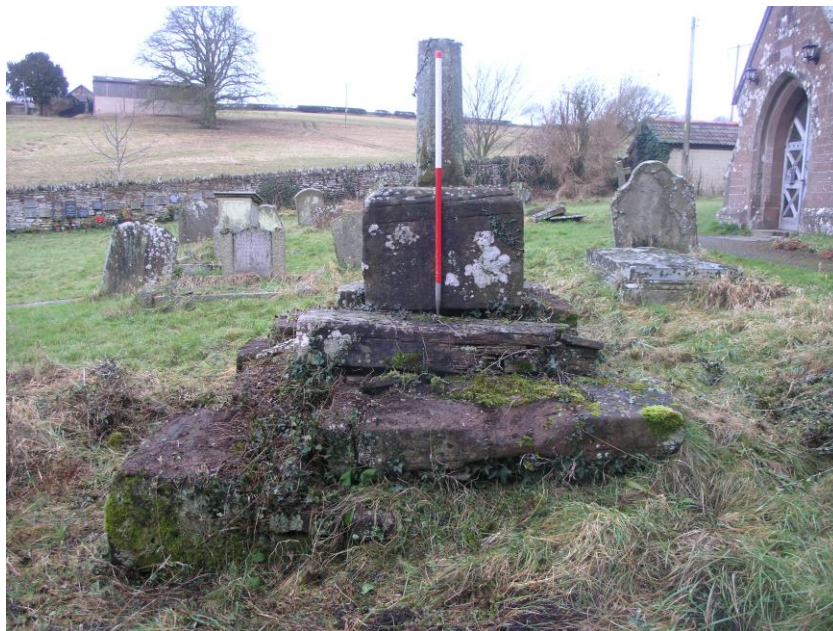
Plate 3: Eastern face of cross base, looking west.

The eastern elevation comprised three steps, with the lowest step running back into the hill slope. The northern end of the top step has fractured and the entire stone has begun to laminate badly. The second step is partially displaced, its front edge having subsided. The southern corner stone of the second step has broken / eroded away so that this corner of the step is missing.

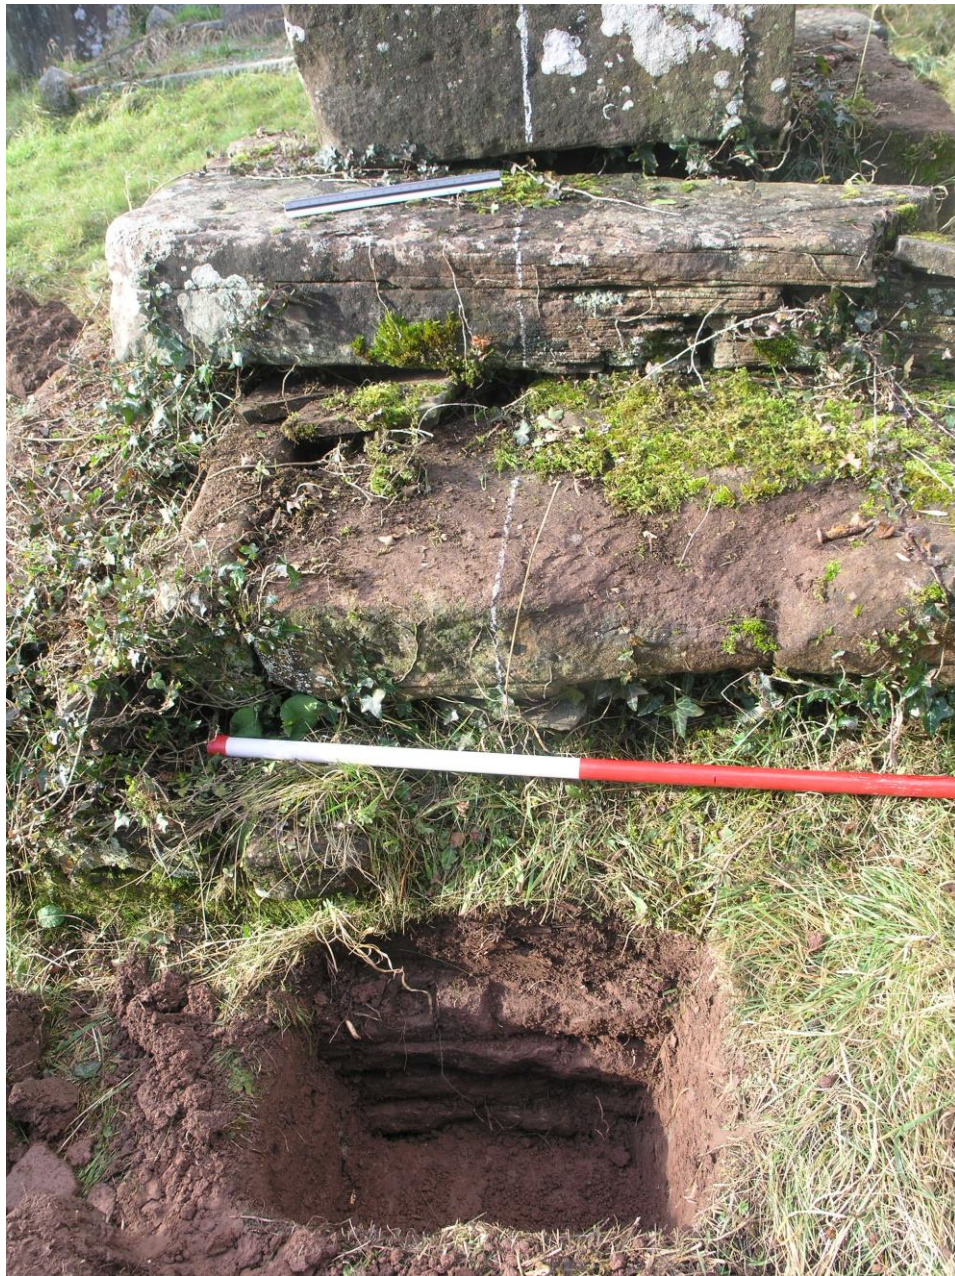
Plate 4: Eastern face of cross base looking west, showing well coursed, but thin, foundation material.

The foundations for the eastern elevation comprised well coursed, slab-like stones. The top of the foundations began at 0.2m below the present ground surface and extended to a depth of 0.5m below the present ground surface. The northern stone or stones of the lower step are missing, which has adversely affected the stone above, causing it to subside. The remaining stones appear to be in their original positions and in good condition. A vertical cut was observed for the foundation. This was cut from approximately 0.3m below the present ground surface.

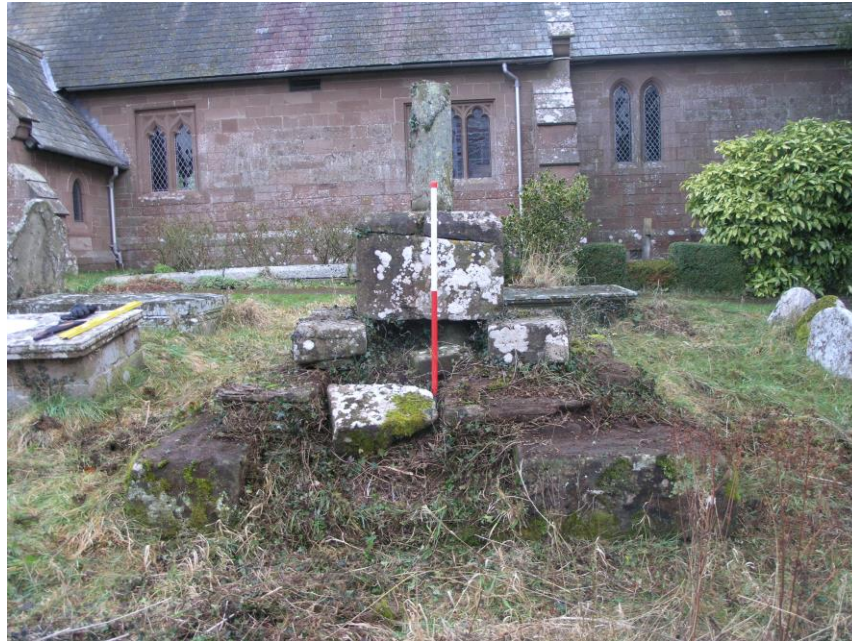
Plate 5: Southern face of cross base, looking north.

The southern elevation comprised three steps, although the central stone of the top step is absent as is the central stone of the second and lower steps. The displaced stone next to the ranging pole in Plate 5 appears to originate from beneath the top stone and for the purposes of this survey its location was not recorded. The eastern stone of the middle step is eroded and badly laminated.

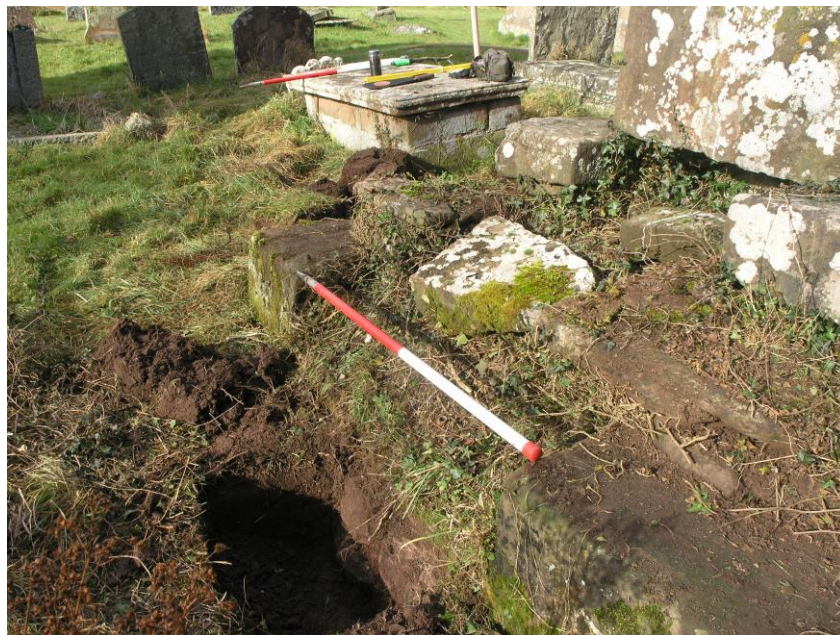
Plate 6: Southern face of cross base, looking north-west, showing first course of foundation.

The foundations of the southern elevation comprised well coursed stones of varying thickness. The top course was made up of relatively thin slabs. The foundation continued to a depth of 0.45m below the present ground surface and appeared to be contained within a cut from a depth of 0.2m below the present ground surface.

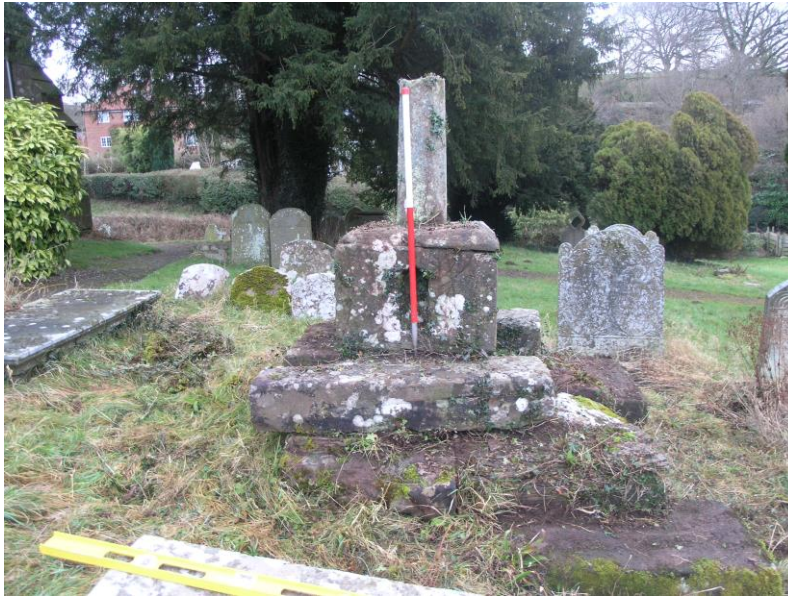
Plate 7: Western face of cross base, looking east.

The western elevation comprised three steps with the lowest step running back into the hill slope. Both of the remaining stones, which form the middle step are badly laminated / eroded. The single stone that forms the top step is displaced and has been pushed out of position at its northern end. The top stone, into which the cross shaft fits, is fractured on its south-western corner.

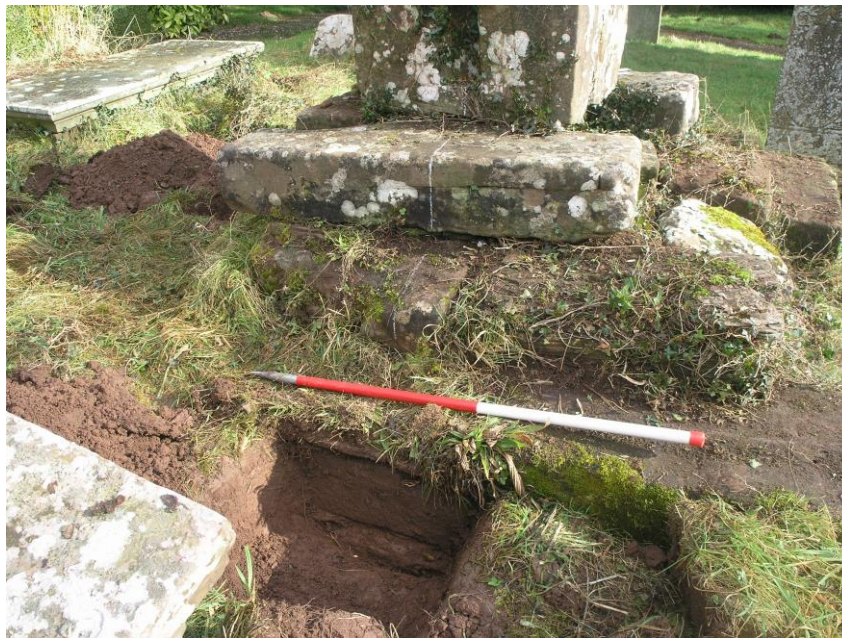
Plate 8: Western face of cross base, looking east, showing well coursed large block foundation

The foundations of the Western elevation comprised well coursed stones of varying thickness. The top course was made up of relatively thin slabs. The lower courses are made of far larger stones with thin fillers stones between. The foundation continued to a depth of 0.45m below the present ground surface and appeared to be contained within a cut from a depth of 0.2m below the present ground surface.
