**CRASWALL PRIORY, ABBEY FARM, CRASWALL, HEREFORDSHIRE**

**A BASIC MANAGEMENT PLAN  
TO ASSIST IN GUIDING THE MANAGEMENT  
OF THE MONUMENT AS PART OF A  
HIGHER LEVEL STEWARDSHIP SCHEME**

Herefordshire Archaeology Report No. 357

**VISIT:** 26<sup>th</sup> November 2015

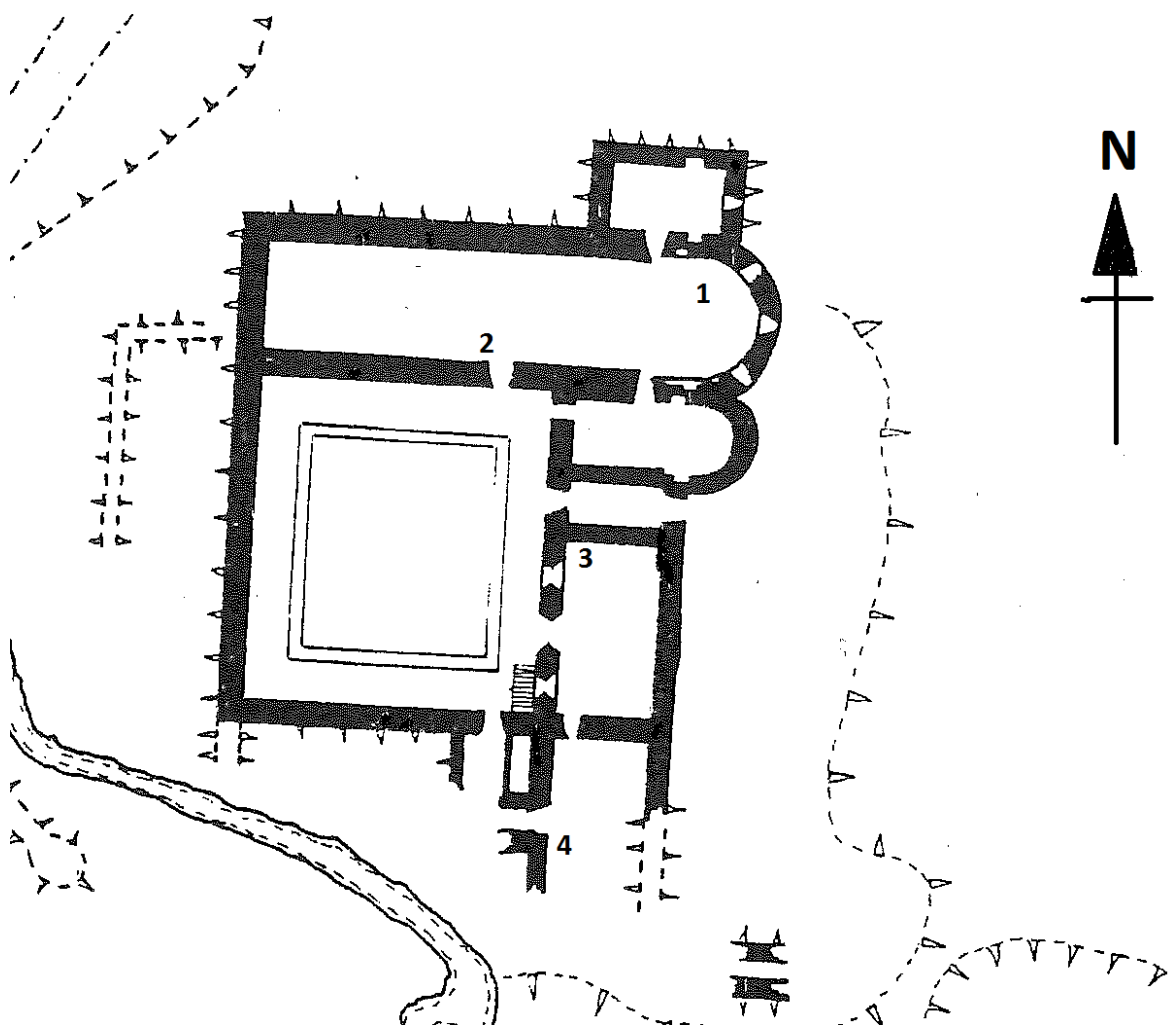
Figure 3: Location of management risks (labelled 1-4) in relation to the monument.

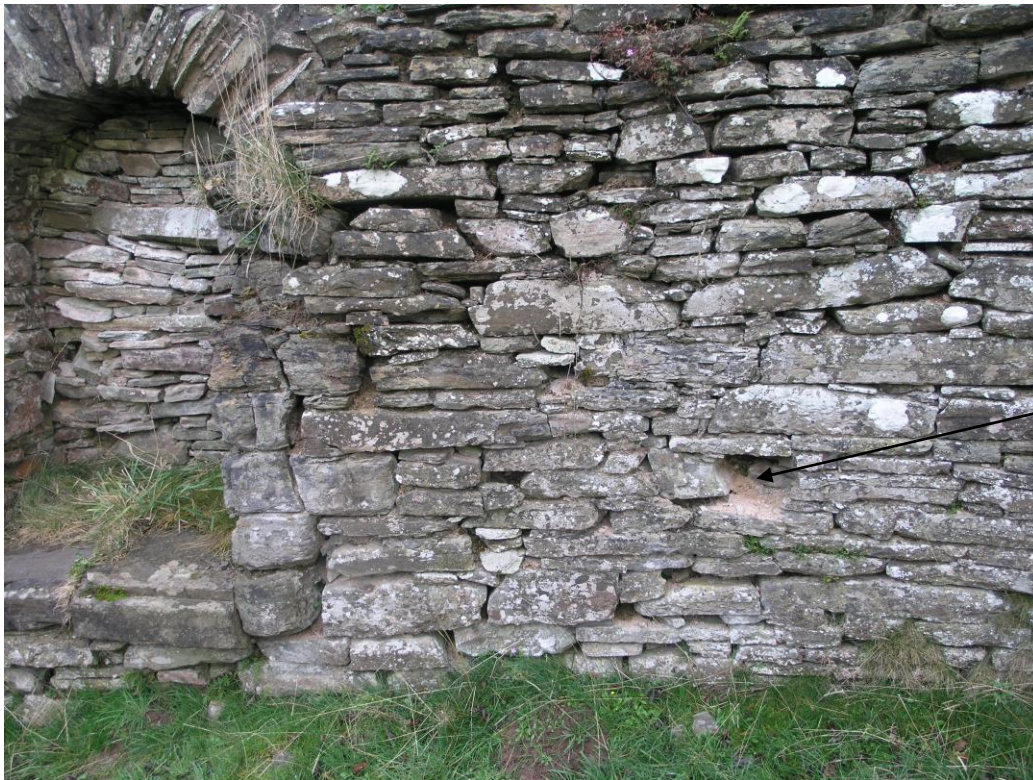
Missing  
stones

1. Two facing stones (or parts thereof), have fallen from the internal face of the northern side of the chancel (see Plate 2 and figure 3). One fragment of displaced stone is on the ground immediately below the void.

Plate 2: Northern internal face of Chancel showing localised area of face erosion.

- 1. *Repair of localised areas of facing / core work which have already been subject to consolidation***  
*Two facing stones (or parts thereof), have fallen from the internal face of the northern side of the chancel (see Plate 2 and figure 3). The consolidation and filling of this void will stop further erosion of this area.*
- 2. *Repair of localised areas of facing / core work which have not already been subject to consolidation.***

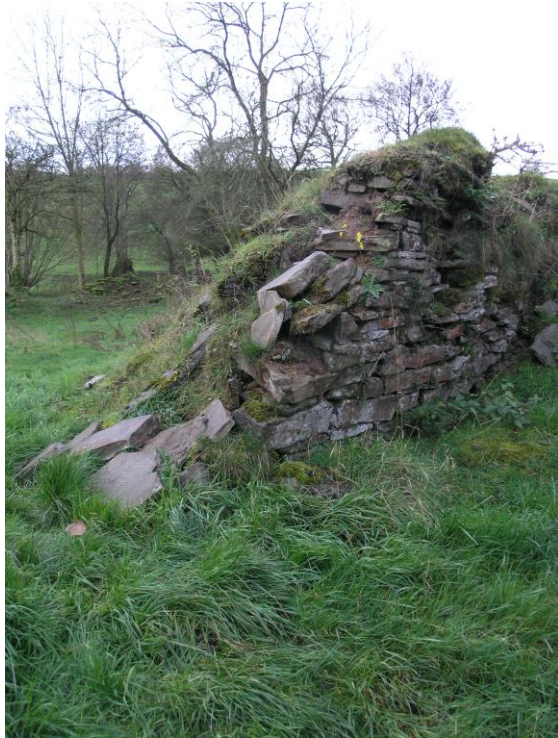
2. Area of core and face erosion on wall stub of south wall of nave. (Plates 3 & 4 and figure 3). A considerable number of stones and other core material has recently been displaced from the east facing wall stub which formed the doorway from the nave into the cloister. It would appear that this area has been badly affected by rain water within the core and would benefit from consolidation and capping. Erosion is still active.

Plate 3: doorway from the nave into the Cloister showing recent tumble.

*Area of core and face erosion on wall stub of south wall of nave. (Plates 2 & 3 and figure 3). Erosion is still active in this area and this area of masonry should be consolidated and capped.*

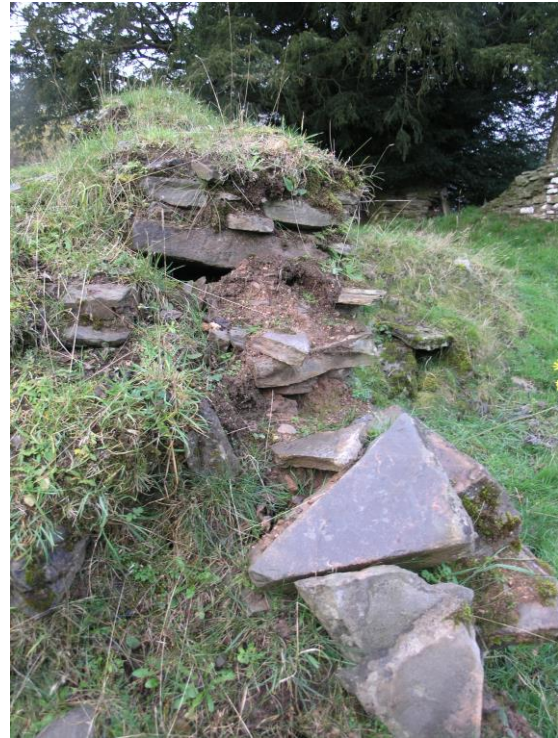
Plate 4: Detail of tumble and exposed core.

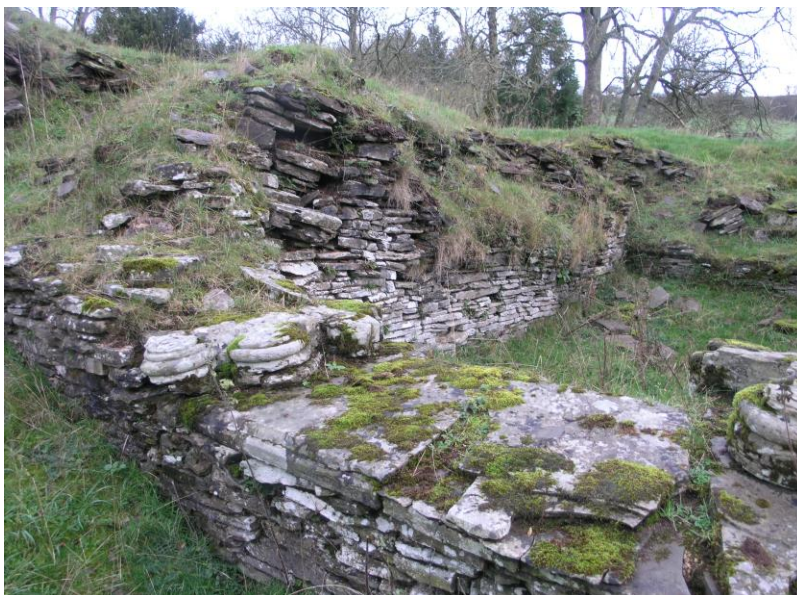
3. Area of face erosion imminent within north wall of Chapterhouse. (Plate 5 and figure 3). A significant area of upper coursing close to the north-western corner of the chapterhouse is unsupported and requires consolidation. It appears to be at more of an angle than the 1997 recording work illustrates, suggesting slow movement.

Plate 5:  
Unsupported  
and vulnerable  
face of northern  
chapterhouse  
wall.

*Area of face erosion imminent within north wall of Chapterhouse. (Plate 5 and figure 3). This area should be consolidated and capped in order to avoid collapse of facing stone.*

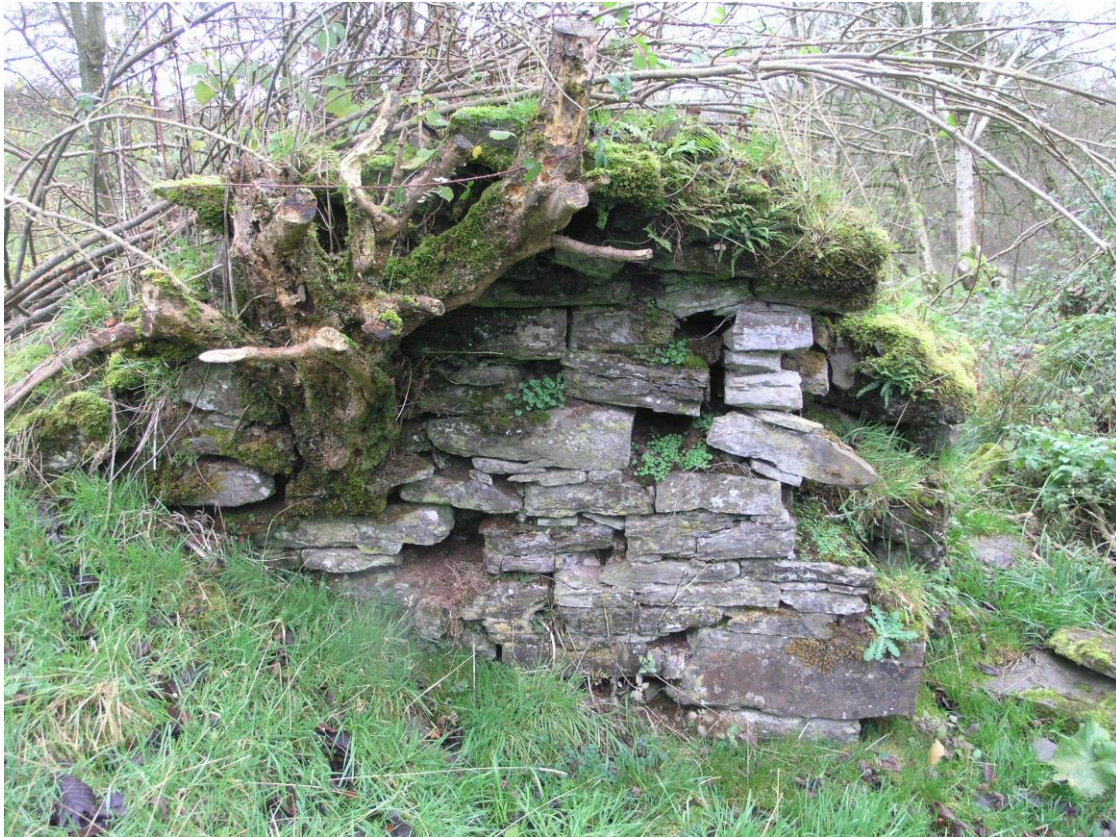
4. Imminent collapse of southern jamb / wall stub of reredorter stair door (Plate 6 and figure 3). This length of wall is in danger of significant collapse, particularly at its northern end due to vegetation and voids.

Plate 6: Southern jamb / wall stub of reredorter stair door.

*Southern jamb / wall stub of reredorter stair door (Plate 6 and figure 3). This length of wall is in danger of significant collapse, particularly at its northern end due to vegetation and voids. This piece of masonry should be consolidated and capped.*

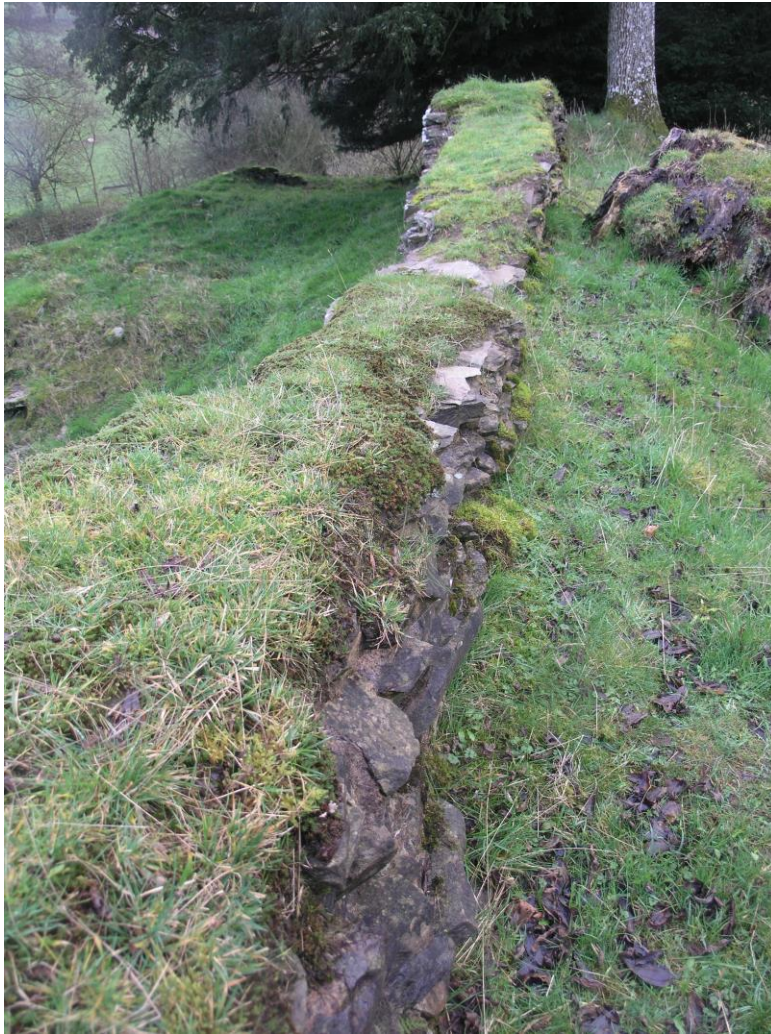
Plate 7: Vegetative capping along northern nave wall (looking west). The light areas are the geotextile between the masonry and the vegetation.

*Where practicable, areas of failed vegetation capping should be replaced. This will require the removal of the geotextile from the wall / shelf and the importation of a suitable soil matrix (subject to the approval of Historic England) and the provision of suitable vegetation to be re-planted. It is recommended that the geotextile is not replaced in these areas. It is recommended that failed capping together with the associated geotextile is removed from areas of core "shelf" and not replaced.*

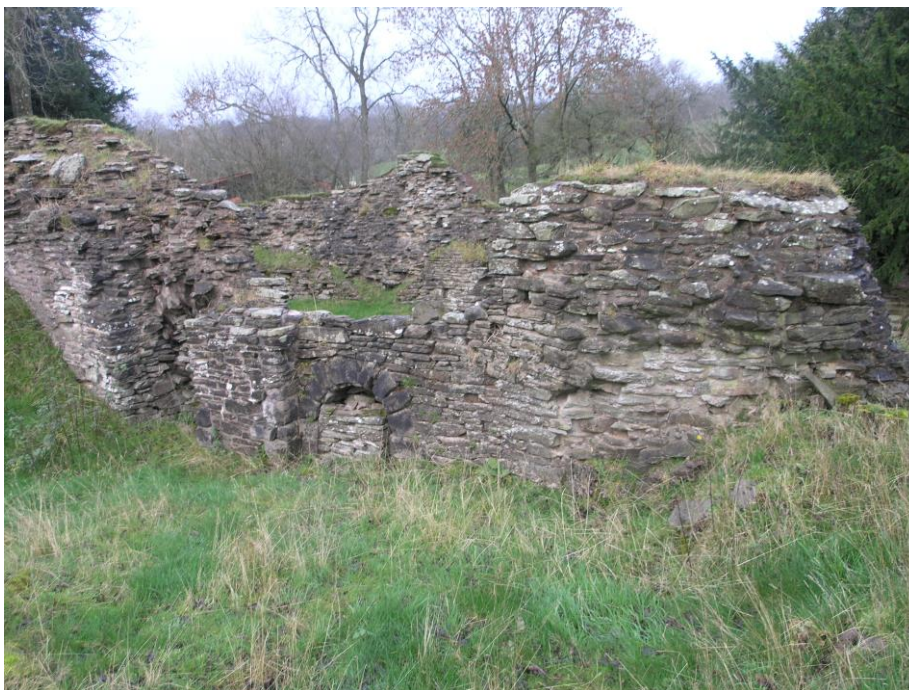
Plate 8: General view of exterior, southern wall of Chancel showing dead, dry vegetation over geotextile membrane.

Localised areas of capping are showing advanced signs of drought stress (as can be seen in Plate 8) where what was once a thick, well developed cap of vegetation is even now (November 2015), dry and brown. This has led to the loss of soil from around the edges which, in turn, has led to the exposure of the geotextile membrane around the edges. This has led to further erosion as the exposed geotextile edges are blown by the wind.

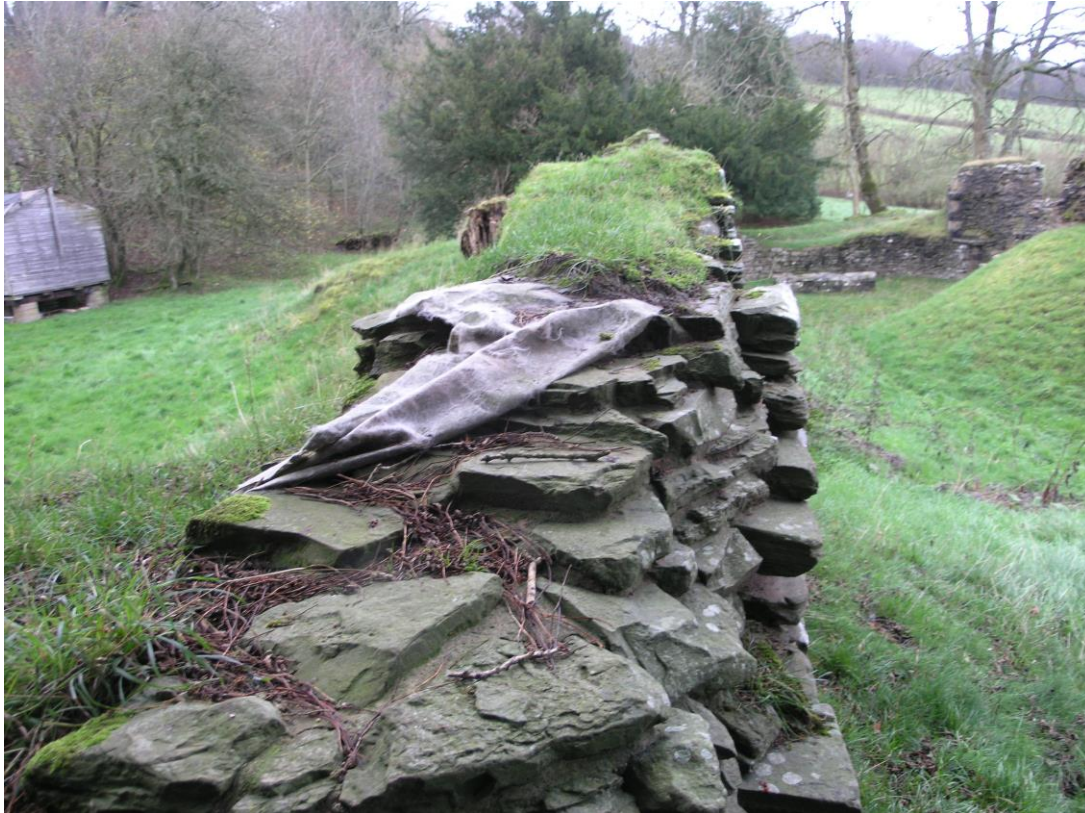
Plate 9: North nave wall looking east showing loose geotextile membrane.

Two areas appear to have been affected by excess water and localised lack of light. Plates 9 and 11 show areas where the vegetation cap has died away exposing the geotextile. In the case of Plate 9, close to the western end of the Nave, it appears that due to shading from the mature Ash tree and the very considerable Yew tree, little if any vegetation cover had been achieved, the lack of sustainable vegetation cover has then led to the soil being washed off by rain and water dripping from branches. It would appear from the folded and displaced nature of the geotextile, that it is being caught by the wind and may be gradually eroding the vegetation cap

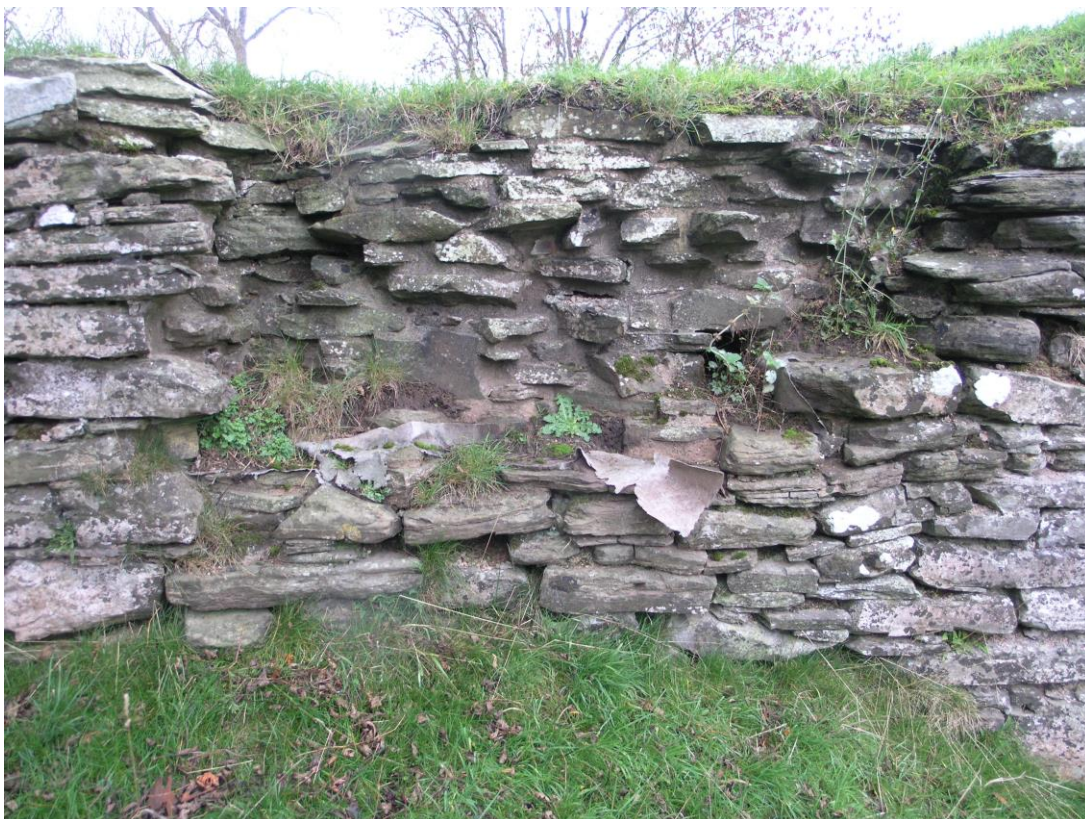
Plate 10: Nave north wall internal elevation showing loose geotextile membrane on core "shelf".

It is clear that this has not been achievable in some locations (see figure 4 areas of red for rough locations / extent). It appears that the smaller / narrower the area covered by geotextile membrane, the more prone to vegetation loss and therefore failure the capped area is. This can be seen on many of the “shelf” areas of core-work in the Chancel and Nave and also along the eastern wall of the Chapterhouse, (see Plate 10).

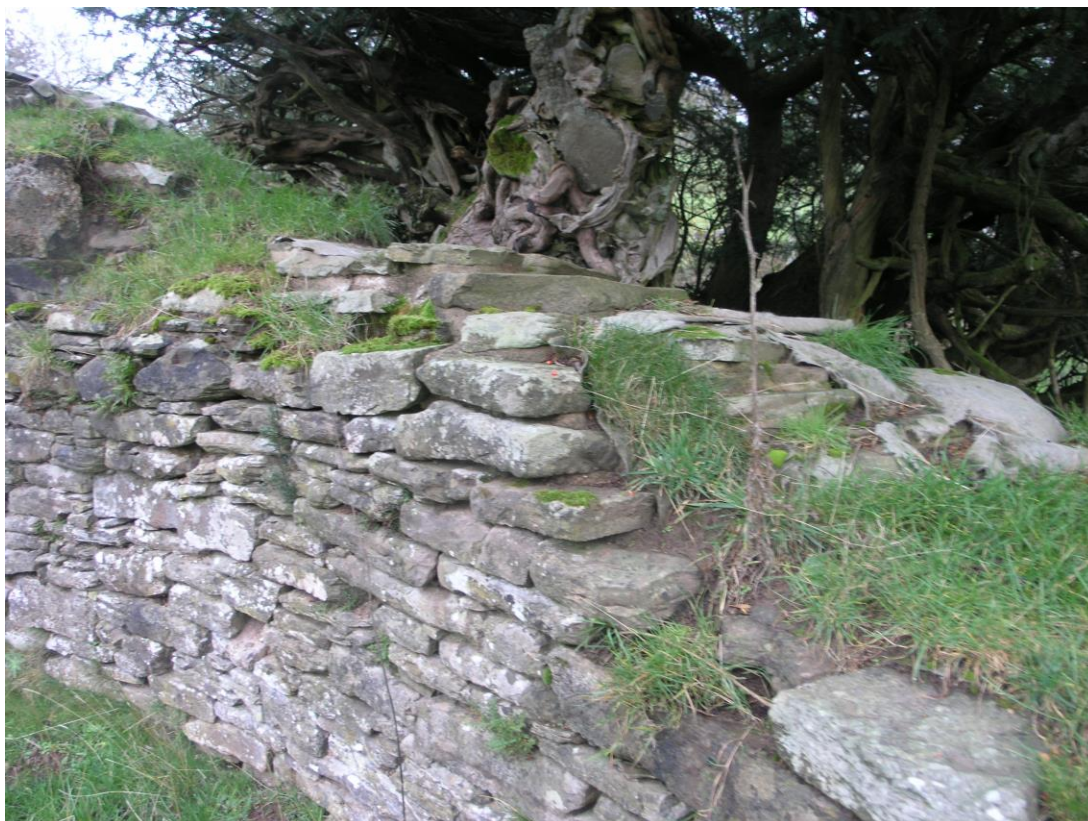
Plate 11: Displaced and loose geotextile membrane under yew tree on northern side of Chancel. The vegetation has been affected by light levels and eroded by dripping water from the tree branches.

further along the wall. Plate 11 shows a localised area under a very mature Yew tree on the northern side of the Chancel. Again lack of light and the dripping of water from branches has precluded vegetation growth and washed soil from this area.

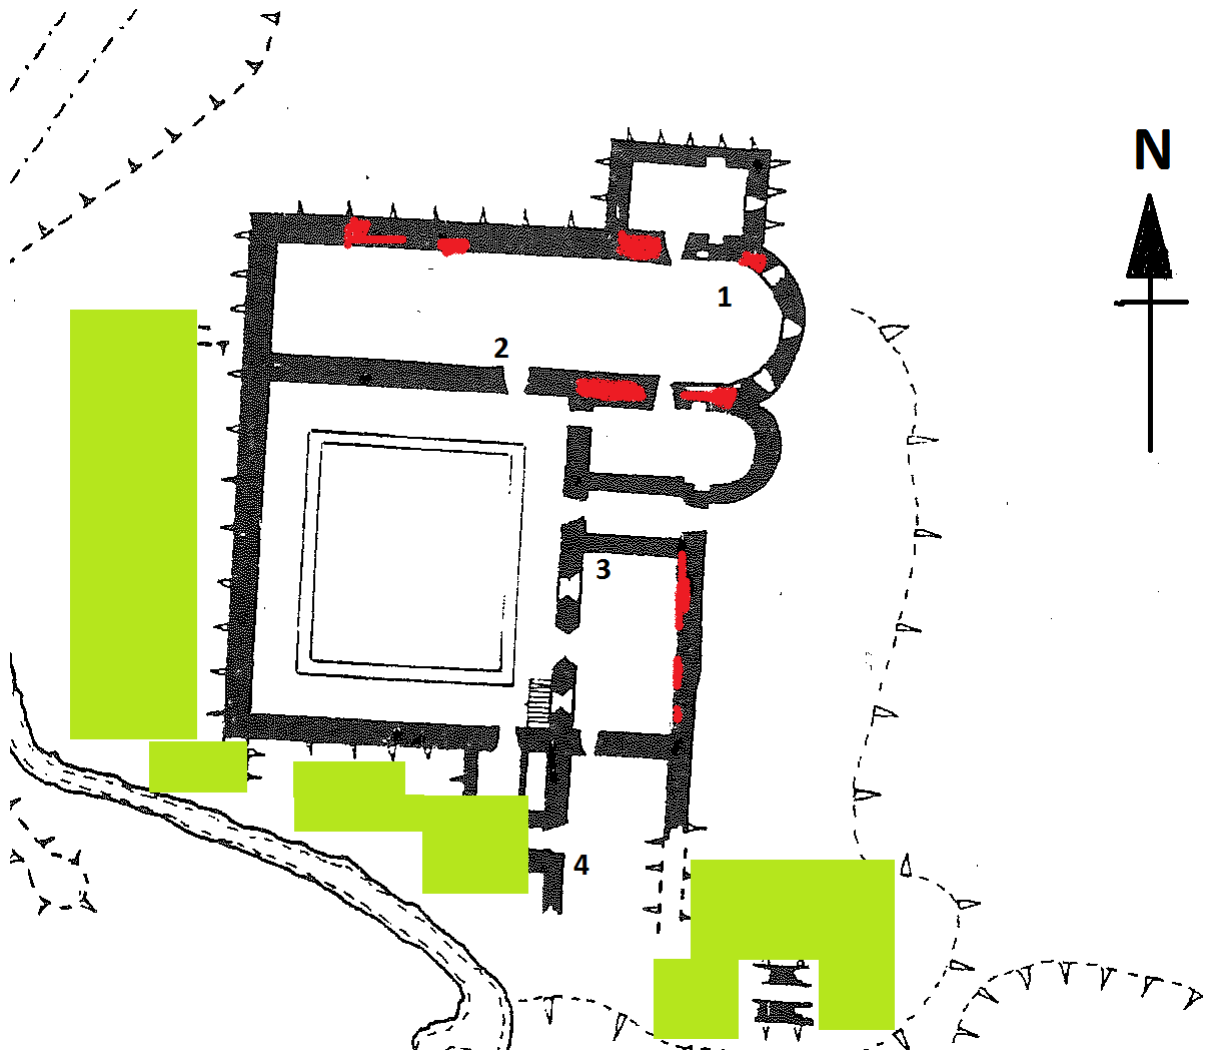
Figure 4: Areas of soft capping to be replaced (red) Areas where Tree and scrub growth need to be controlled (green).

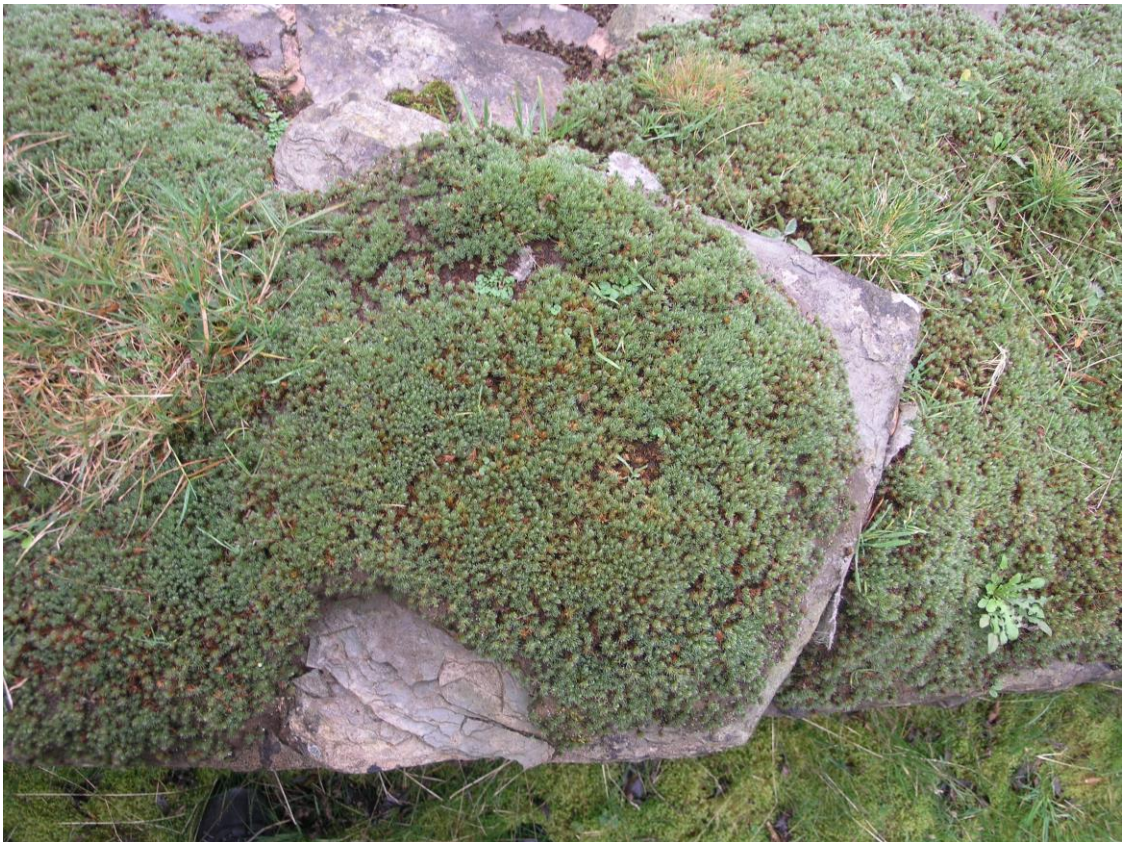
Plate 12: Heavy moss cover along north Chancel wall top.

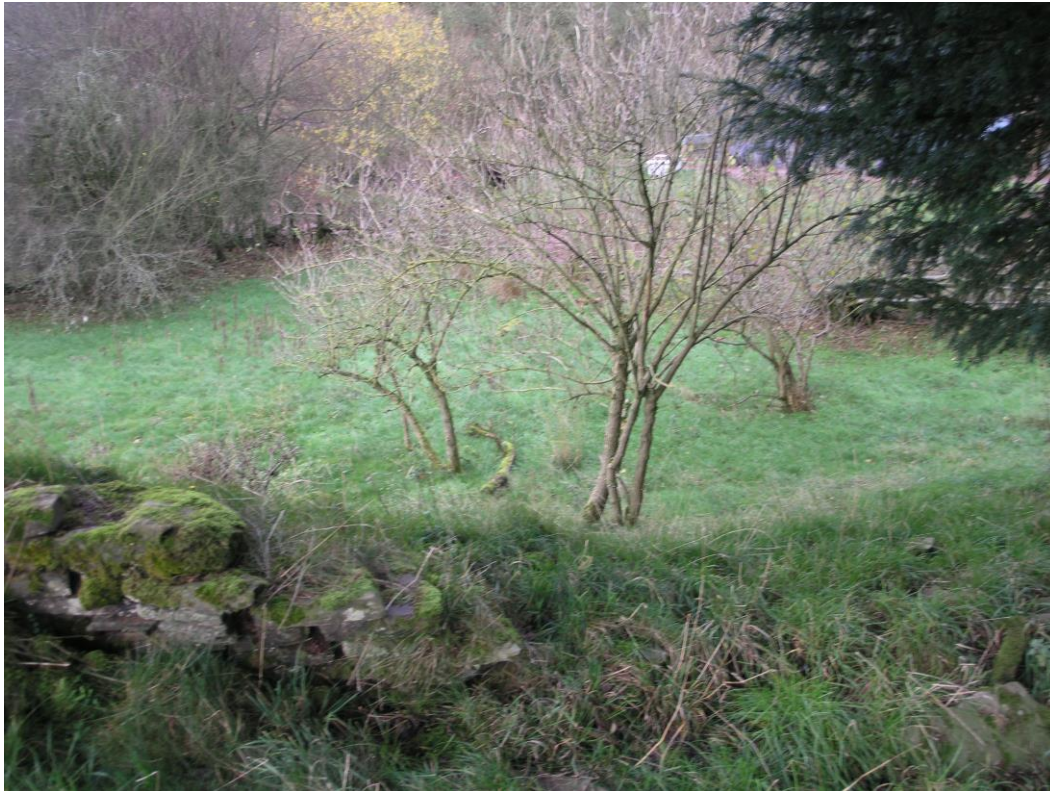
Active small tree and scrub growth management was noted during the visit. This was, in the main, confined to the southern portion of the site, particularly the area between the reredorter and the stream. Further management is needed within this area together with the removal of scrub on the western side of the site outside of the western wall of the Cloister (see Plates 13 and 14).

Plate 13: Elder growth to west of Cloister.

1. *Continue to remove / coppice hazel, hawthorn and elder along stream bank and remove elder from the grass area to the west of the Cloister.*

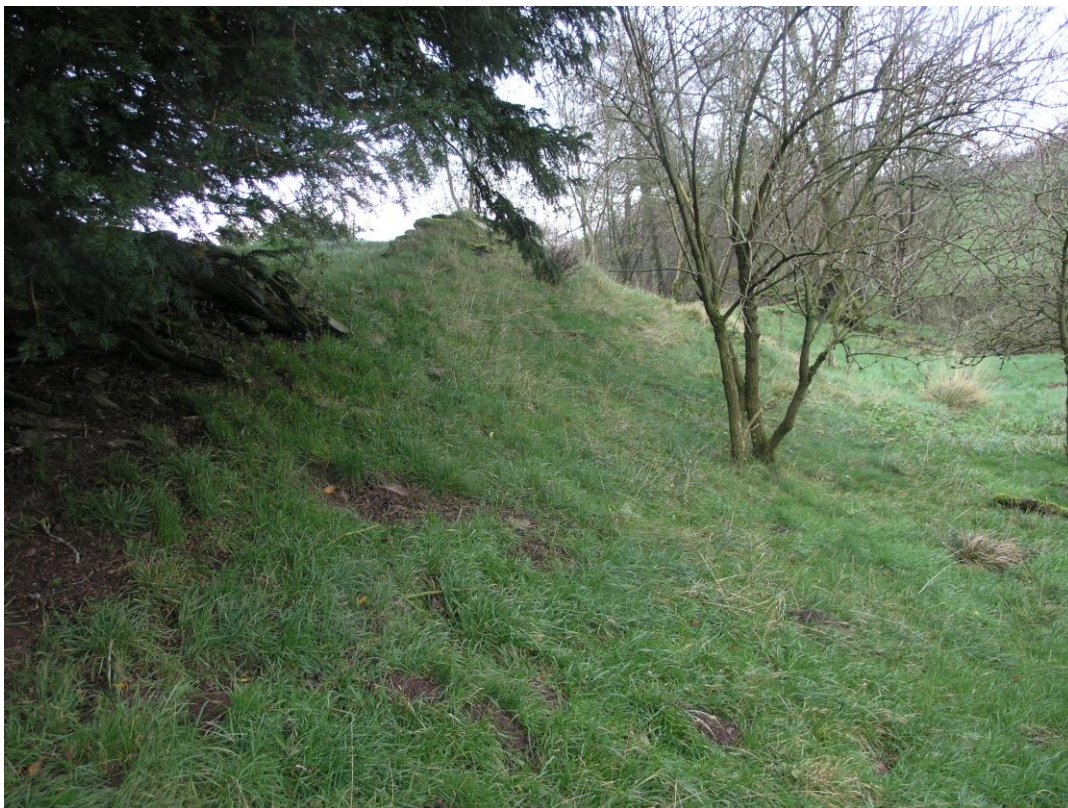
Plate 14: Elder growth to west of Cloister.

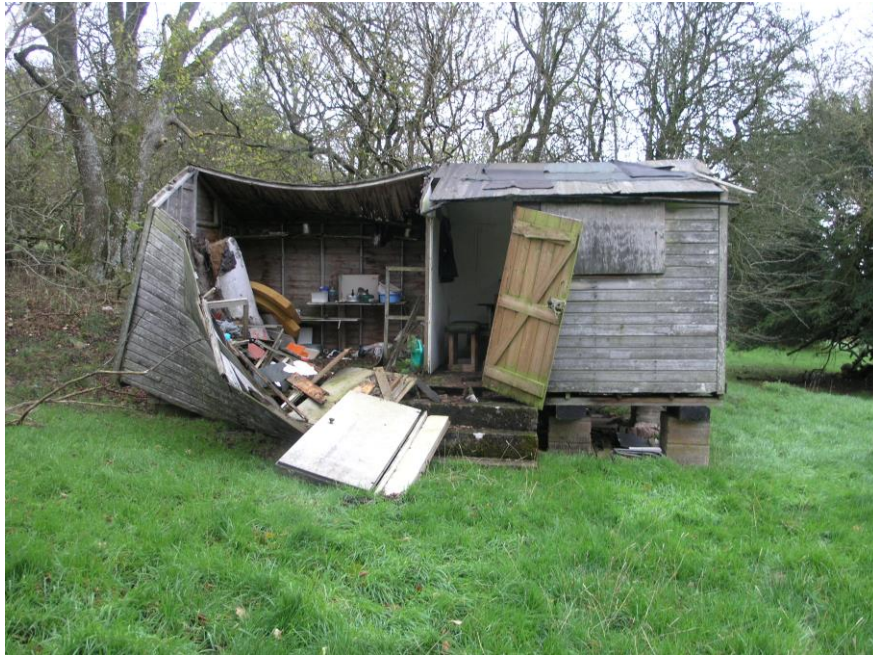
During the site visit it was noted that after over 30 years the shed, used to store conservation tools, to shelter in and even to sleep in, has begun to collapse. This needs removing from site. (Plate 15)

Plate 15: The shed

The Shed needs to be removed (including its concrete block supports).

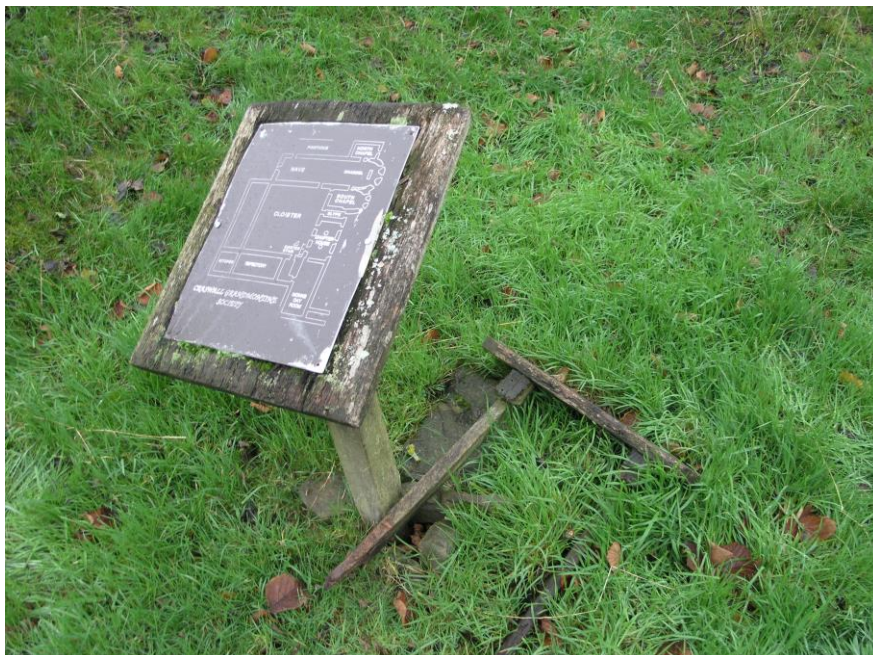
The site is in desperate need of new, updated signage / display boards. The present board has rotted and fallen over and is practically unreadable. (Plate 16)

Plate 16: The only signage / display panel on the site.

New signage / display panels are required.

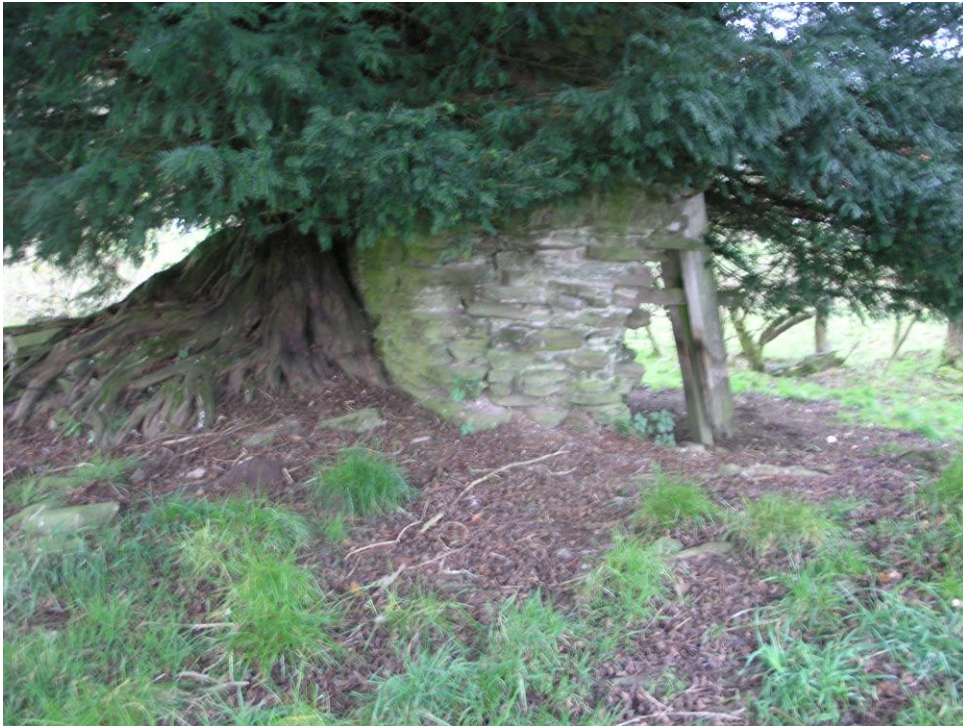
The wooden support for the masonry stub (semi encased by the Yew tree), at the western end of the Chancel has rotted at its base and is providing no support. A decision needs to be made concerning the stability of this piece of wall and the effect that the Yew tree is having upon it. If a prop is required this should be constructed in stone in order to provide a suitable level of support. (Plate 17)

Plate 17: Wall Section with rotted timber “support”.

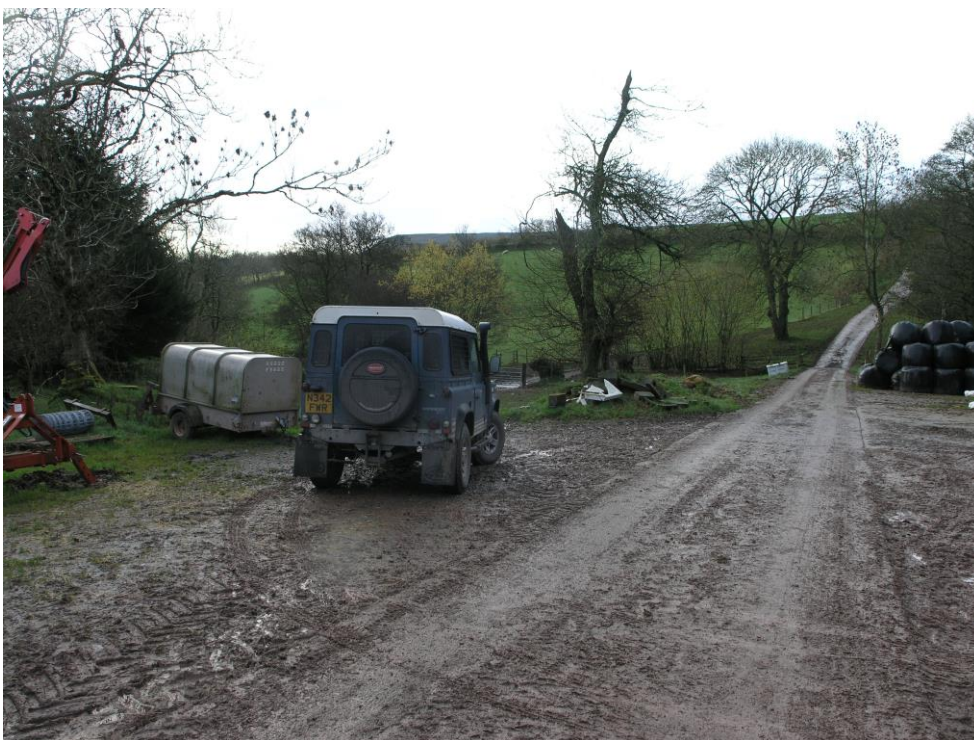
It was also apparent that a number of pieces of agricultural machinery are being parked / stored within the scheduled area (immediately outside of the fenced elements of the Priory). The process of moving such machinery may have a negative impact upon shallowly buried archaeological features / deposits and certainly inhibits the growth of stable grass cover. They also add to the general feeling that the site is currently “un-loved”. (Plate 18)

Plate 18: Agricultural machinery parked within Scheduled Monument (excluding the land Rover).
