HEREFORDSHIRE ARCHAEOLOGY

The archaeological supervision & recording of mitigation works associated with unauthorised activities at the site of Rotherwas House, Rotherwas, Herefordshire.

**Herefordshire Archaeology Report No. 353
Event No. EHE 80167**

**Scheduled Monument No. 1014880
HER No. 9438
NGR: SO 5355 3839
Event Number: EHE 80167**

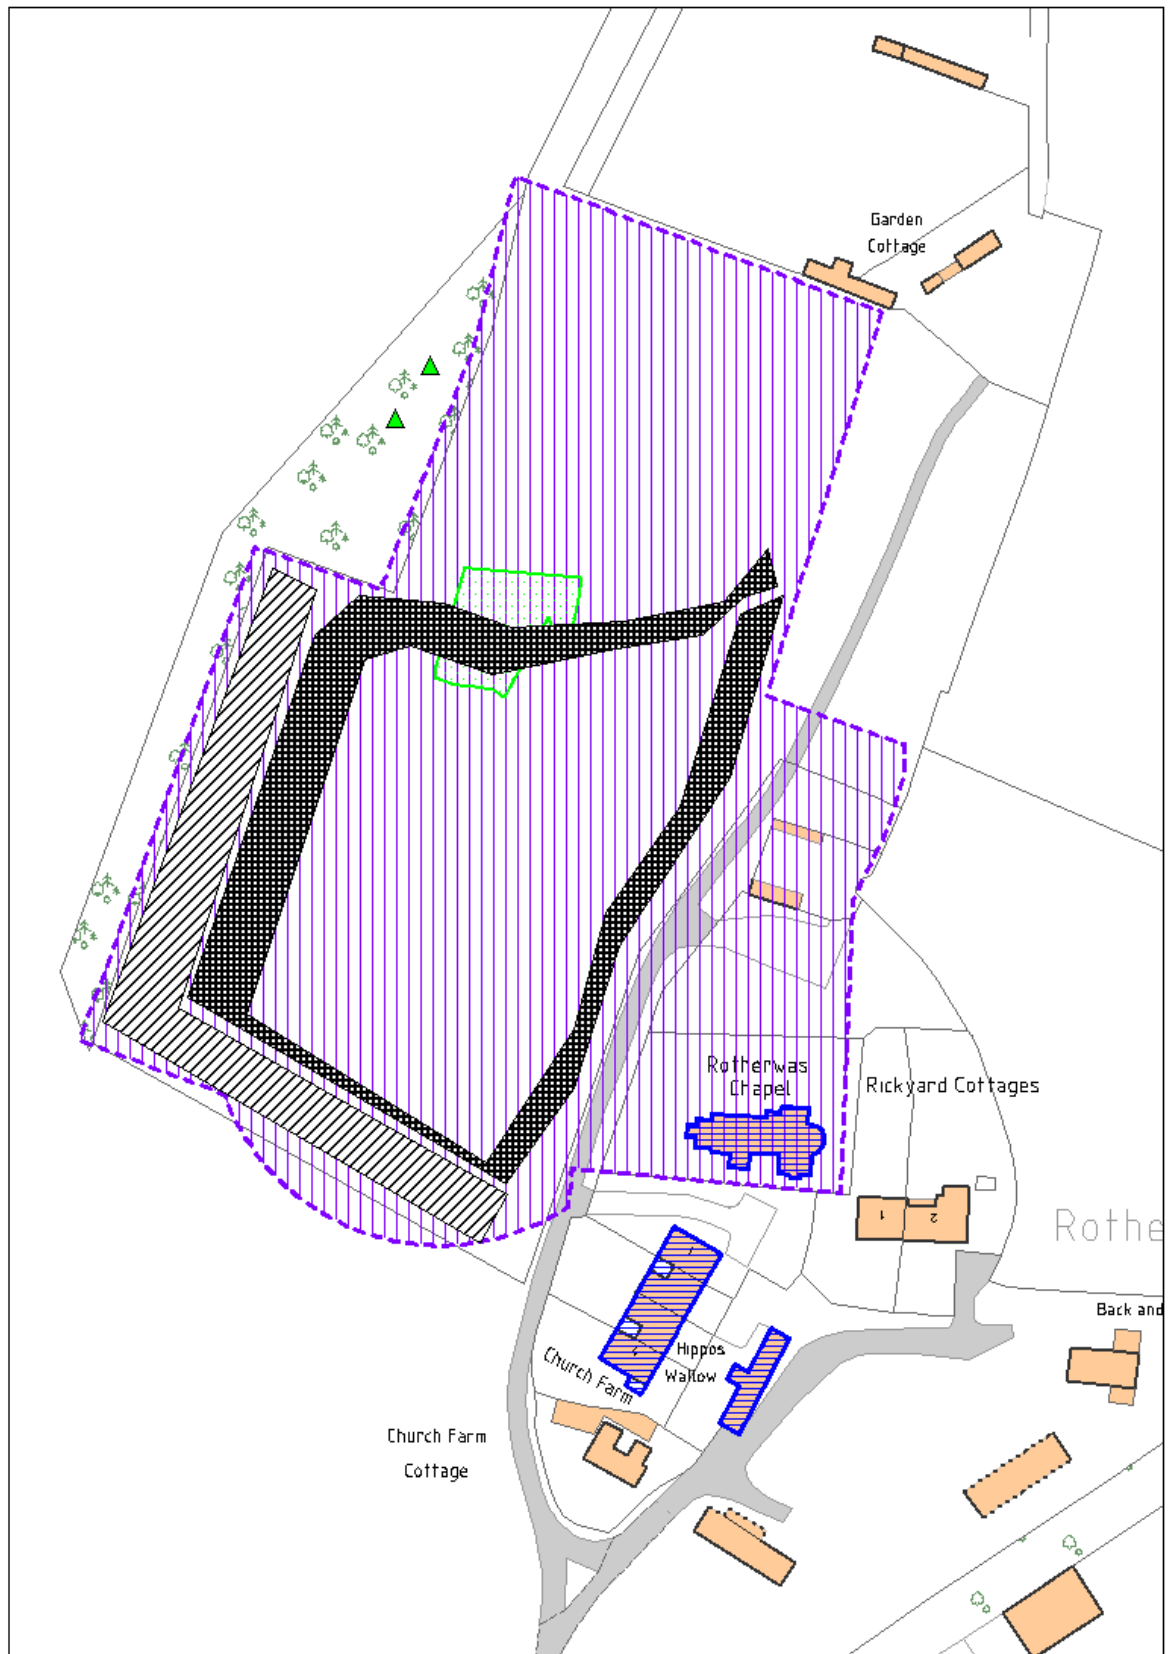
Figure 4: Area and extent of dumping (cross-hatch) and rutting / tracking (black with white dots). © Crown copyright. All rights reserved 100024168

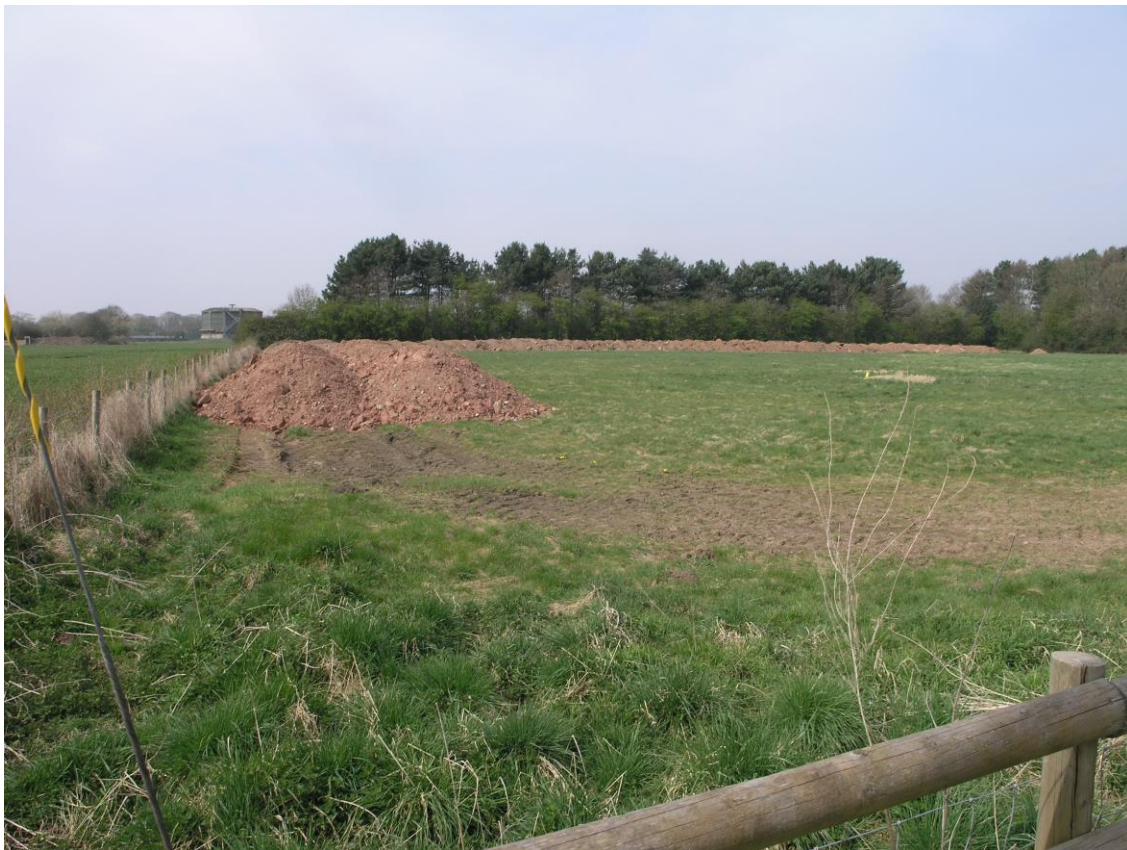
A mix of rubble and earth had been dumped along the southern and western boundaries of the site. (Plates 1 & 2). This had been done, it is understood, in as a precursor to the material being covered in earth and a hedge planted along its top in order to mask recent and future development within the Enterprise Zone from local residents. During the dumping of this material, localised areas within the Scheduled Area were affected by rutting, (Plates 2 & 3).

Plate 1: View looking to the west showing extent of dumped material.

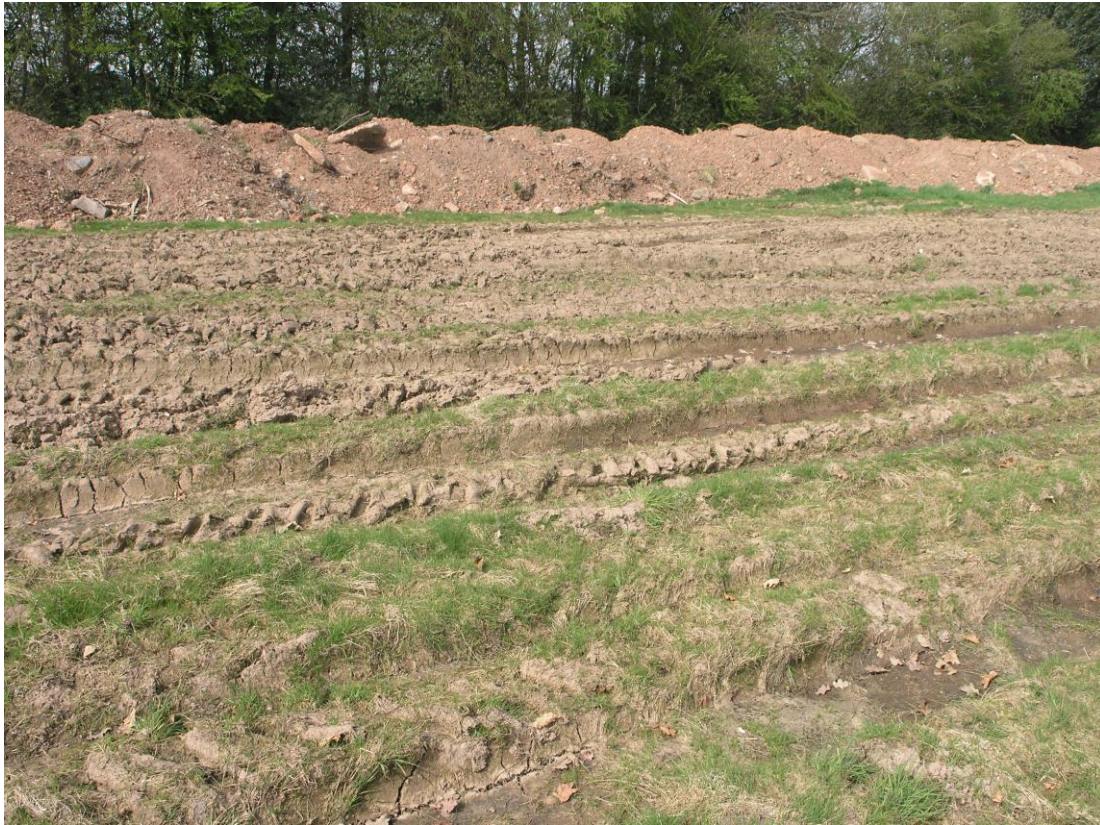
Plate 2: Close up of western dump of material and associated rutting.

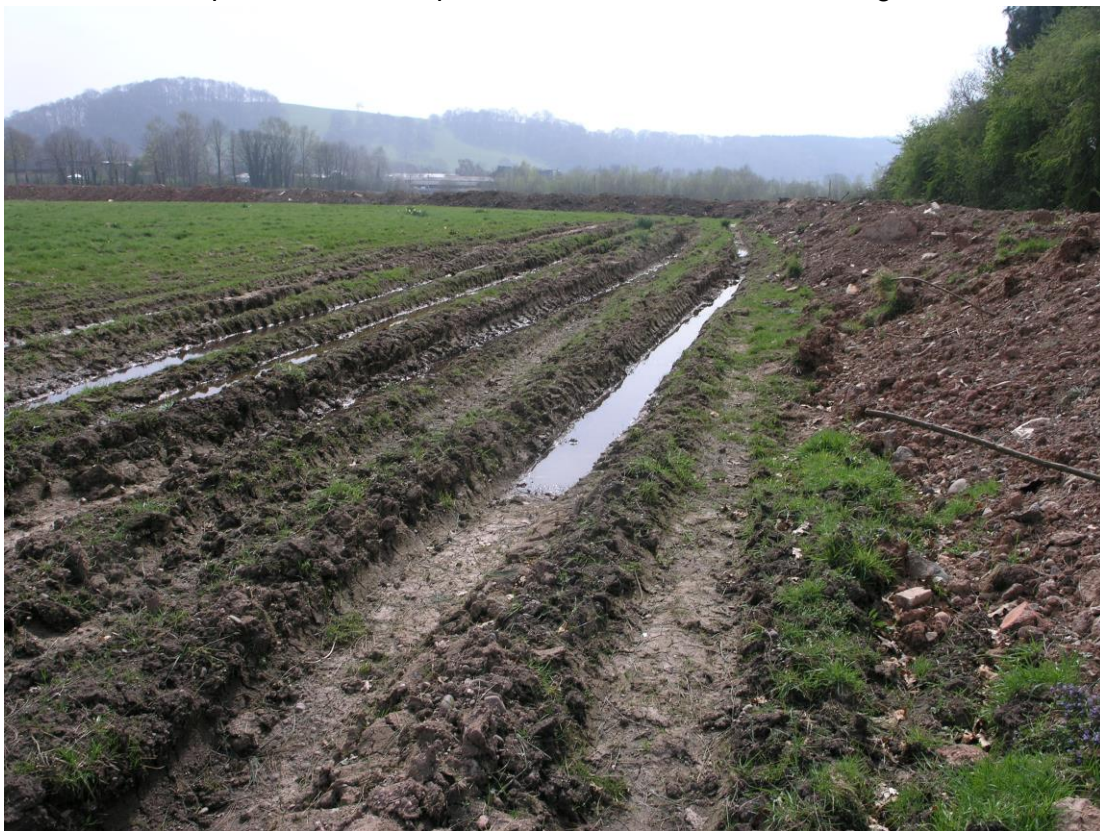
Plate 3: View to the south looking along the western boundary.

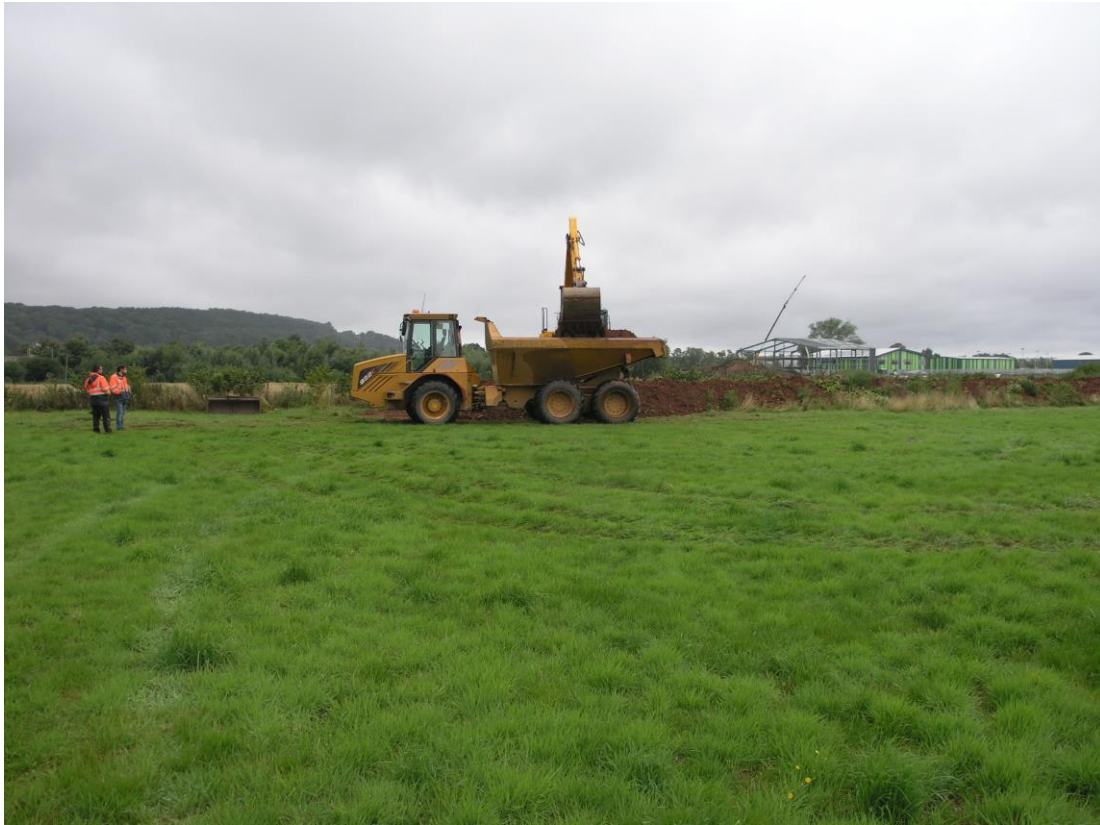
Plate 4: Machinery used in the removal of dumped material.

Material was removed from site after sustained dry weather in order to mitigate further rutting. All machinery used for the transportation of material had flotation type tyres in order to spread load and minimise impact on the ground surface, (Plates 4 & 5). The weather during the works was mostly fine and no further intrusion / damage occurred during the works.

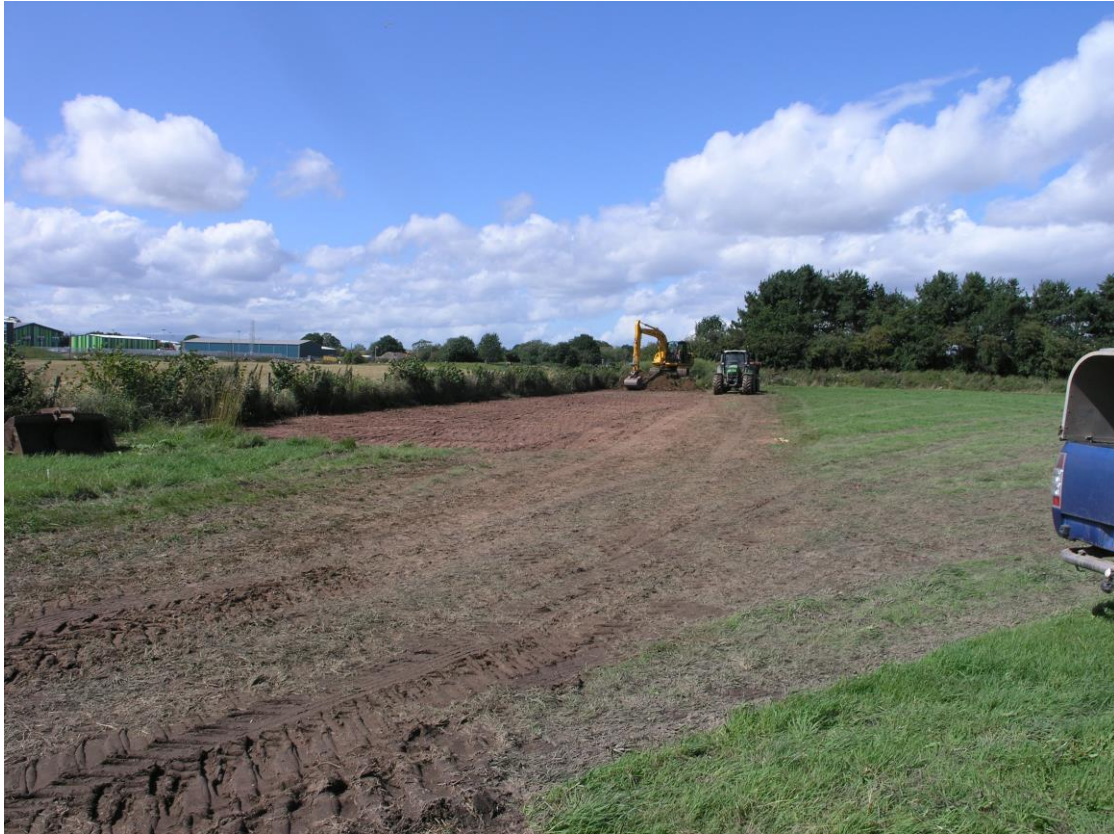
Plate 5: Material along southern boundary being removed.

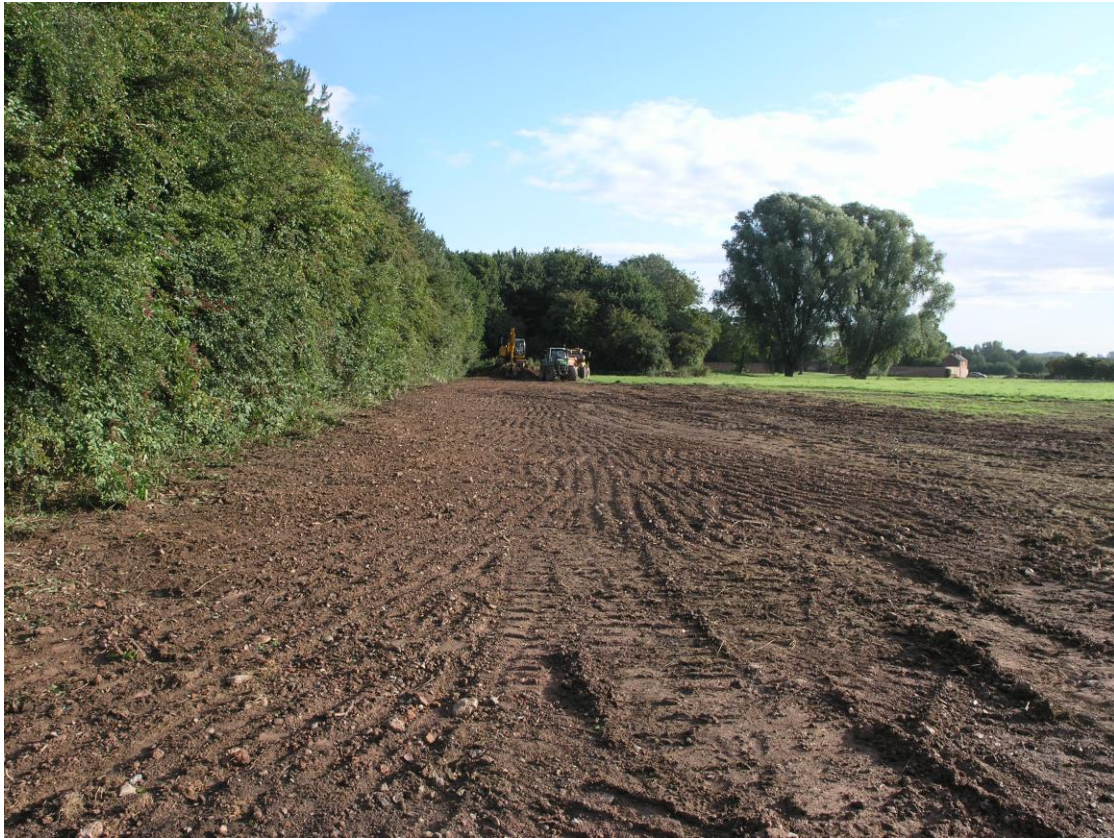
Plate 6: Removal of material along western boundary after initial harrowing / topsoil spreading.

Upon removal of material, topsoil from a local source was thinly spread over areas damaged / affected by rutting prior to being harrowed to remove any upstanding ridges. (Plates 6 & 7). The areas were then sown with the same seed mix as the rest of the field, prior to being disc harrowed, (Plate 8).

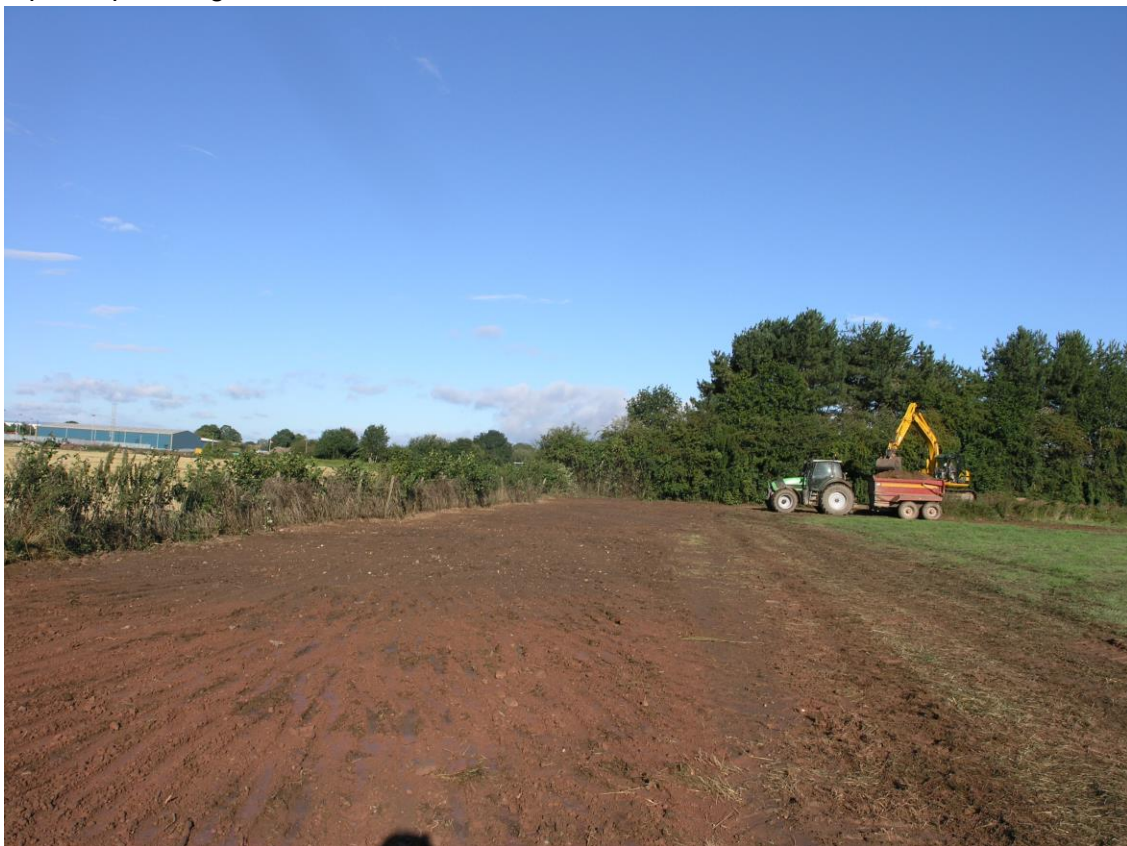
Plate 7: Southern boundary after removal of dumped material and prior to harrowing

and seeding.

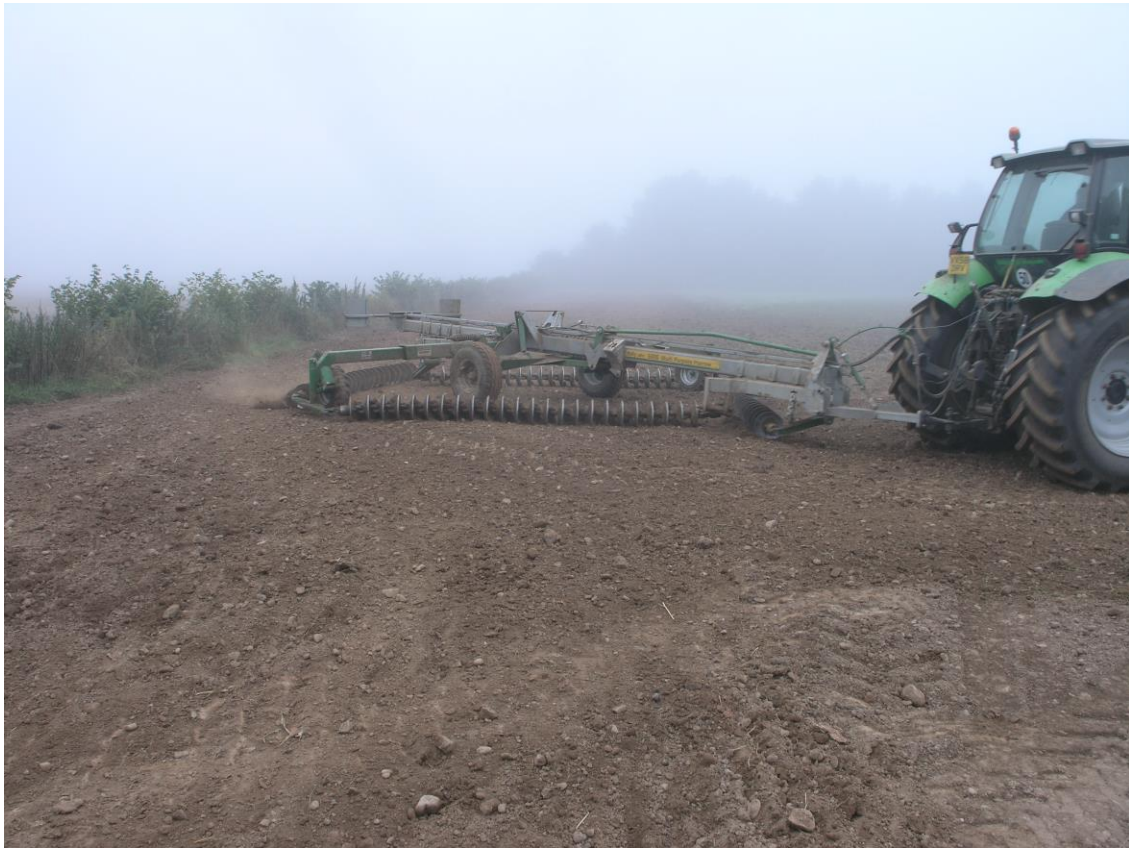
Plate 8: final harrowing after seeding.
