Penyard Castle, Herefordshire

A report on a site visit

Herefordshire Archaeology Report No. 336

Prepared by Dr Nigel Baker BA PhD FSA MIFA

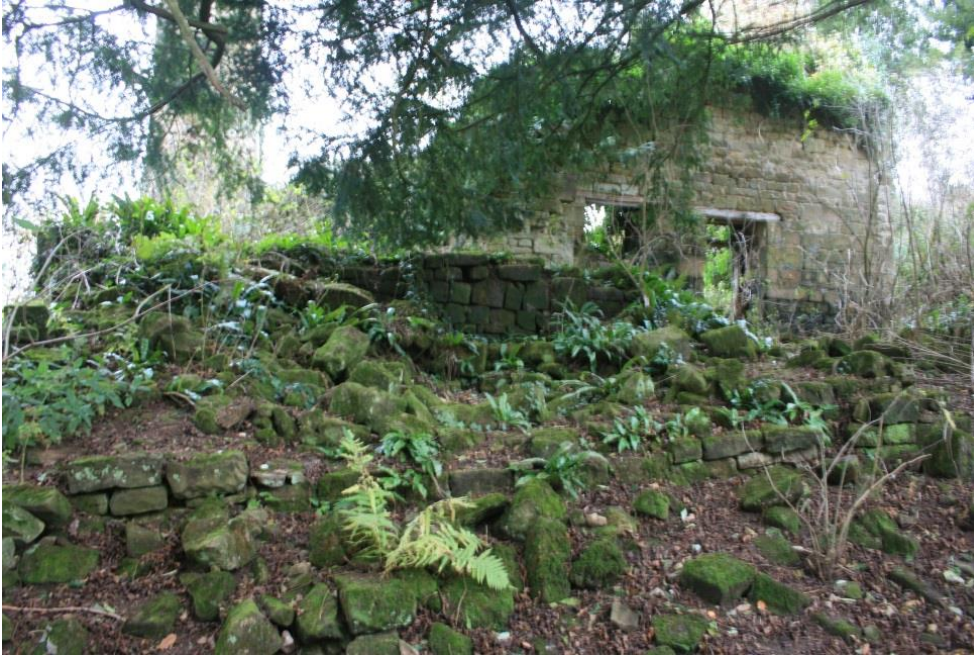
The structure is a ruined house in extremely poor overall condition. It consists of a main block aligned north-south with gables at each end and a ruined, lower, extension to the east forming an overall L-plan. It stands to the south-east of the surviving castle masonry and its surrounding earthworks, in different ownership, within woodland. There are breaks-in-slope down to the east and (sharply) down to the south with a substantial tumble of stone at the corner suggesting the presence of a former masonry perimeter, the structure under discussion standing in the SE corner of the overall castle site. The wooded slopes to the south shows evidence of at least one charcoal burning platform and an unidentified hole, possibly a well or mineshaft. The structure is ringed by veteran yews on its north and east sides.

General view of the building from the east; the low walls in the foreground and middle distance belong to the eastern 'outbuildings' range

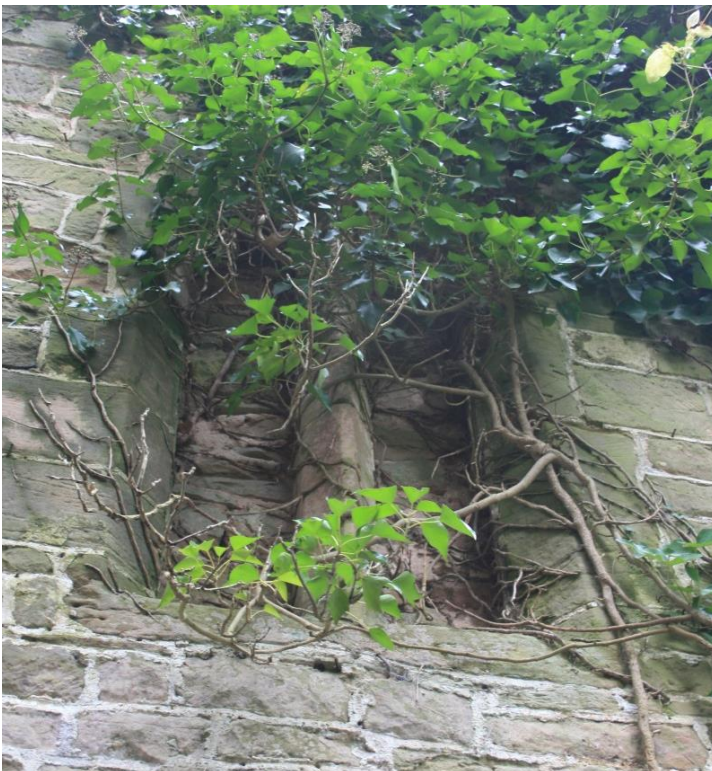
This stands almost to its apex, which has a heavy covering of ivy. The wall itself (1994 component 23) is coursed squared sandstone rubble laid in thin (10-20cm) courses, with ugly but sound 19th- or 20th-century strip pointing in the joints. At first-floor level is a centrally-placed window of medieval character with a central mullion. Its head is now obscured but the 1994 report describes the lights as having pointed trefoiled heads dated to the 14th century (component 47). A substantial straight joint at the NE corner shows that the gable wall is a separate build to the east (long) wall, which appears to have been butted up to it and tied in with two through-stones. The joint has opened up to a width of 5-7cms suggesting movement in the structure, particularly outward movement in the centre of the long wall. One possible explanation of the structural separation of the gable wall from the side wall is that the latter was originally timber-framed between gable ends, and that the framing was gradually replaced in (re-used) masonry (see below).

The north gable wall appears to be in relatively sound condition insofar as it is visible: its top and inner face are completely obscured by ivy. The condition of the ivy-covered oven superstructure/flues on the inside of the wall is unknown.

The north gable end wall (exterior) showing the medieval window (blocked) in the apex. Note strip pointing

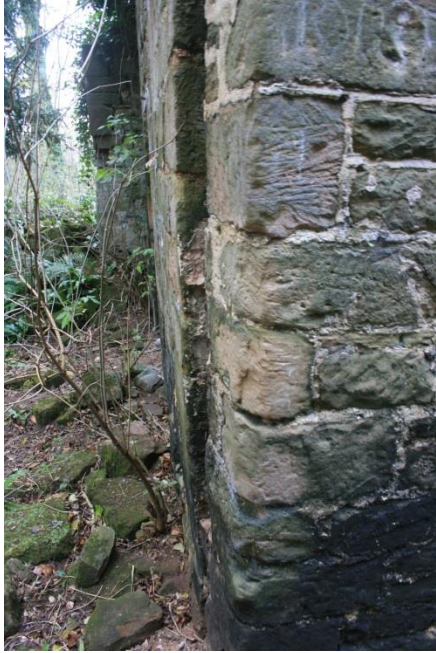
The east long wall has (as reported above) shows signs of long-term outward movement at its north end. The projecting chimney has quoin stones missing, which endangers the corner of this part of the chimney block which has a buttressing effect on the long wall: this defect was identified by EH for propping in 2007 but this has not been undertaken. There has evidently been further damage to the inside face of this wall since the 1994 report, though the overall state of the wall cannot be quantified given the present vegetation.

The north east corner, looking south. The long east wall is moving outwards and separating from the gable end wall at the straight butt joint

- Immediate propping of the damaged areas to the south gable wall and east wall projecting chimney
- Clearance of ivy and fallen timber with provision for instant remediation of further damage exposed by this process
- A full programme of archaeological fabric recording and analysis, contextualised by geophysical survey to examine the relationship between the house/cottage discussed here and the upstanding remains to the west. There is scope also for limited excavation to determine the extent, nature and relationship of the reported undercroft to the SW as this appears to impinge in some way on the standing structure
- A full programme of consolidation and repair, guided by the archaeological analysis and making use of the drawings generated, to safeguard the long-term viability of the monument

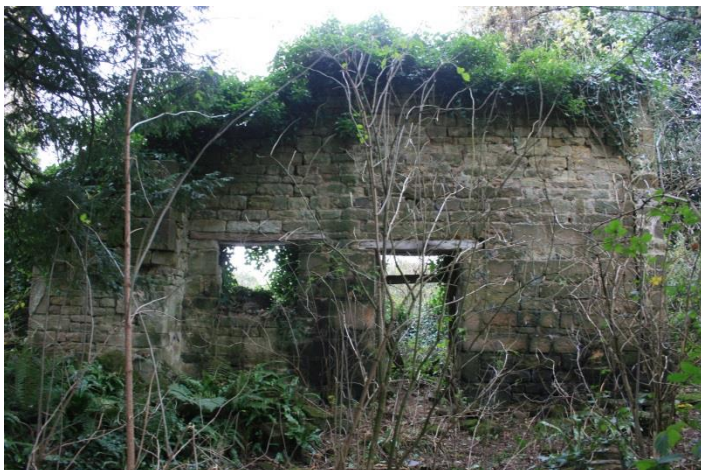
The main/latest doorway is towards the north end of the wall and has a timber lintel composed of four re-used joists or similar members laid flat, side-by-side. Further south is a rectangular window opening, also with a re-used timber lintel. Further south is a projecting buttress-like block, c.1.8m wide. This could not be positively identified at the time of the 2013 visit as ivy masked the presence of a first-floor fireplace on its inner face that shows this to have been a projecting chimney (component 32). This chimney, and the wall to its north, are mostly composed of large blocks of good quality ashlar. However, inspection of a damaged area of its inner face just south of the doorway revealed a block of medieval-type window jamb, suggesting that the ashlar is re-used material, probably post-medieval work. The chimney is contemporary with the re-used ashlar of the north end of the wall but is quite distinct from, and appears to be butted to, fabric consisting of very small coursed squared sandstone blocks (component 29). Within this at the southern end of the wall is a low rectangular opening (component 30, identified as a cupboard) with a flat stone lintel, blocked from the inside, partly obscured by fallen masonry from the eastern outbuilding. No relationship between the east wall and south gable wall could be determined.

The east wall (exterior) general view. Left to right: chimney, window, doorway

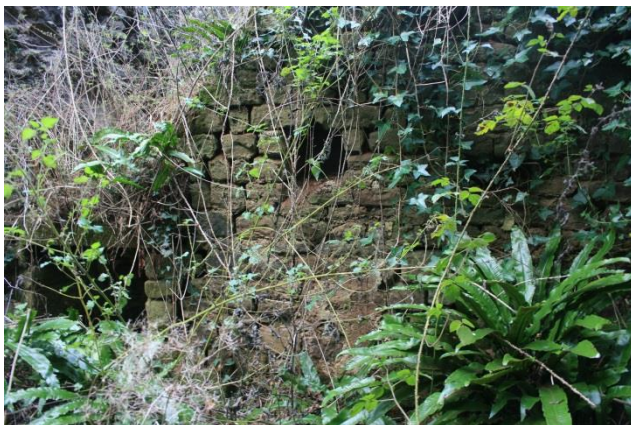
The east wall (exterior): the south end showing different (smaller) masonry type and cupboard-type feature bottom left

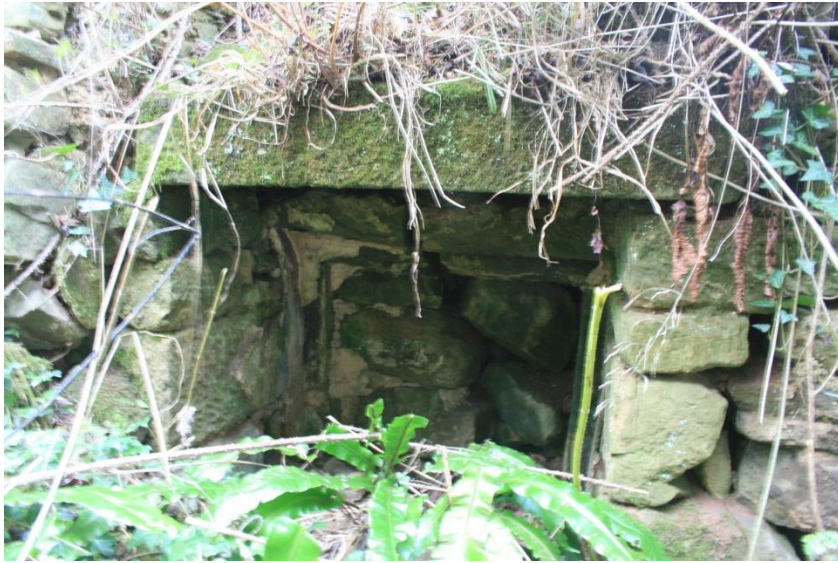
The east wall (exterior); cupboard-like feature at south end

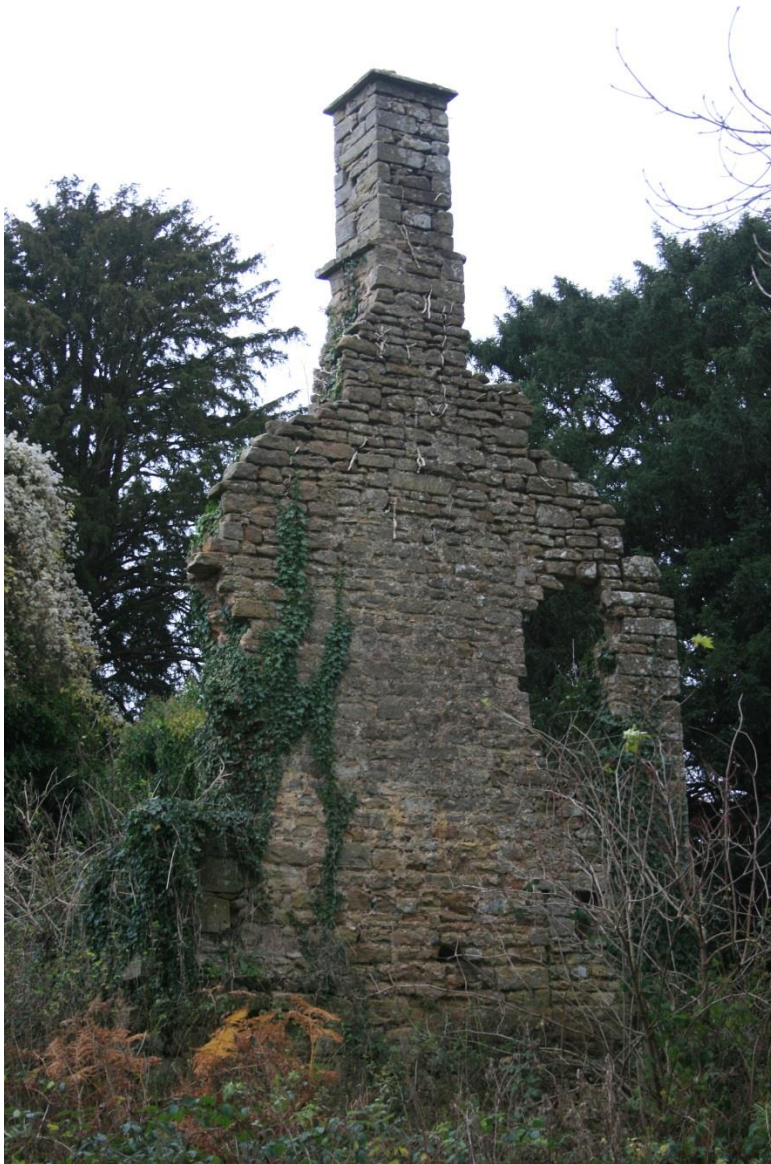
This survives to its full original height with its chimney projecting from the apex. It is composed of similar flattish coursed sandstone to the north gable. On its east side are two openings. At first-floor level is a damaged opening, badly eroded in its head with stones obviously having dropped out since 1994; this is recommended (below) for immediate attention. Directly below is a square opening within a larger blocked opening c. 1.2 x 0.8m, possibly a doorway but more likely a window. The base of this feature is coincident with a horizontal offset or ledge about 1.5m above modern ground level, the base of the wall stepping out by c.0.1m (component 25). At the SW corner of the elevation is a blocked doorway (component 26) with ashlar jambs and a flat four-centred arched head of probable 15th-16th-century type, the door jambs in the same plane as the lower part of the wall. The south-west corner of the building survives to less than c.2m in height and there is no obvious relationship discernable from the present exposure between the south gable wall and the remains of the west wall. The south gable wall may however have extended further to the west. This is not now clear but would be consistent with the RCHM view that a structure containing a vaulted undercroft lies corner-to-corner to the south west. A possible octagonal pier base (component 18) adjoins the west end of the gable wall but whether or not this is in situ must be doubted.

The south gable wall is in critical condition in that the head of the first-floor opening has dropped out (compare with 1994 photos), leaving only three stones in depth between the top of the opening and the sloping top of the gable. This was recommended for immediate propping by acrow and spreader plate by the EH engineer in 2007, but this has not been undertaken. The failure of this area of stonework will put the SE corner of the building at risk; it will also negate the buttressing effect that this stonework currently has supporting the chimney stack (a fine, well-built feature) on its east side, imperilling that too. The condition of the masonry and its pointing, particularly the north face, is very poor.

The south gable wall (external). Note state of masonry above opening, upper right

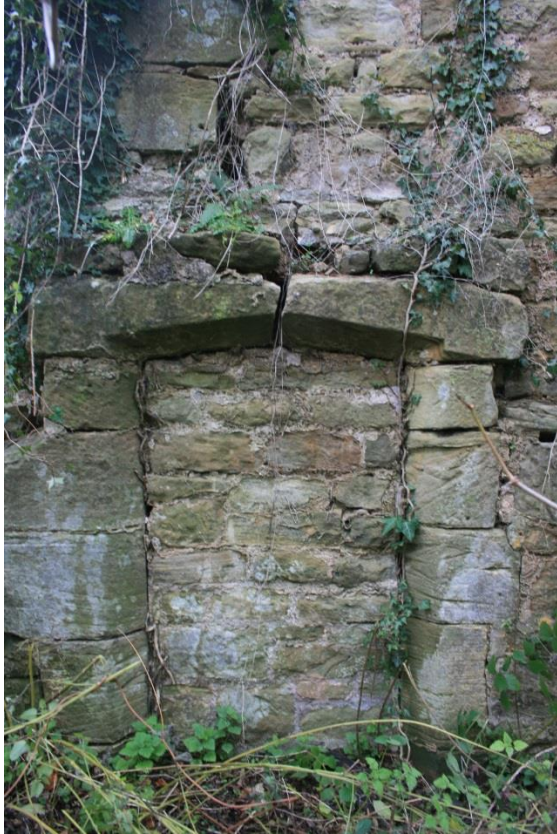
South gable wall (exterior): blocked doorway at south-west corner

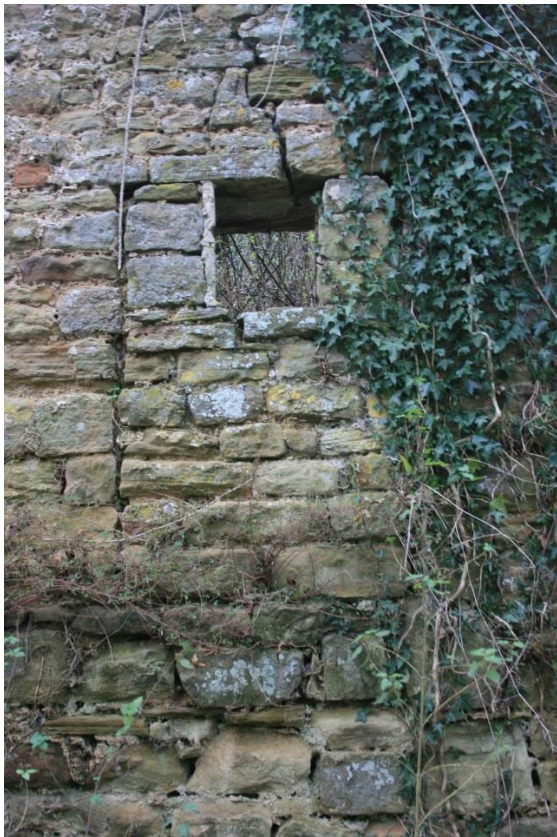
South gable wall (exterior): opening on east side, within larger blocked feature

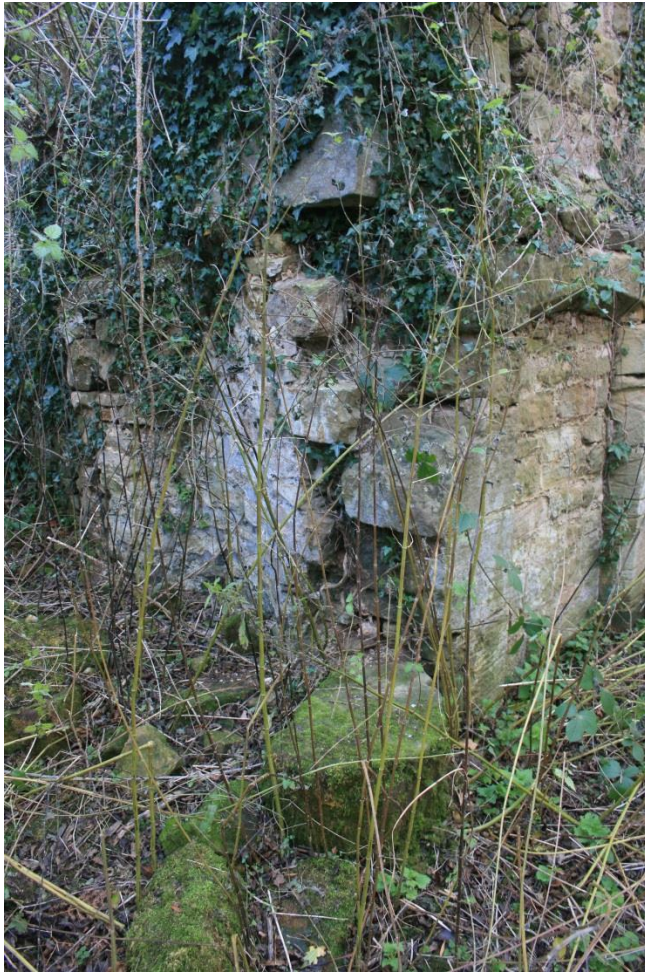
This is now only visible at its south end where the wall fabric is of small squared blocks of similar character to the south end of the east wall opposite (component 39). This fabric incorporates a hollow curve or indentation that has been suggested as one side of a former circular staircase giving access to an undercroft below. A 14th-century doorway with chamfered jambs and a two-centred head reported by the

The south-west corner (exterior) showing west wall fabric with curved hollow (partly rendered). The large stone in the foreground at the corner may be an alleged column base

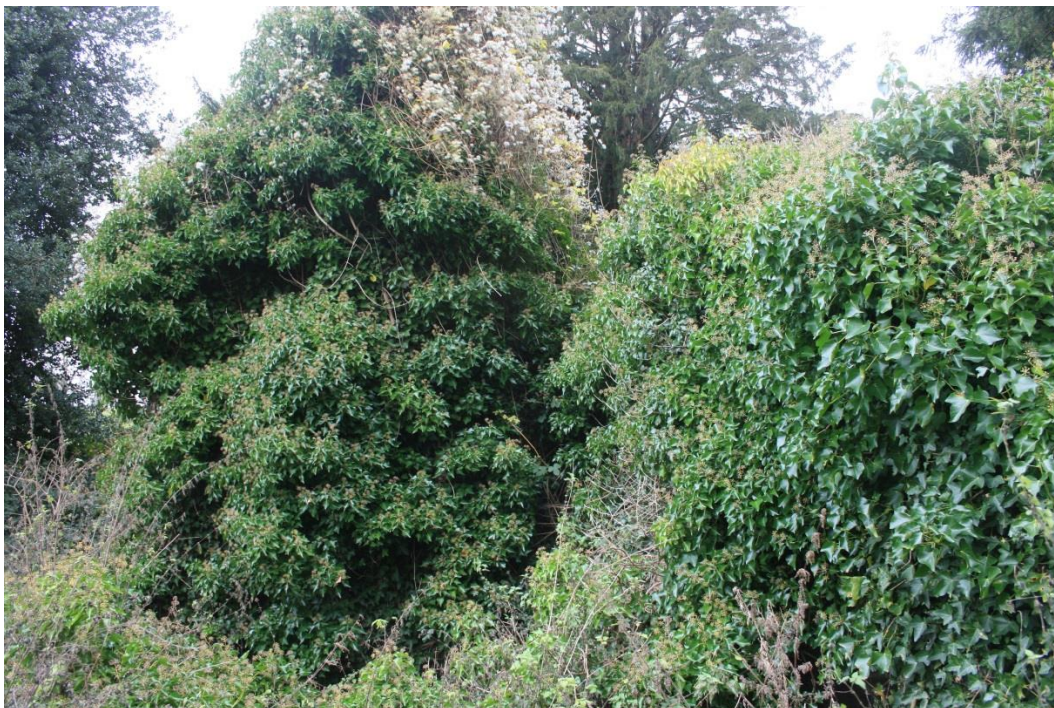
RCHM in the 1930s in the middle of this wall had been much reduced in height by 1994 and is now completely invisible, like the rest of the wall, behind vegetation, fallen timber and masonry. Nor is there any visible trace of an 'octagon stone chimney on the west outside wall' reported by the RCHM in the 1930s.

The west wall (exterior) looking north

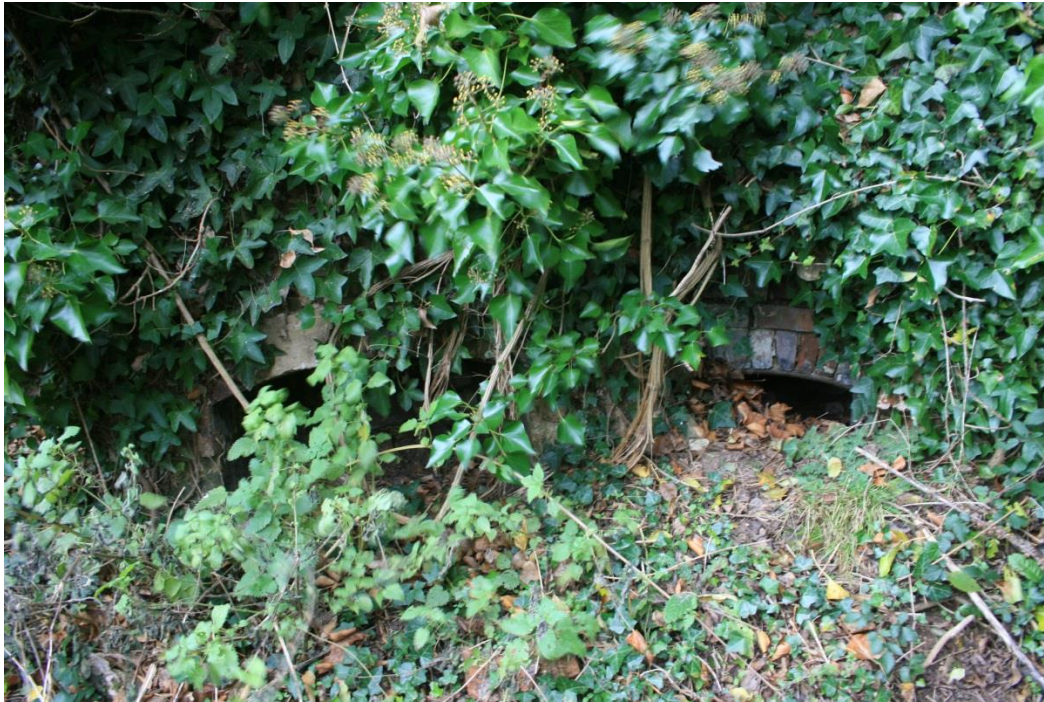
The interior is only easily accessible at its north end via the doorway in the east wall: two-thirds of the interior to the south is choked with vegetation, rubble and fallen timber. The interior face of the north wall is totally obscured by vegetation, though a pair of oven doors is just visible in a projecting block built into the building's NE corner. The ovens, of brick and iron construction, are probably 19th-century; their flue is probably the brickwork visible above blocking the medieval window in the gable.

The north wall (interior): two oven openings within the NE corner

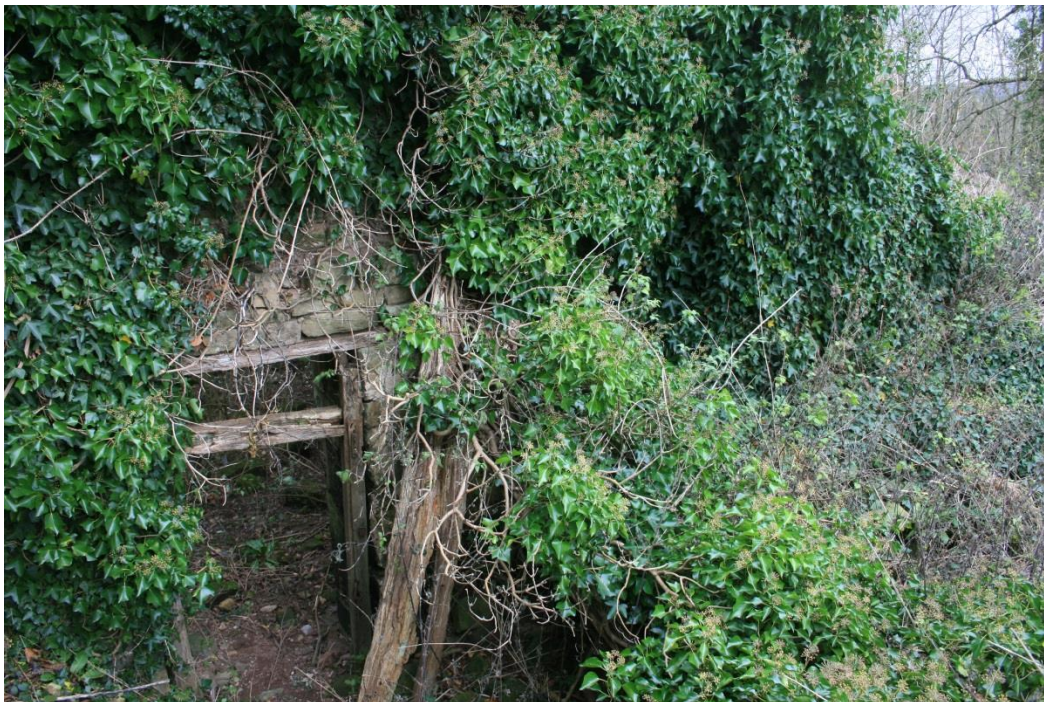
The internal door frame survives under the innermost timber lintel. The walling around the doorway is composed of smaller material than is visible on the outside. The facing stones have fallen away from the south of the doorway showing that some at least of the ashlar visible externally is re-used material. Walling further south, where it can be glimpsed through the ivy, is a mixture of large ashlar and brickwork. The first-floor carved stone fireplace (component 31) described as a 'very grand affair' in 1994 is now completely invisible and its presence was unsuspected by the December 2013 surveyors. It was thought to be of probably 17th-century date (Cook 1994, 7, based on a pers comm from Duncan Brown).

The east wall (interior), looking east over current doorway; the darker green ivy, top right, conceals a 17th-century fireplace, condition unknown

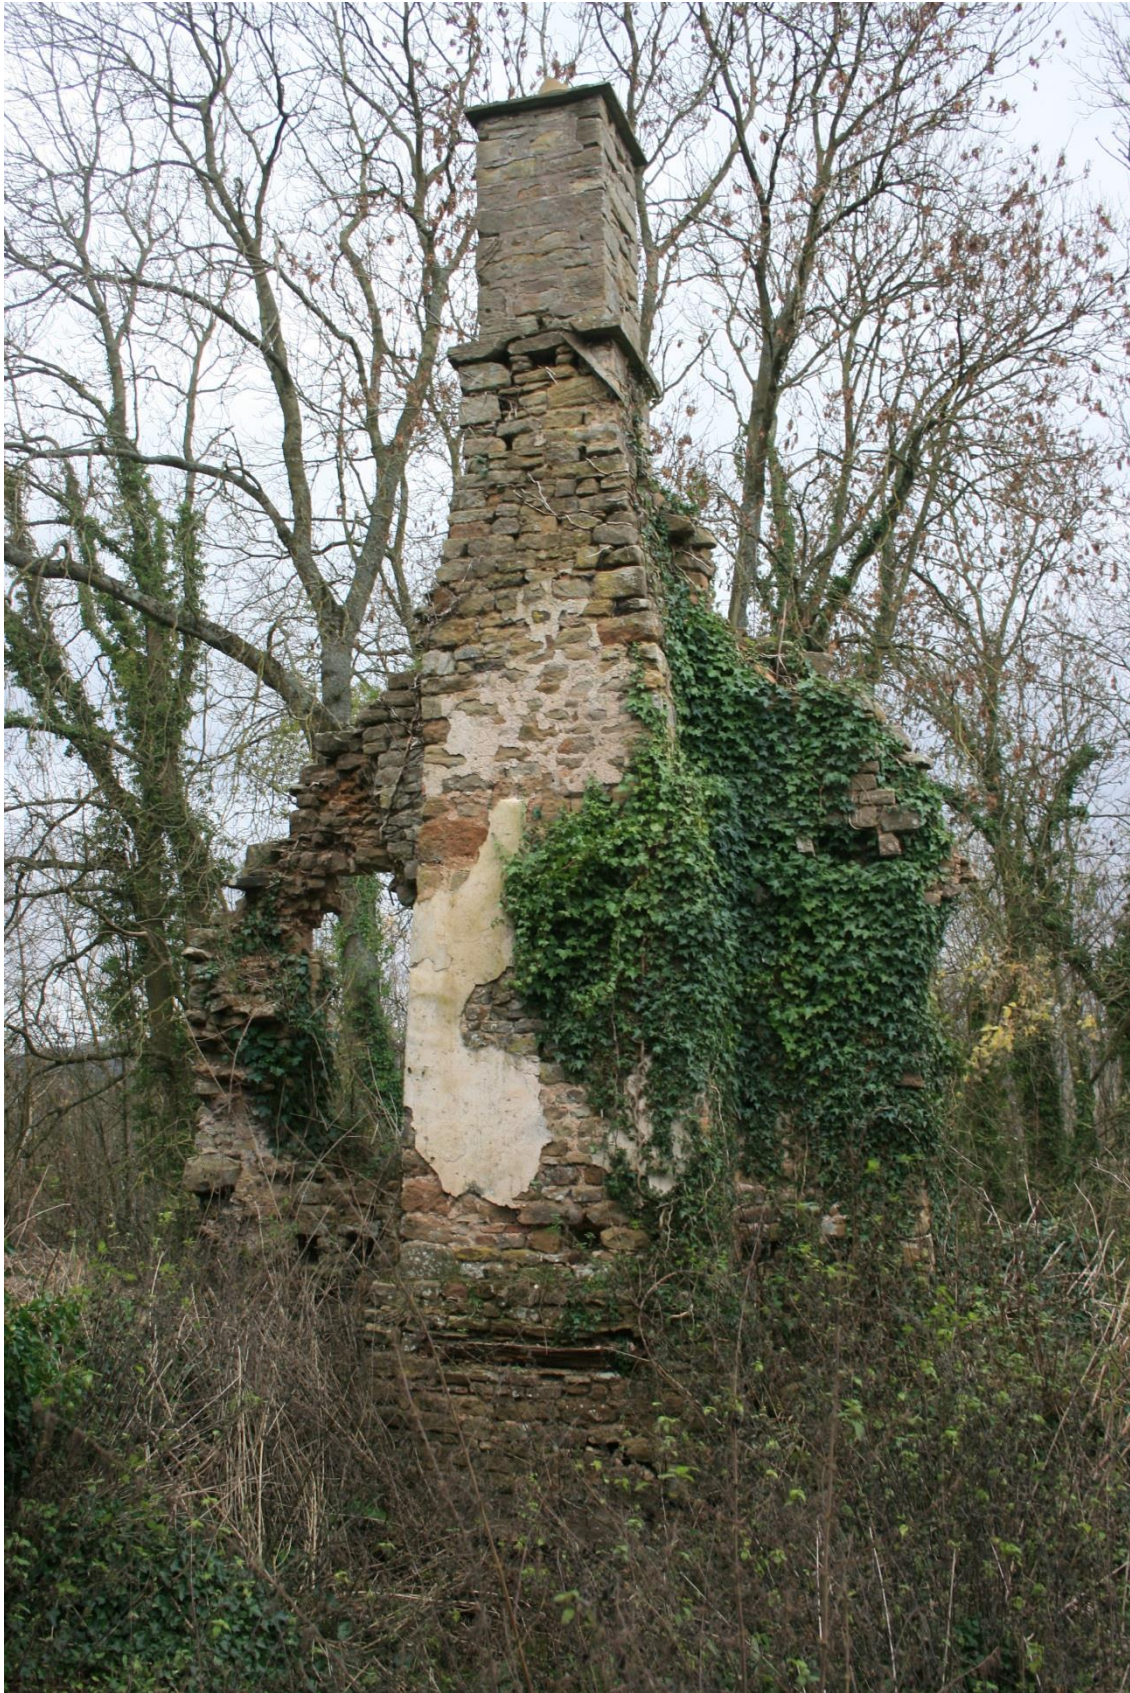
This has a central chimney stack projecting into the interior with a top section rising from a chamfered offset. The wall tops and a small fragment of coping shows the roof pitch to have been extremely steep, suggestive of a stone-clad roof perhaps but certainly consistent with a medieval date. A timber lintel to the ground-floor fireplace is visible but the opening is largely blocked by debris and vegetation. There is a further lintel built into the wall higher up as a spreader. Joist holes for the missing first floor are visible at the same level as the opening at the south-east corner; further

joist holes appear at first-floor ceiling level and a single central joist hole can probably be identified as having held a ridge piece.

South gable wall interior. Note condition of masonry, particularly above the opening top left. Also note steepness of roof pitch and joist holes for roof and upper floor timbers

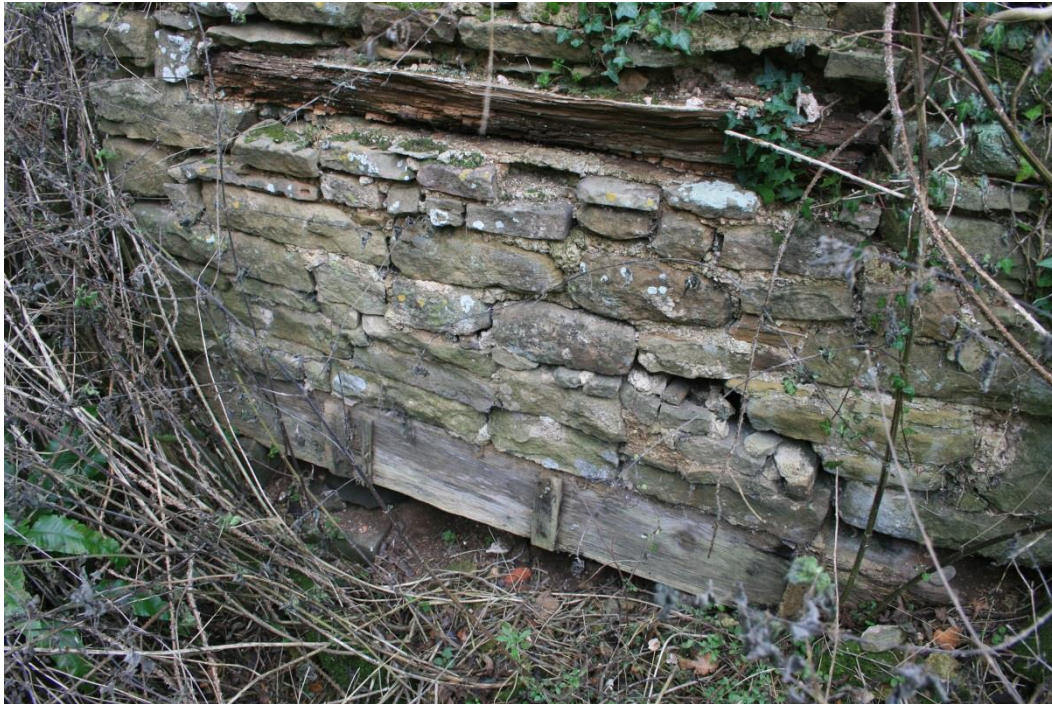
South gable wall interior: fireplace opening at base of stack. Note condition of masonry
