Bronsil Castle, Eastnor

**Recording of a conservation and repair
programme.**

**Herefordshire Archaeology Report No. 317
EHE 1992**

May 2012

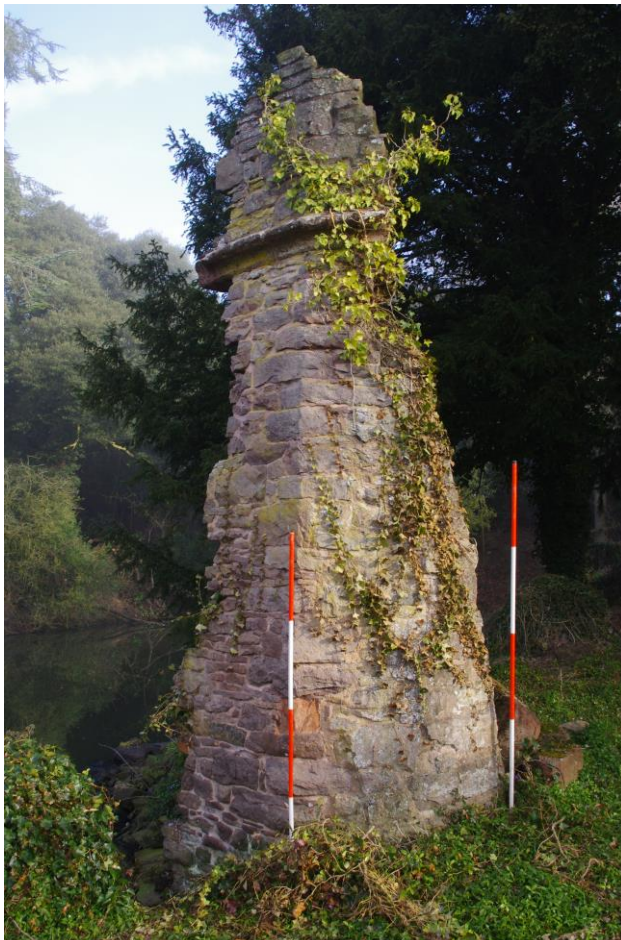
Plate 3: The gatehouse tower as seen from the southeast. Continued erosion of the earth around the base is clearly visible (bottom left).

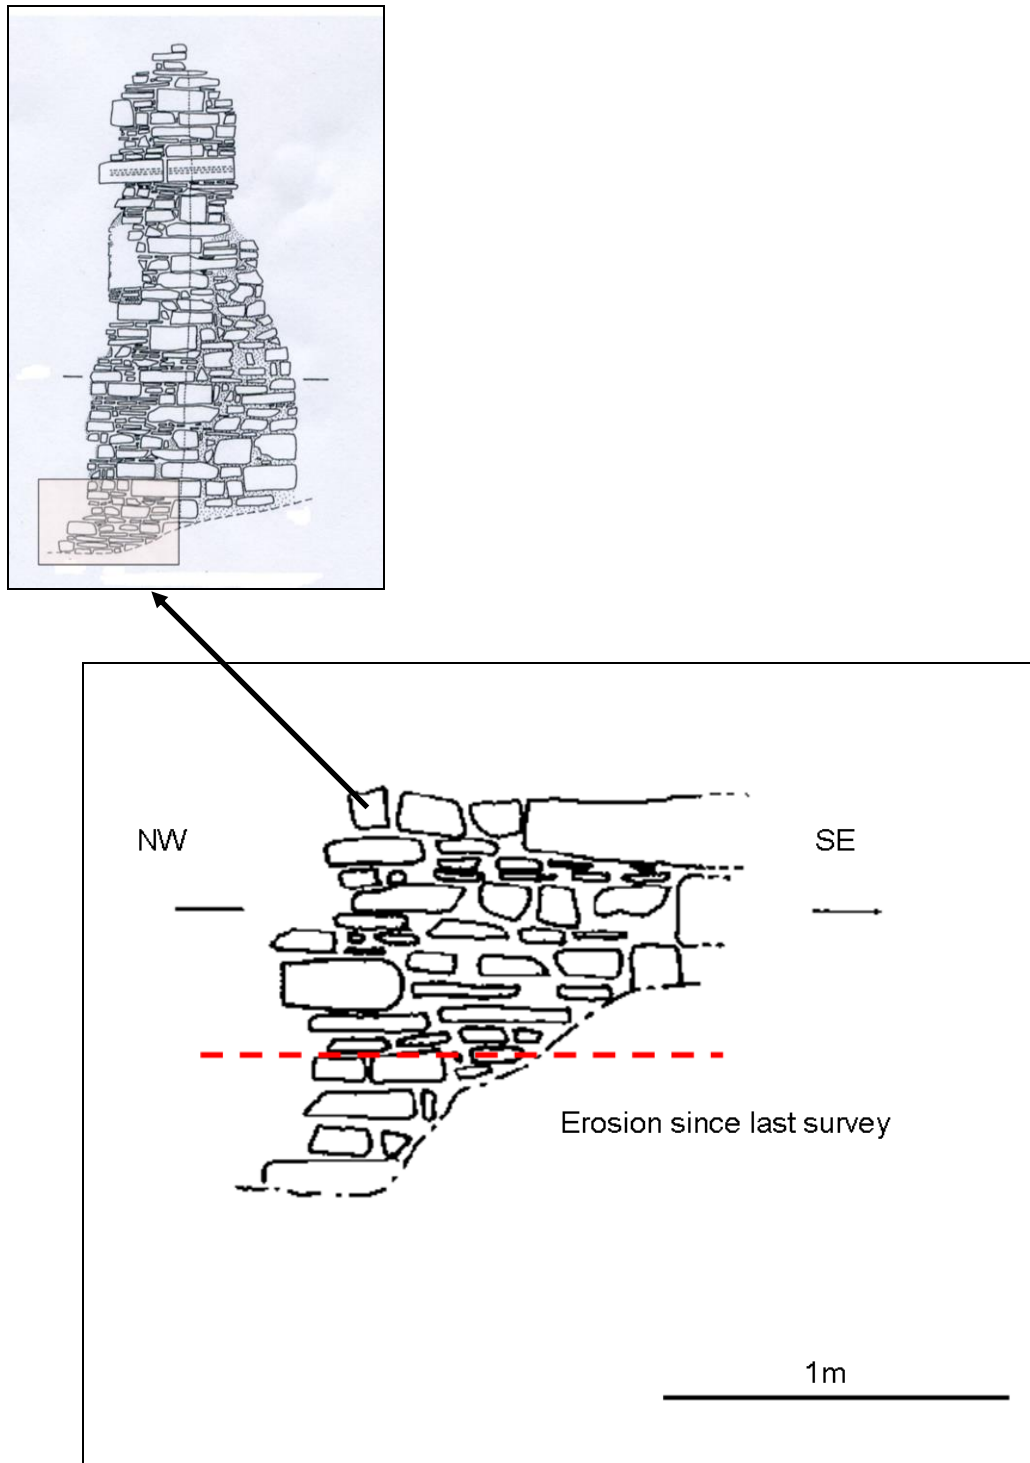
Figure 5: Re drawn lower section of the gatehouse tower showing the extent of erosion

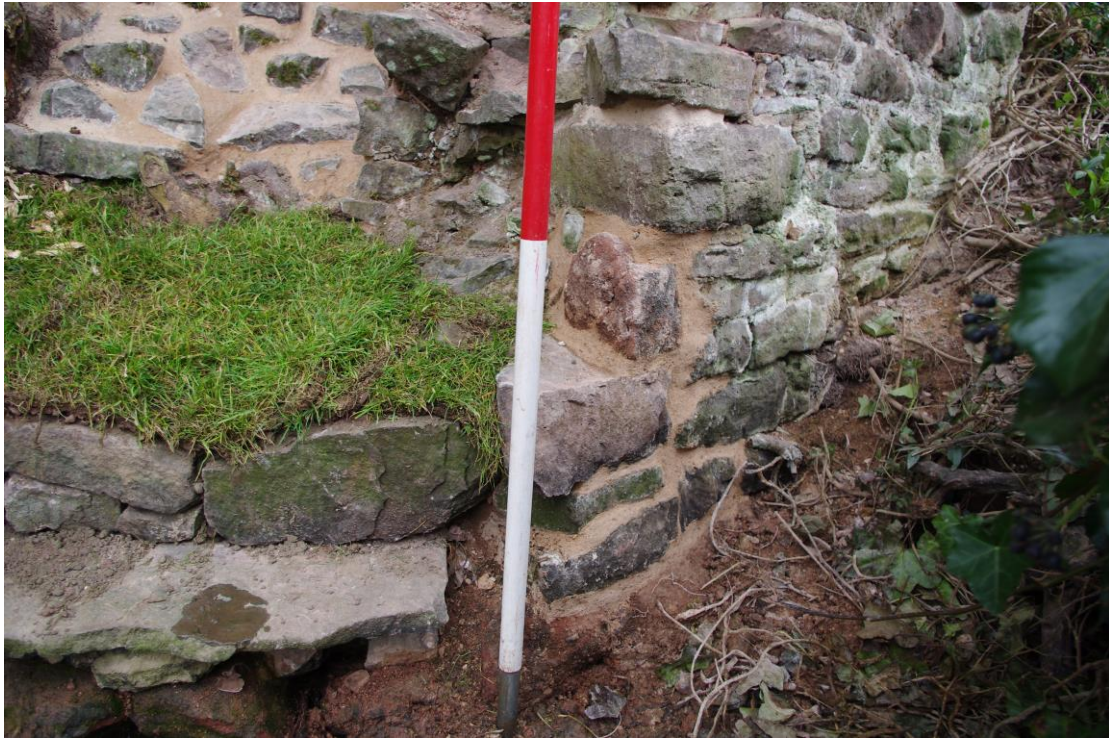
Plate 4: Re-pointed section at the base of the Gatehouse tower as seen from the west.

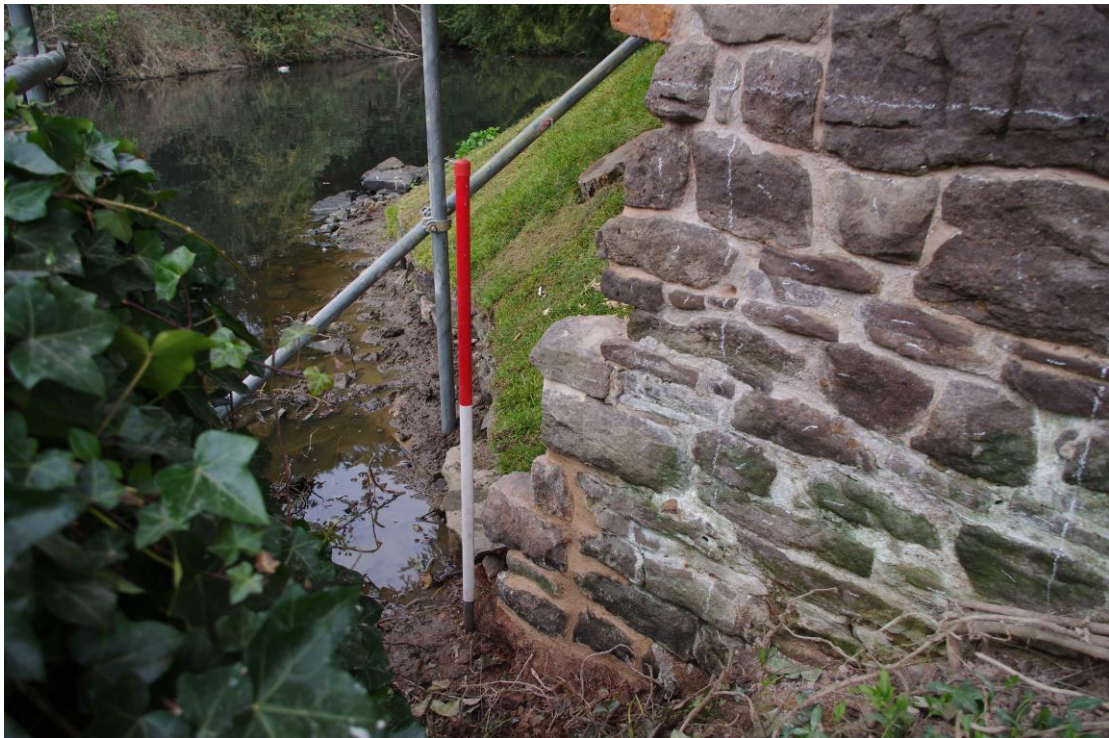
Plate 5: Re-pointed section at the base of the gatehouse as seen from the South.

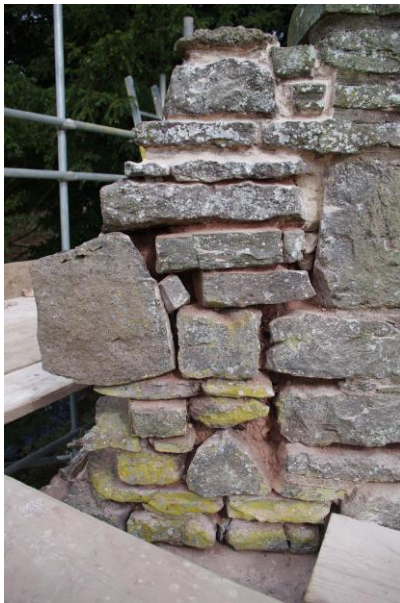
Plate 8: Upper portion of the raked out section above the moulding as viewed from the southwest.

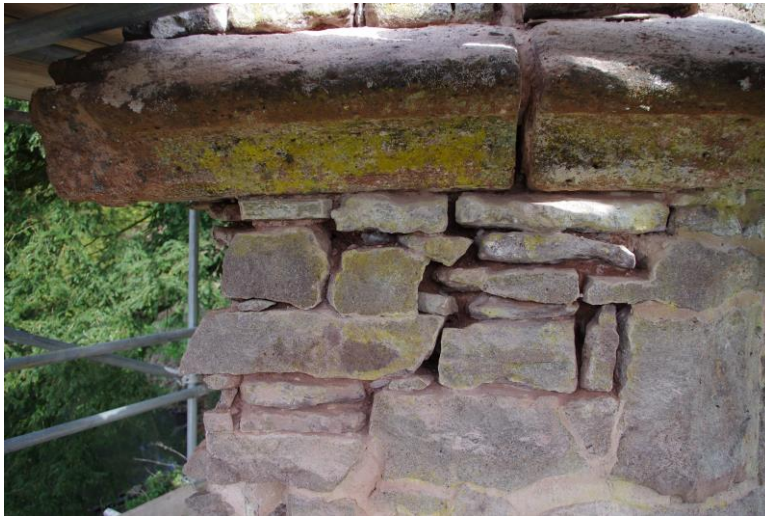
Plate 10: Raked out area beneath the moulding.

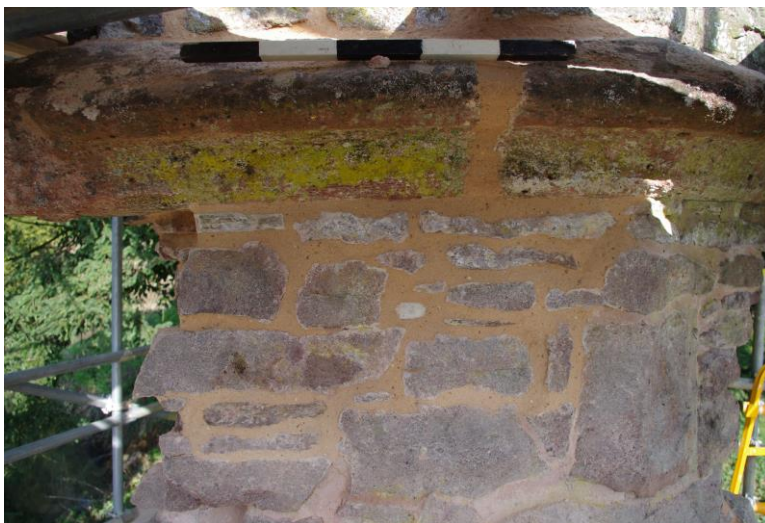
Plate 11: Area beneath the moulding after consolidation.

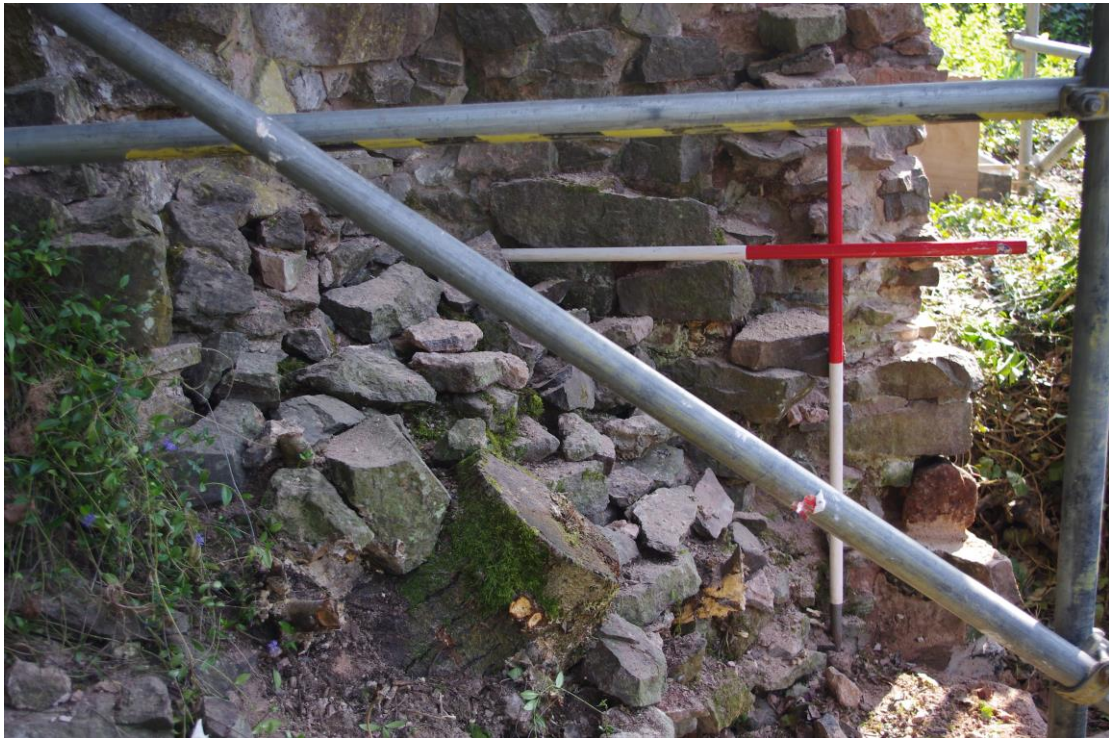
Plate 14: View of the gatehouse tower core work from the northwest, before Consolidation.

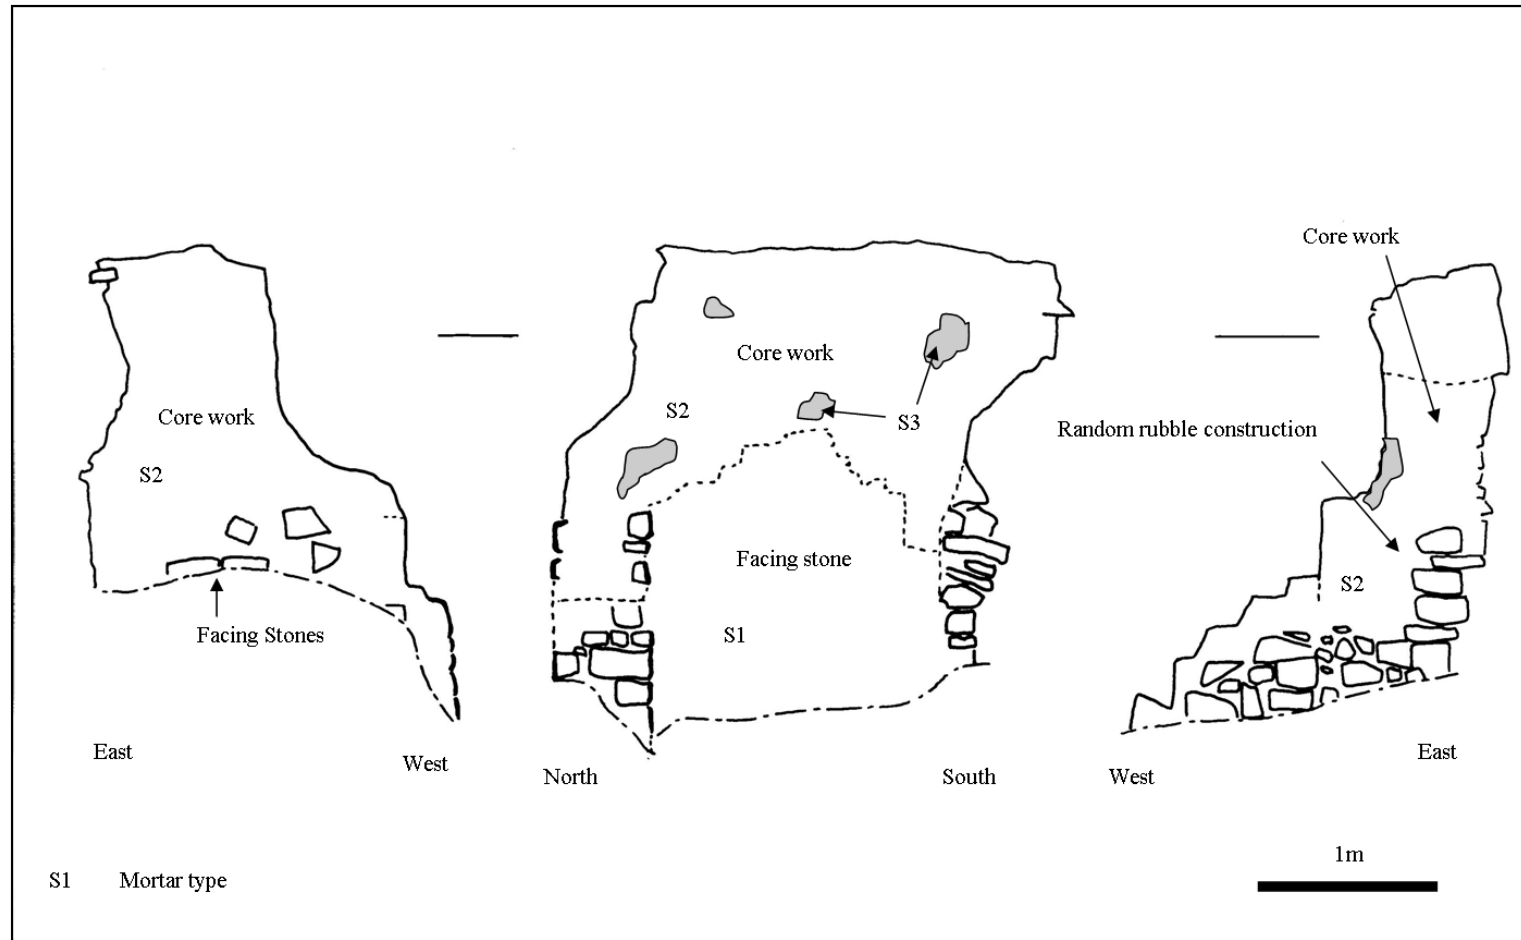
A significant feature is the unstable overhang at the top of this elevation (Figure 9, Plates 18, 19 and 26). This overhang extends out from the vertical c.0.40m, it is 0.50m high and 0.70m wide. It consists of corework and is in a very unstable condition. This was supported, after the vegetation was removed, by a timber frame, before the construction of the stone pier, (Figure 11, Plates 29 and 30).

Figure 9: Profile of the stair tower after cleaning but prior to consolidation (north elevation, west elevation [after excavation], south elevation).

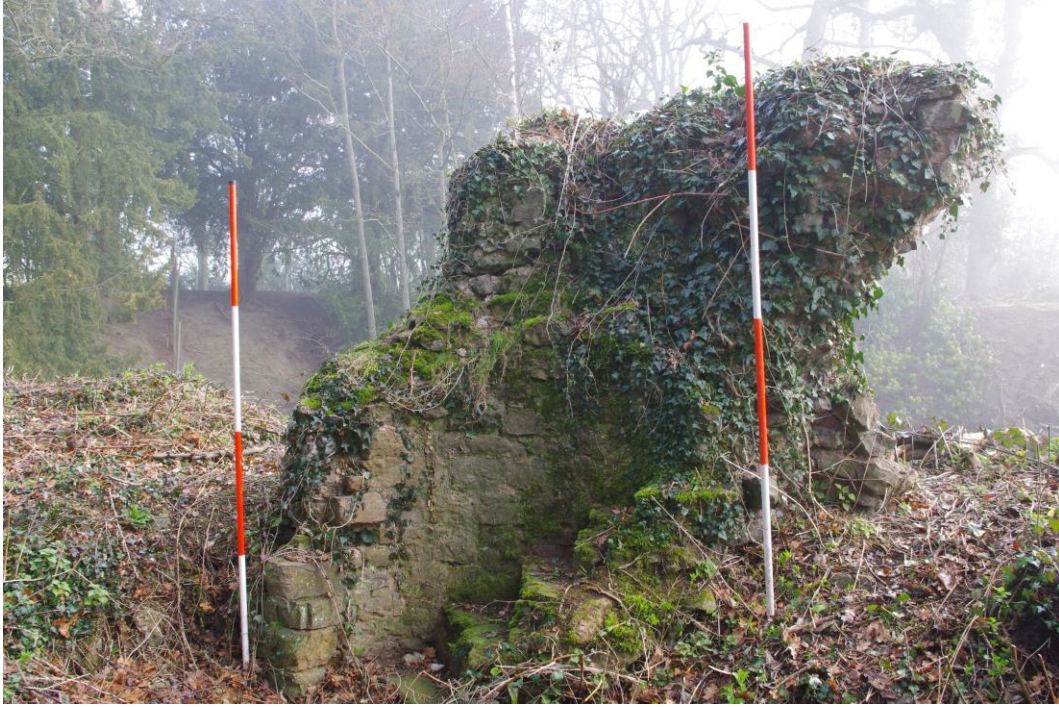
This elevation was covered in ivy (Plate 18) and this was cleared off (Plate 19) prior to recording and consolidation. The removal of the vegetation allowed access to the whole elevation showing the full extent of the consolidation required and a measured drawing was produced at this stage (Figures 9 and 10). The lower section of this elevation was in a reasonable state of repair. It consists of an east-west aligned wall at the north end of the structure, which is 0.50m wide and stands to a faced (but damaged) height of 1.30m. The pointing mortar is S1 (see Table 1) and where the face has been damaged random rubble stonework is visible in a matrix of S2 mortar. The western end of this wall is faced suggesting that this marks the base or is near to the base of the staircase.

Plate 18: View of the Western elevation of the Stair Tower as seen from The southwest, before work began.

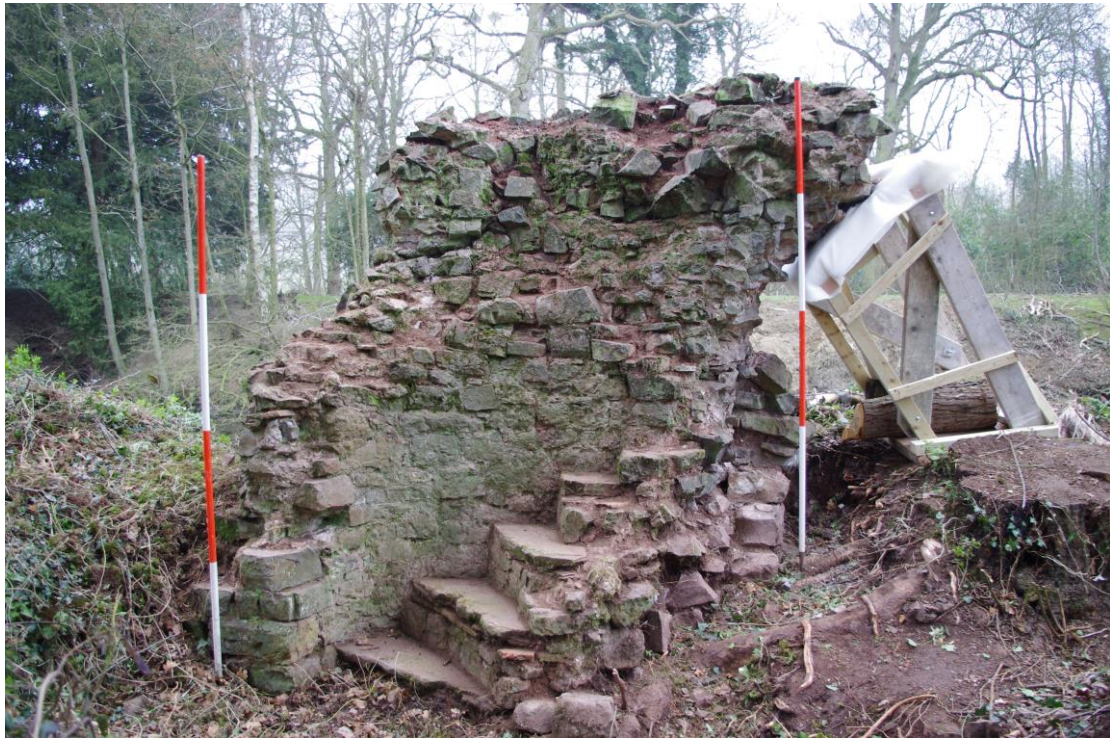
Plate 19: View of the Western elevation of the Stair Tower from the southwest after it had been cleaned and the over-hang supported.

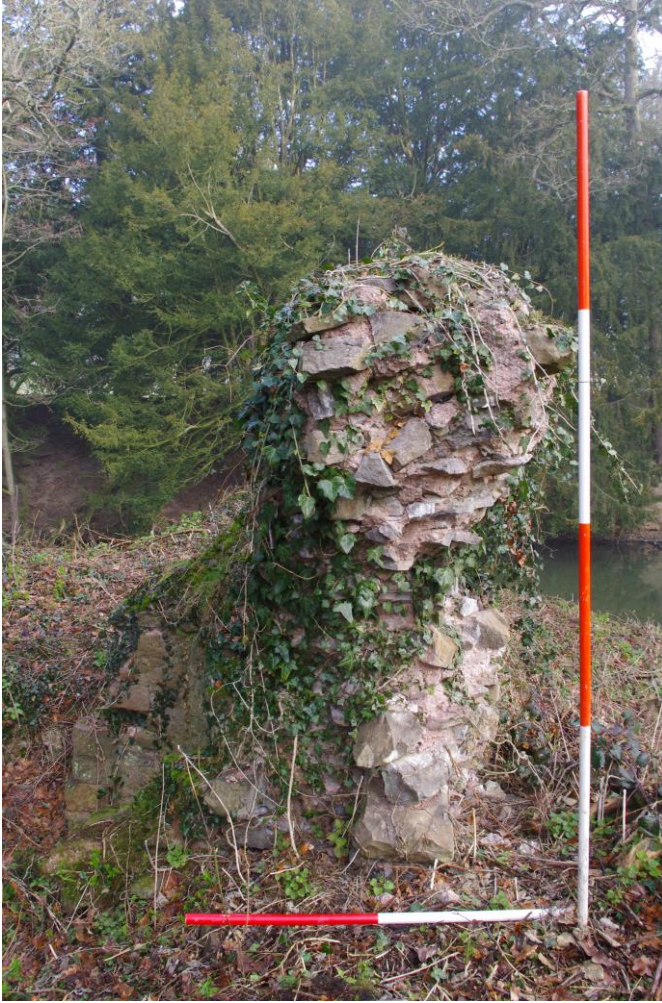
Plate 26: View of the stair tower from the south before clearance.

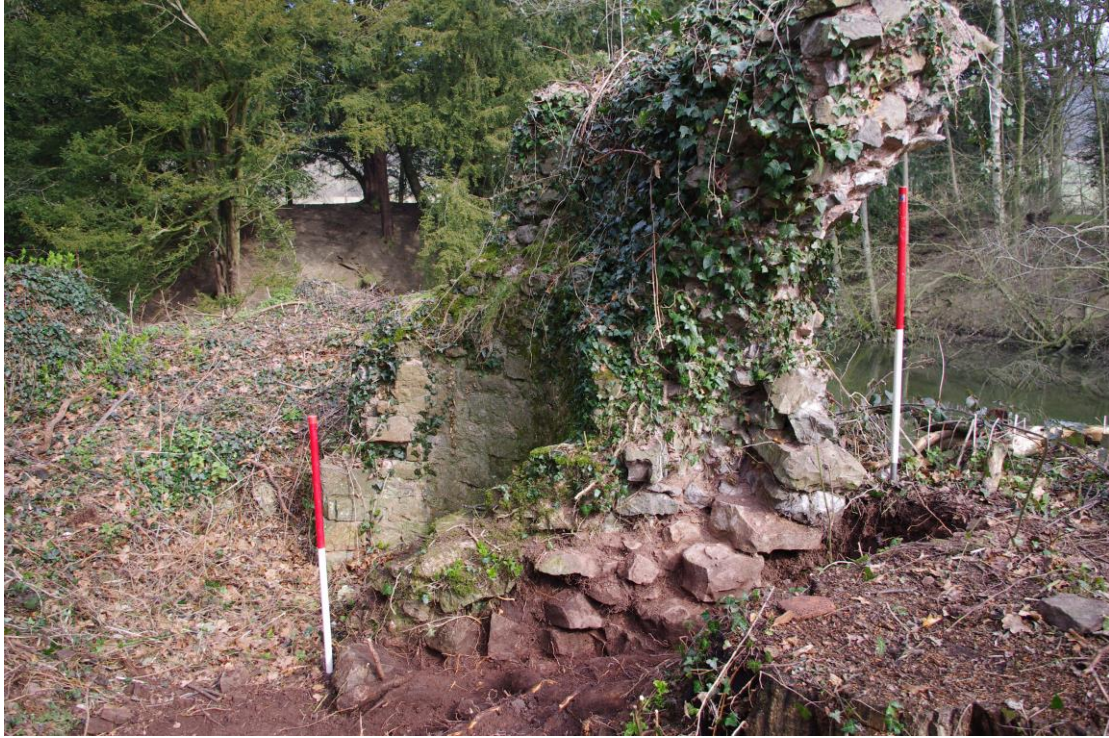
This elevation was 2m long (east-west) and 2.10m high before excavation (Plate 26 [see B1.2]) and 2.60m after (Plates 27 and 28). The majority of this elevation was made up of corework, random rubble, mainly angular stone in a disintegrating matrix of S2 mortar with S3 inclusions. Near the base, on the east side, were four squared facing stones devoid of mortar. Their function could not be determined at this stage.

Plate 27: South facing elevation after the trench was excavated.

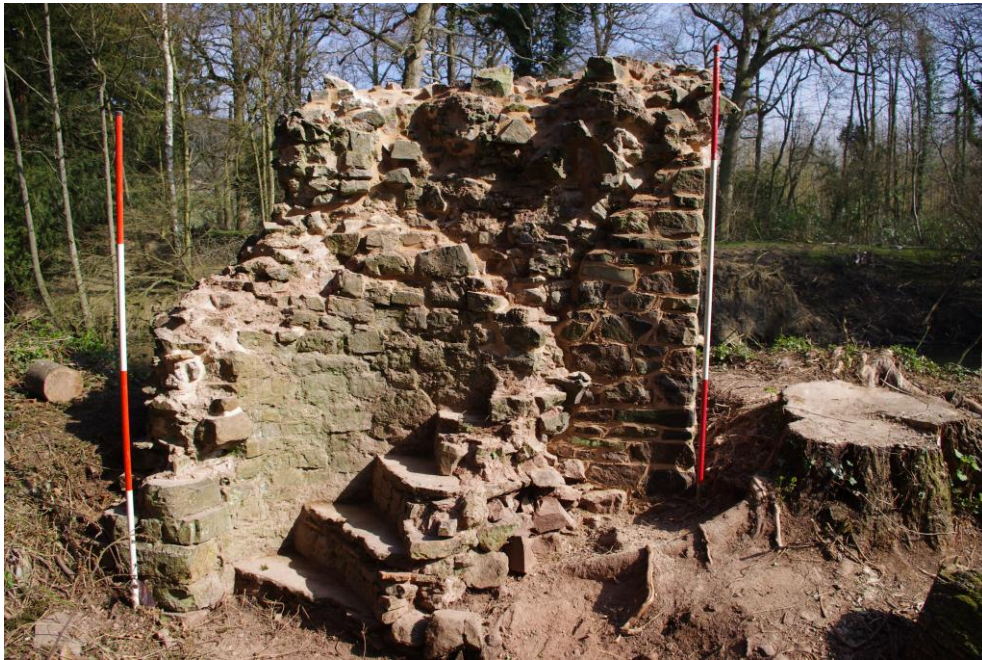
Plate 29: The completed stair tower after pointing and the addition of the support wall.

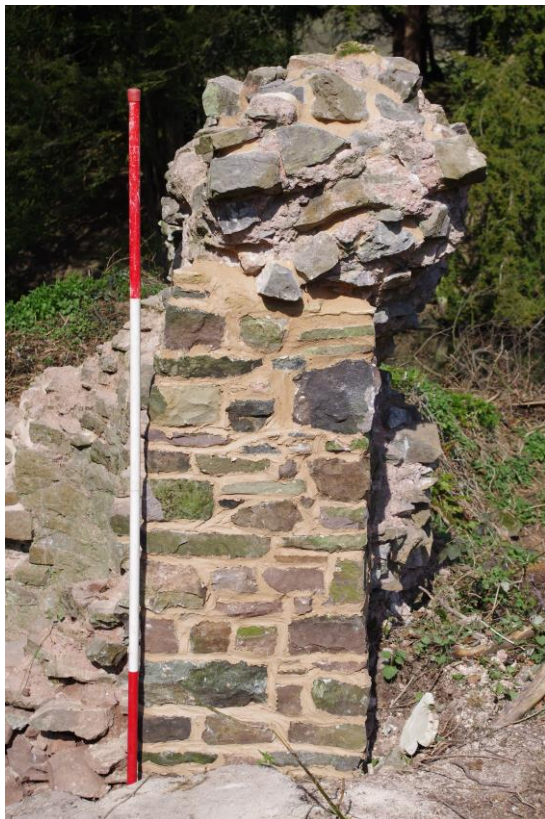
Plate 30: View of the completed support wall as seen from the south.

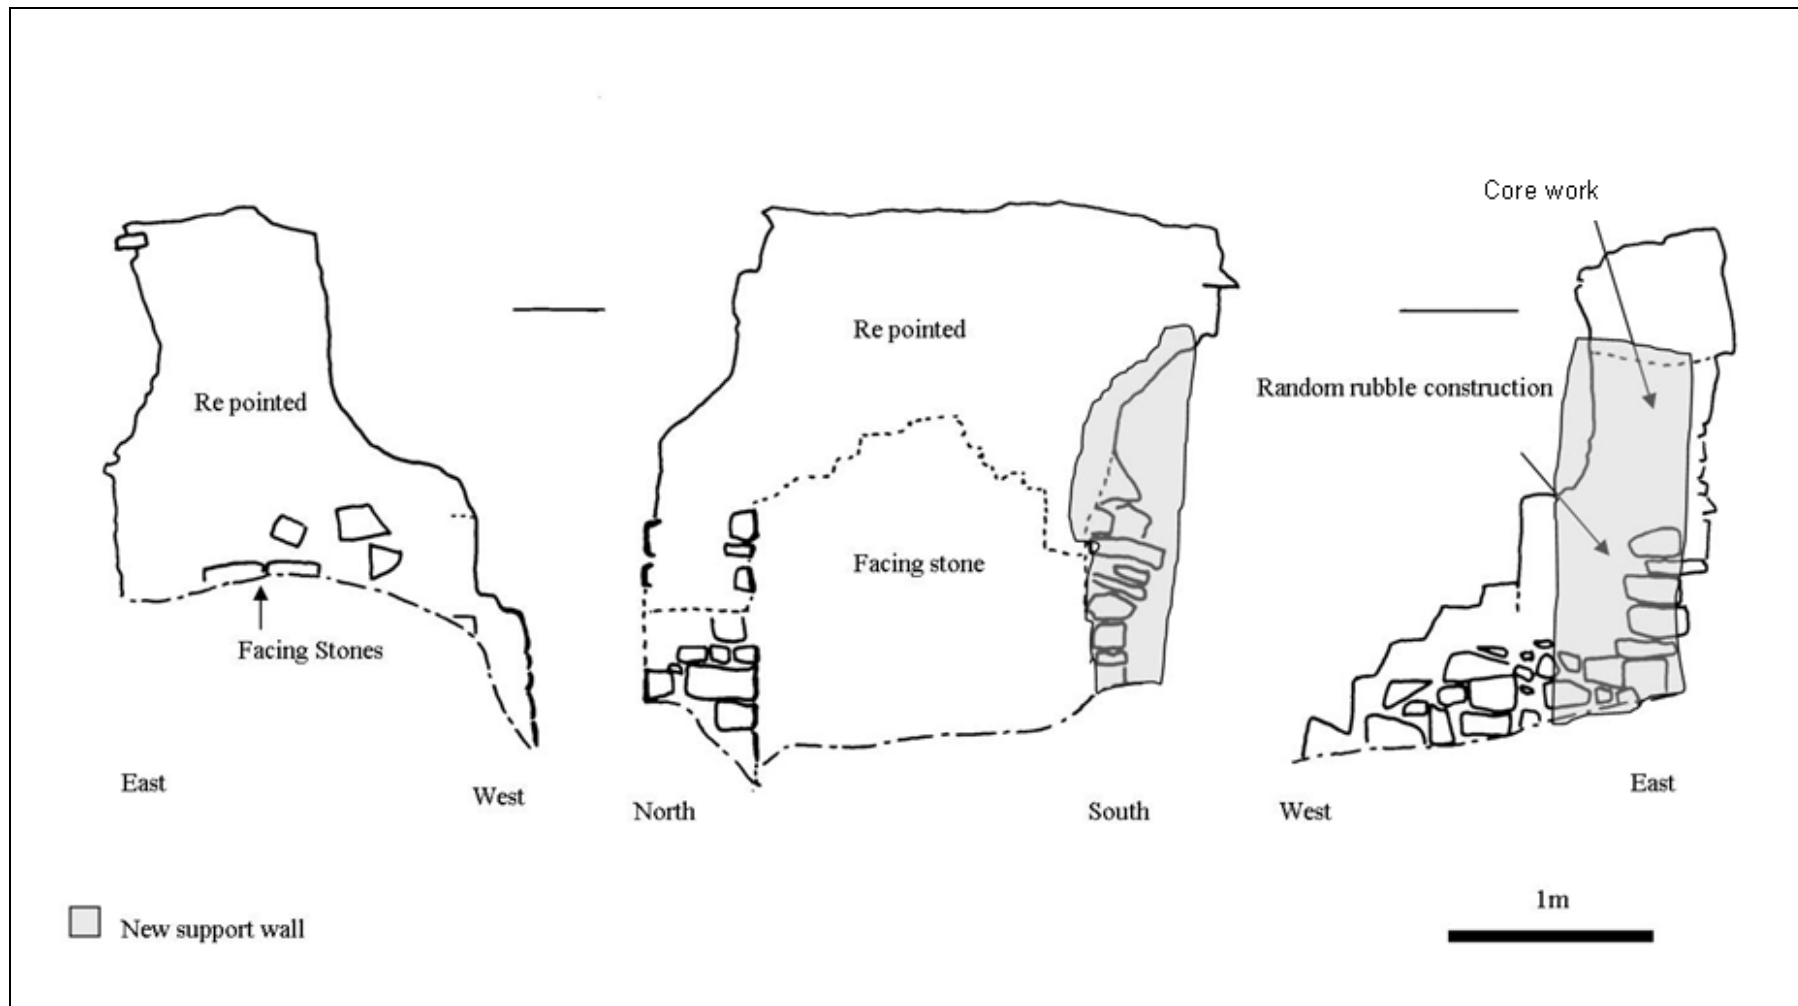
Figure 11: Elevations showing the repaired stair tower and the new support wall.

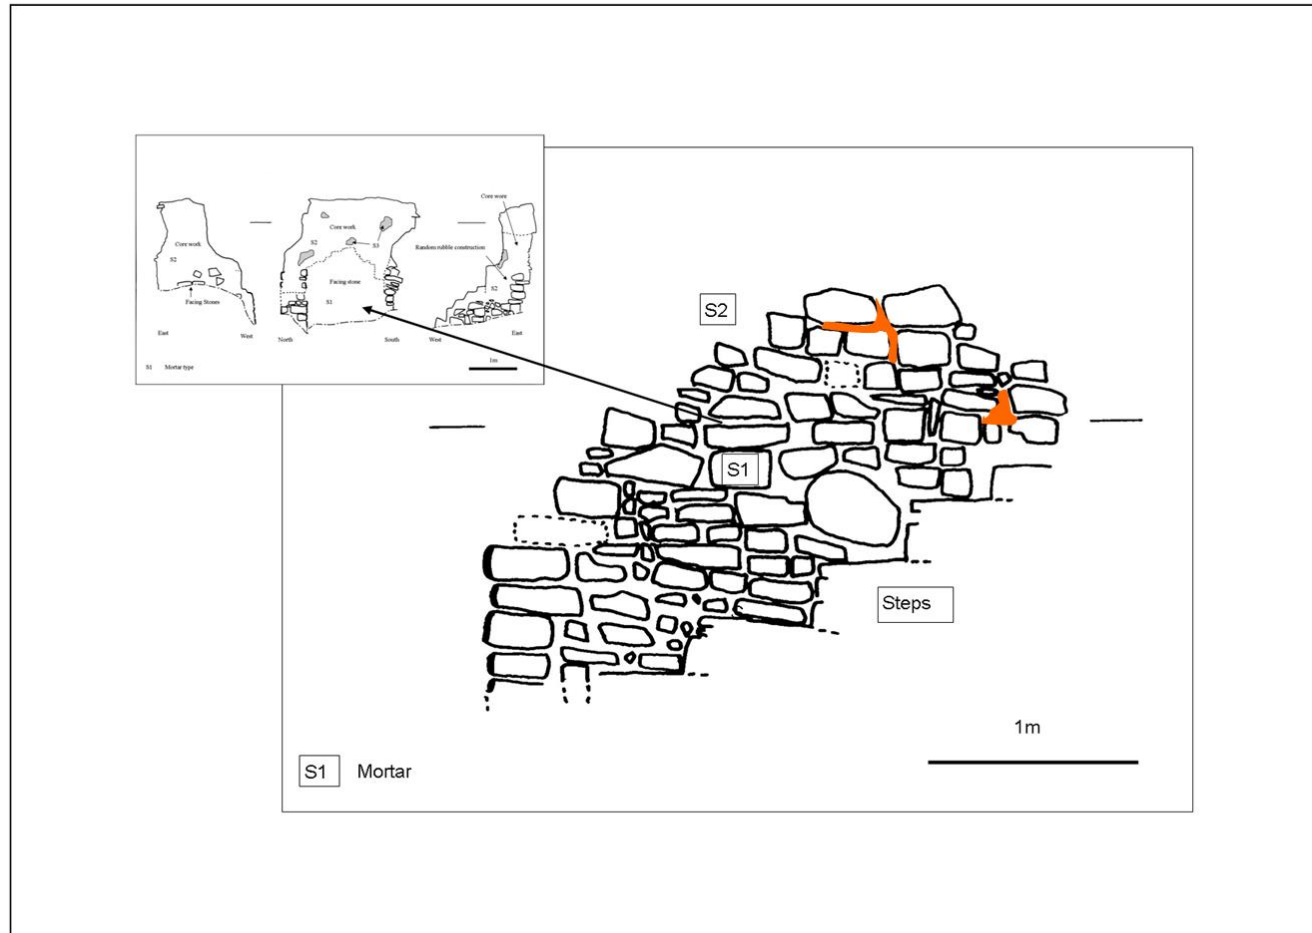
Figure 12: Staircase facing stones showing the limited pointing that was required.

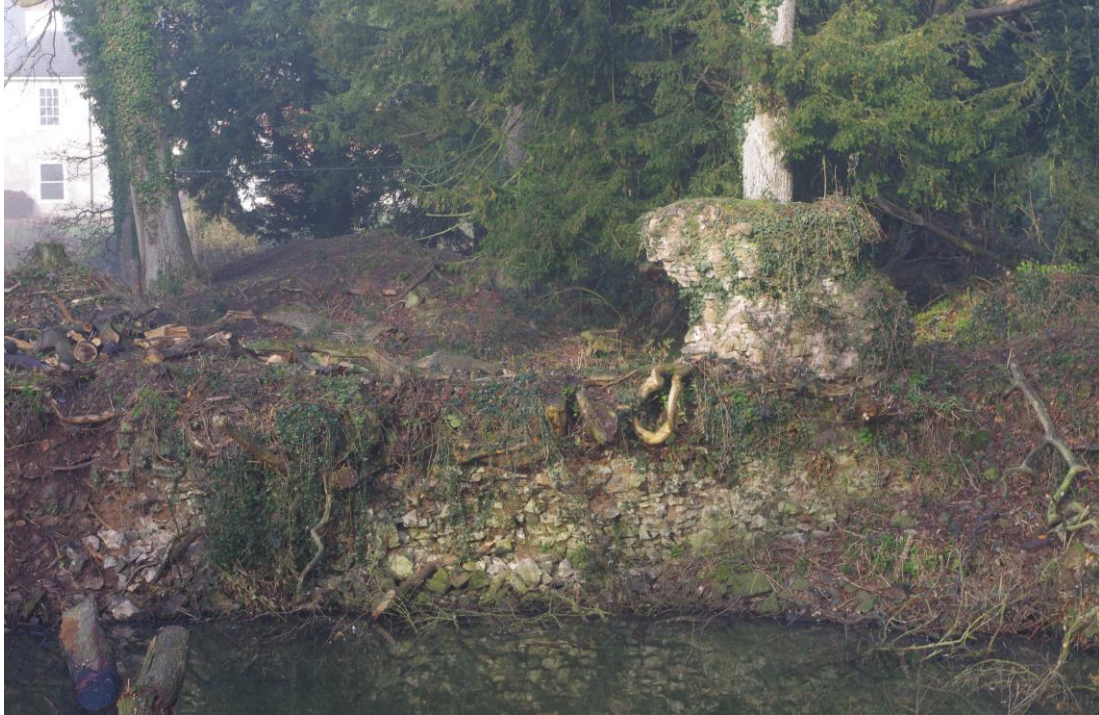
The curtain wall is in a very unstable condition. It is being progressively eroded by the fluctuating water level in the moat and is no doubt being effected by freeze/thaw. A humic soil has formed on the top of this section of curtain wall and this has in turn encouraged tree growth. The root system of one tree in particular (only the stump remains above ground) has had a dramatic effect on the underlying curtain wall. The roots passage through the wall has led to substantial damage. It is however also noticeable that the support of other sections of root have helped to preserve the only remaining section of wall face.

Plate 31: View of the Stair Tower and the eroding curtain wall as viewed from the east before work began.

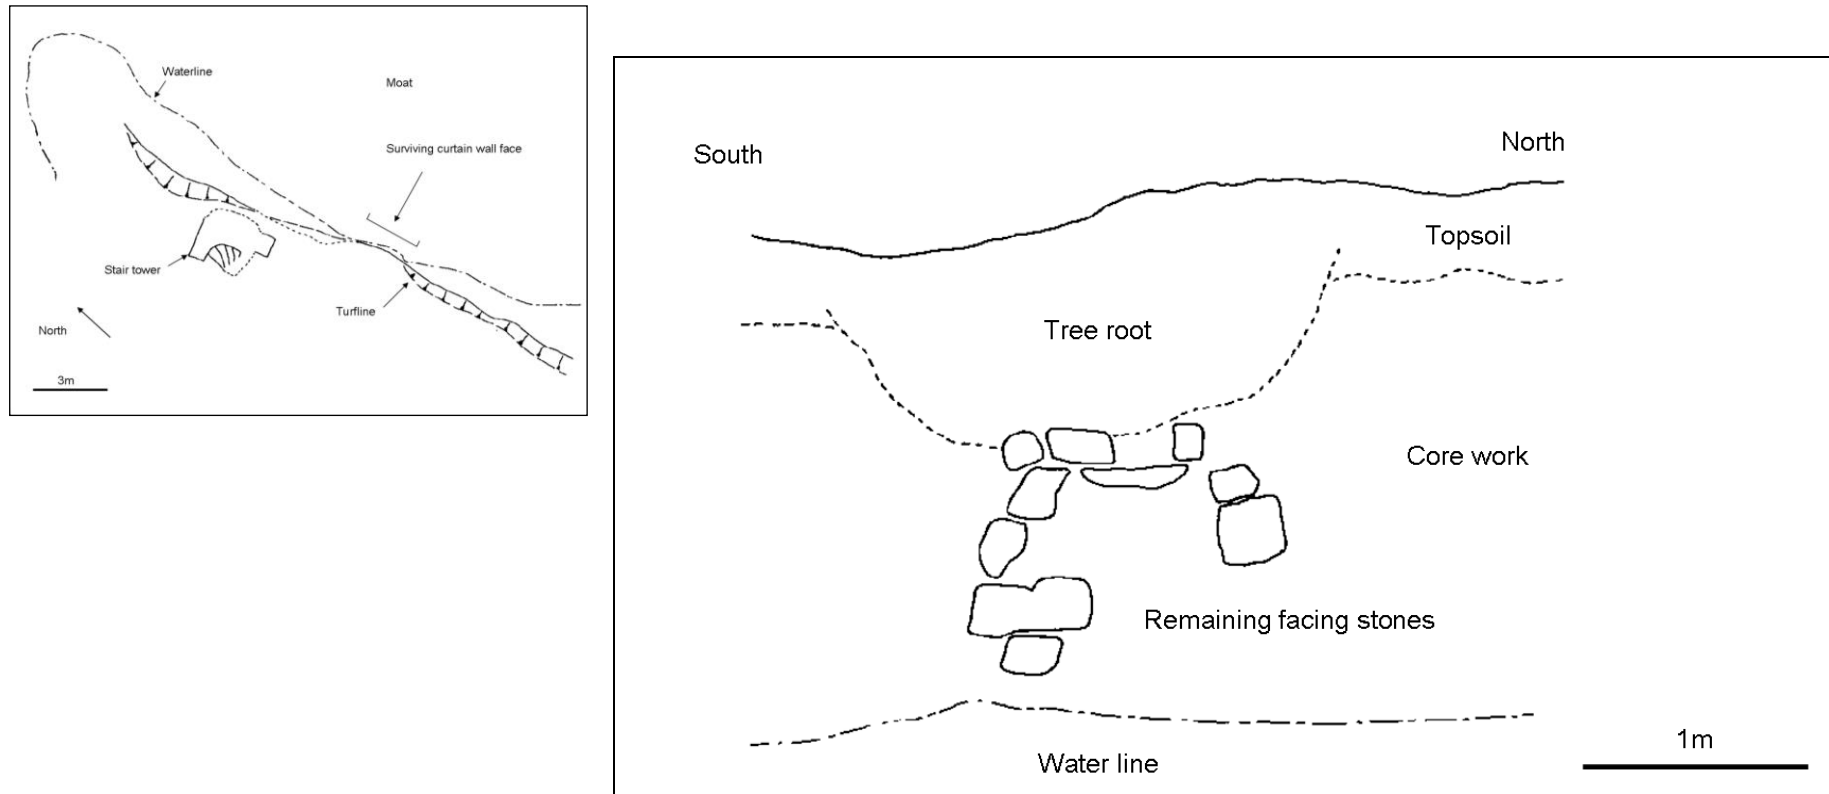
The only remaining section of wall face (Figure 15) is located towards the centre of the remaining section of wall. This consists of ten cut stones either square or rectangular in shape that are bonded with a very fine, red/brown lime rich mortar (C3)

Figure 15: The remaining curtain wall facing stones and their location.
