December 2012

Archaeological Assessment of the moat at Lower Brockhampton, Bromyard, Herefordshire

Herefordshire Archaeology Report No. 314

**NGR: SO 6874 5590
EHE 2061
HAR 314**

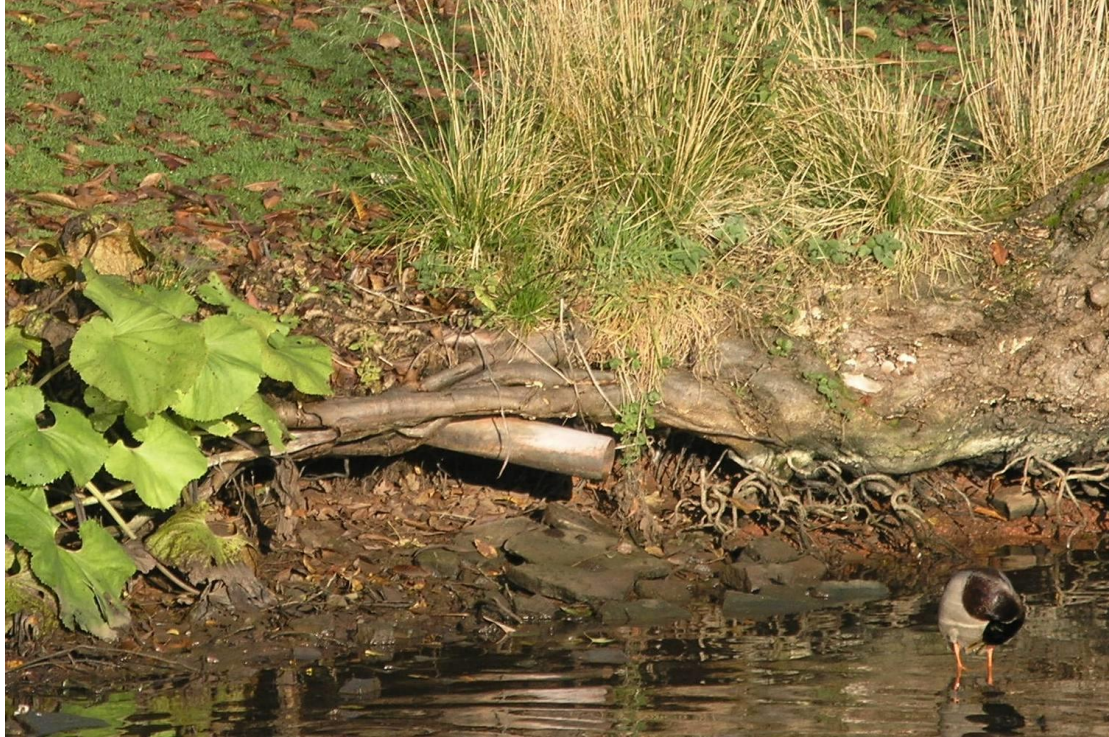
0.4m (east-west). The end of this pipe was almost flush with the moat-edge in 1993 (Morris & Hoverd 1994), and the area around it has been under-cut by a further 0.4m, indicating active erosion for almost a metre in the last 20 years (Plate 1).

Plate 1: Plastic pipe laid in 1993 showing amount of erosion and undercutting over the last 20 years.

- The erosion is easiest to quantify in the internal eastern bank. Here there is a point of reference in the plastic drain which was laid in 1993. It now extends into the moat due to erosion and has been undercut to a depth of over 0.35m. This would suggest that the eastern internal bank is being eroded at a rate of over 0.3m each decade. During the course of the fieldwork it was noted that erosion appeared to have been minimised at points where beds of iris had been planted next to the bank.

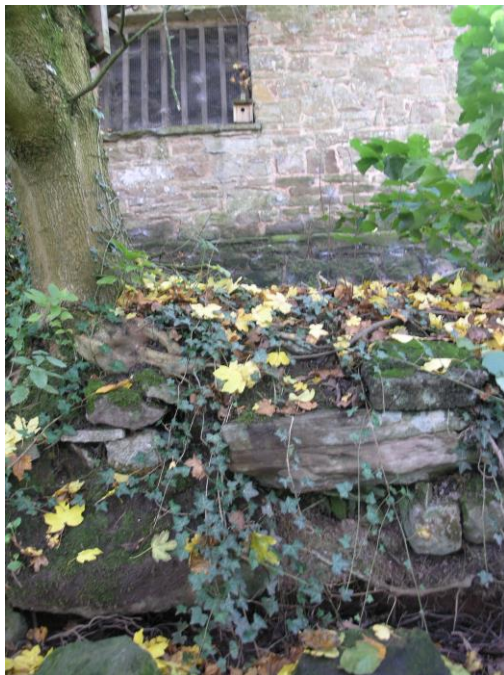
Plate 2: Remains of masonry wall along the north-facing edge of the inner bank of the northern arm of the moat. Note the proximity of the north gable end of the east wing of the house, and the extent of under-cutting of the bank and of the consequent undermining of the revetment wall.

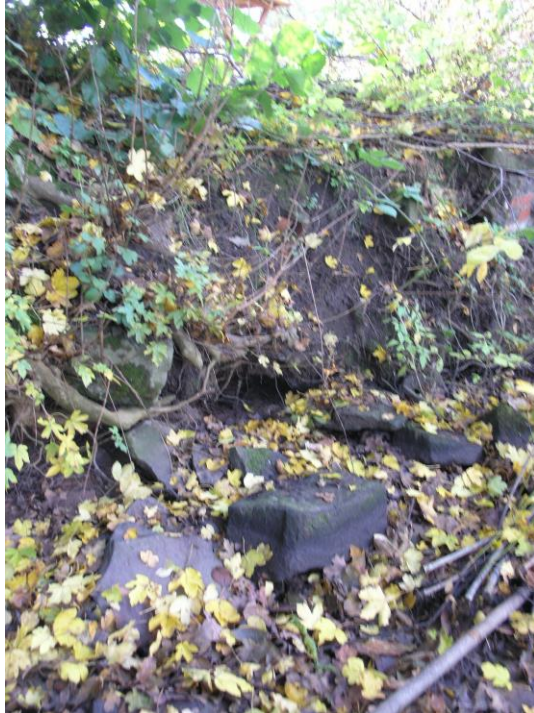
Plate 3: Collapsed wall immediately to the west of plate 2. Note the recent erosion of soil in the bank above the masonry.

The collapsed masonry is particularly dense along the line of the north gable end of the most northerly part of the east wing of the house, and the rubble continues around the inner bank-edge of the western arm of the moat. This suggests that this bank, also, was once revetted by a stone wall (Plate 4). In places, large stone blocks appear still to be attached to the bank. However, not enough survives to indicate the original scale of the revetment.

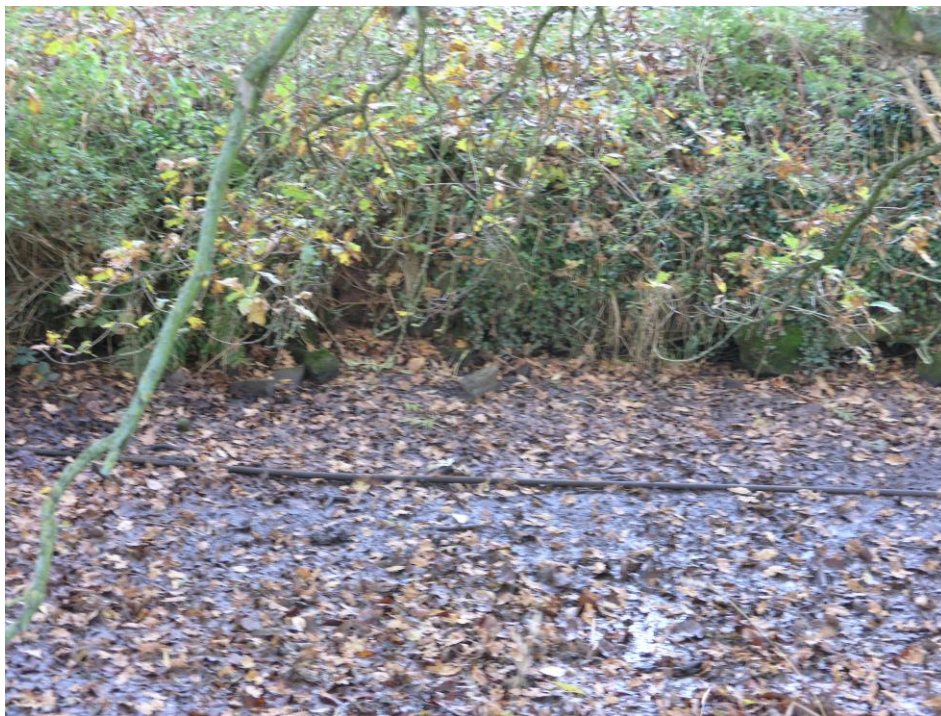
Plate 4: Squared stone rubble along western internal face of moat.

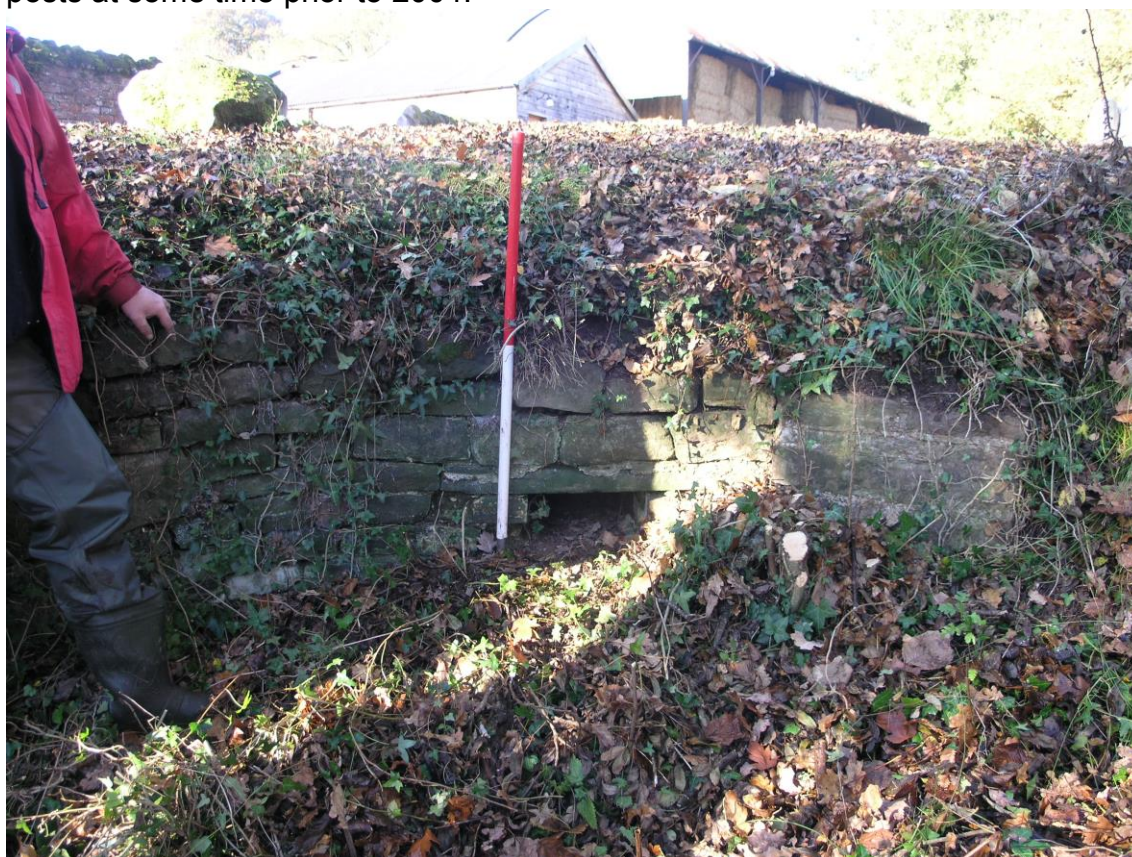
This drain measured 0.35m wide and 0.15m high and clearly came from the fold yard 25m to the south (Plate 5). It appears that the drain has been purposefully blocked by a stone slab approximately 1.6m from its end. (Plate 6). The well-built wall clearly terminates approximately 0.8m to the north of the drain. However, in the opposite direction to the south and west some degraded walling continues to run for at least 3.5m, gradually becoming fragmented by tree roots as it runs around the moat terminal. In general this length of surviving walling represents a revetment clearly defining the south-western end of the moat, presumably dating from the construction of the fold yard in the late 18th or 19th century.

Plate 5: Stone wall and drain in south-western corner, external bank.

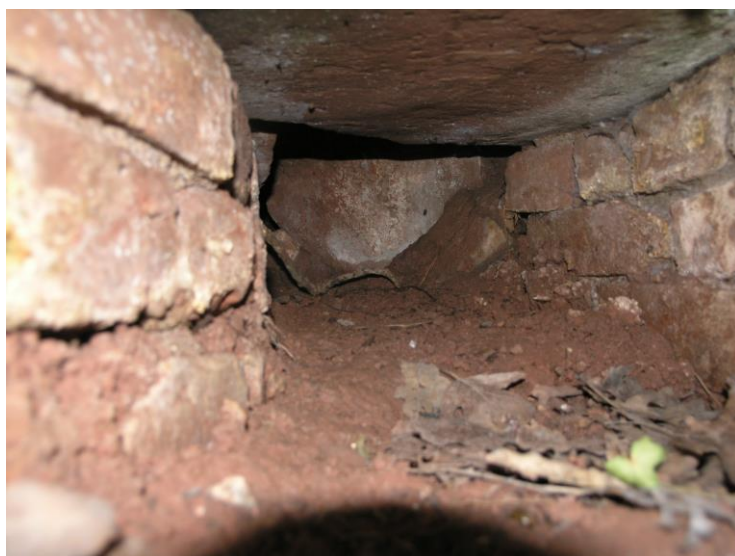
Plate 6: The inside of the drain showing the vertical slab used as blocking.

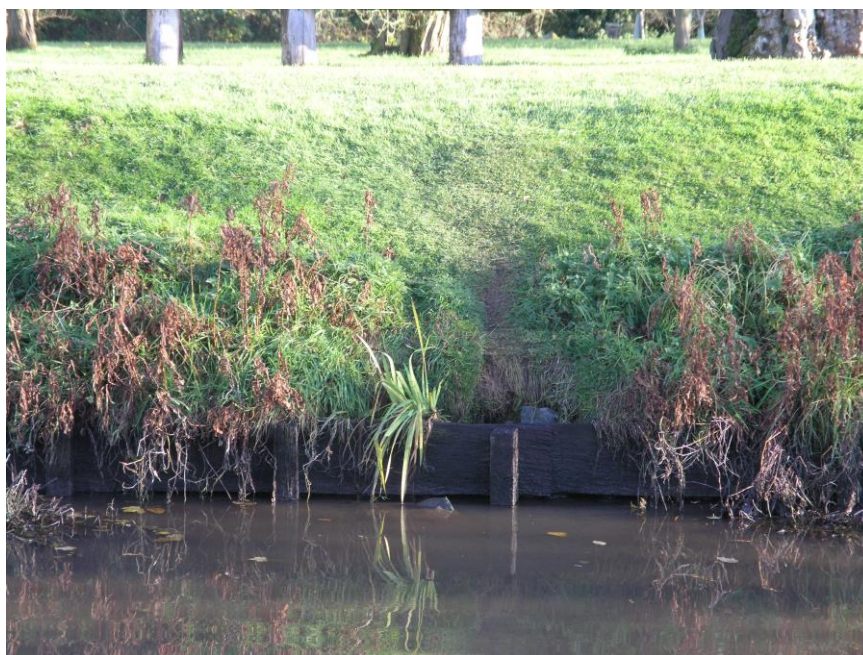
This system of timber revetment was presumably an attempt to halt both erosion through water action and more localised decay caused by water-fowl. This system of bank stabilisation appears to have had only limited success as the water has penetrated behind the planking and has undercut the bank (in some cases substantially). Further scars are being produced by water-fowl using localised areas to enter and exit the moat, (see plate 7).

Plate 7: Timber revetting showing under-cutting and scaring due to water-fowl.

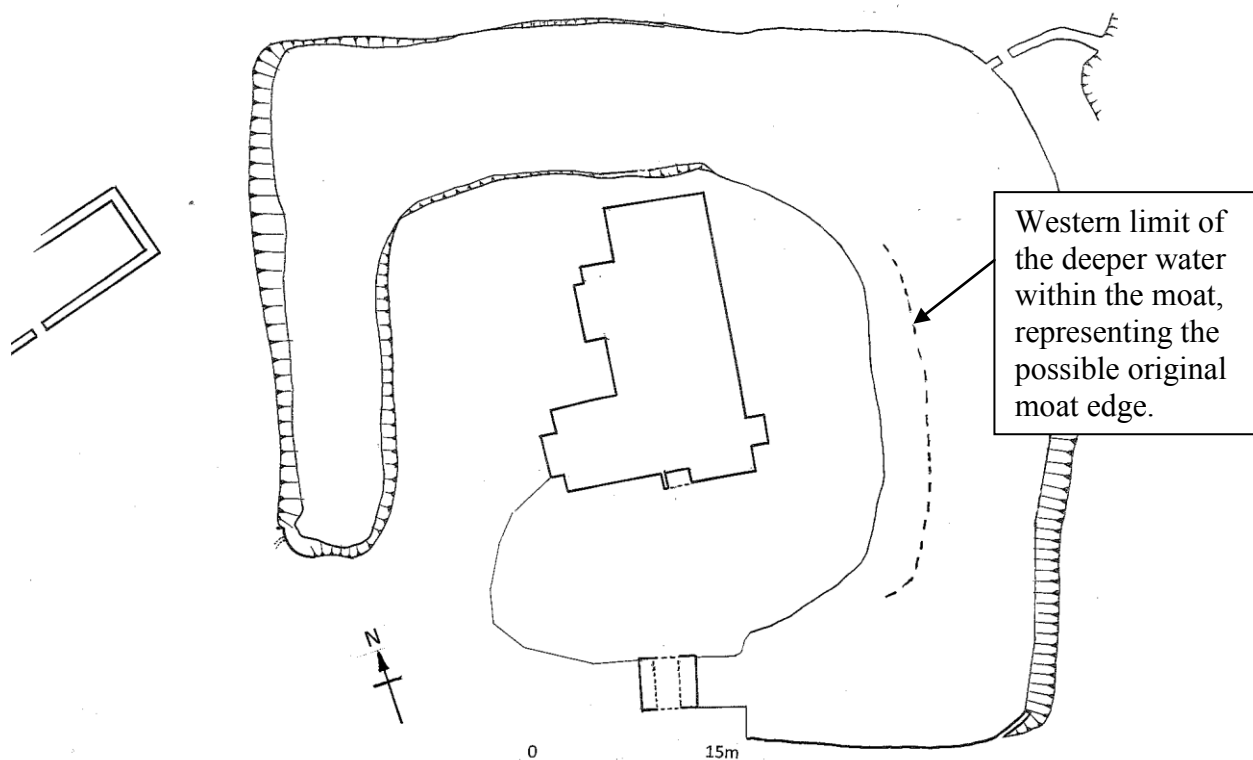
This line representing greater depth to the moat was traced along the eastern side of the moat and found to turn quite sharply into the southern arm of the moat. It is suggested that this abrupt change in the current moat base represents the remnant of the original cut for the moat. If this were proved to be the case it would not only provide a far more even and regular form to the moat but also place the house closer to the centre of the island, in line with the earliest close mapping of the site in 1769.

Figure 12: Location of deepening of water detected within the moat and possibly relating to the line of the original moat

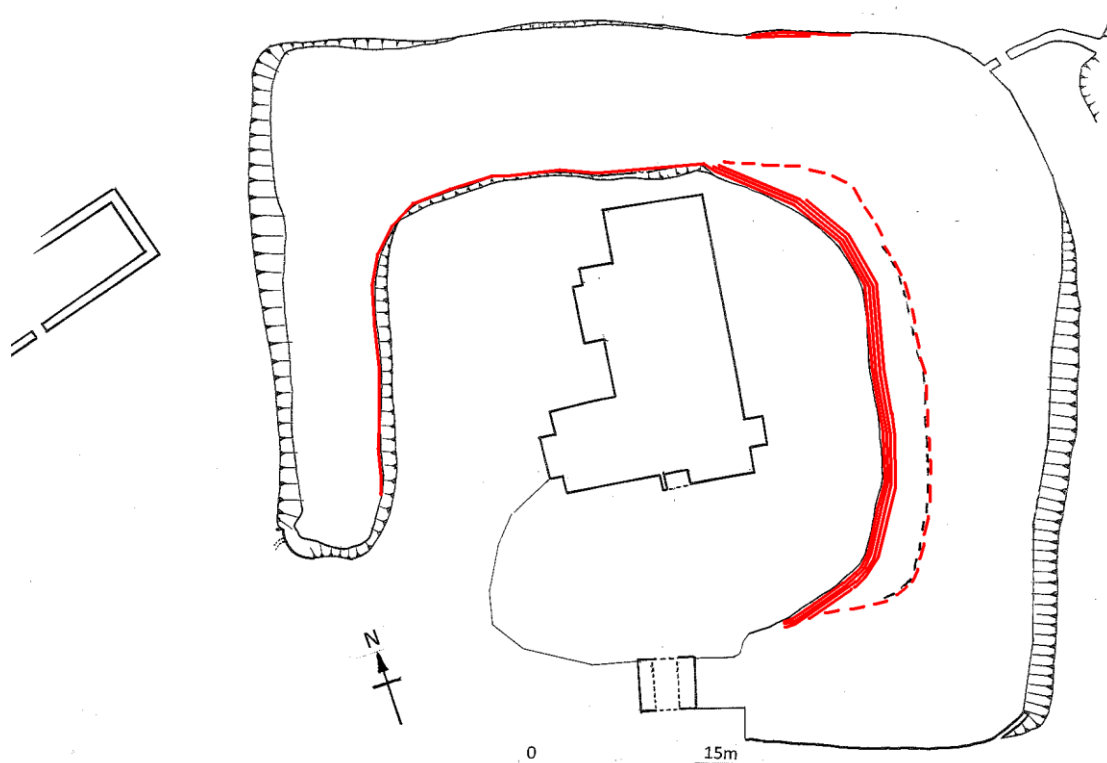
- 5.1 Along the *inner* bank of the moated area, it is clear that the greatest erosion has occurred along the east-facing bank. This could have been deliberate, but perhaps has rather comprised the gradual cumulative impact of waterfowl movements, and lack of bank-side management. Whether this latter was caused

- 5.2 It would appear that certainly much of the northern inner moat bank was at one point in the past retained by a revetment wall comprising well-coursed, squared, stones of large size. The northern inner bank is the closest to the house and therefore such a solid structure might be expected at that location. It does, however, seem probable that this wall continued around the western arm of the internal bank of the moat
- 5.3 All other bankside erosion can be attributed either to a failure to maintain revetment walls, or (in the case for instance of the outer eastern moat bank) the application of unsuitable methods of bank stabilisation. Along the northern outer bank of the moat, erosion could be attributable simply to a failure to manage bankside trees and vegetation adequately.

Figure 15: Areas and extents of erosion of the banks of the moat (highlighted in red)

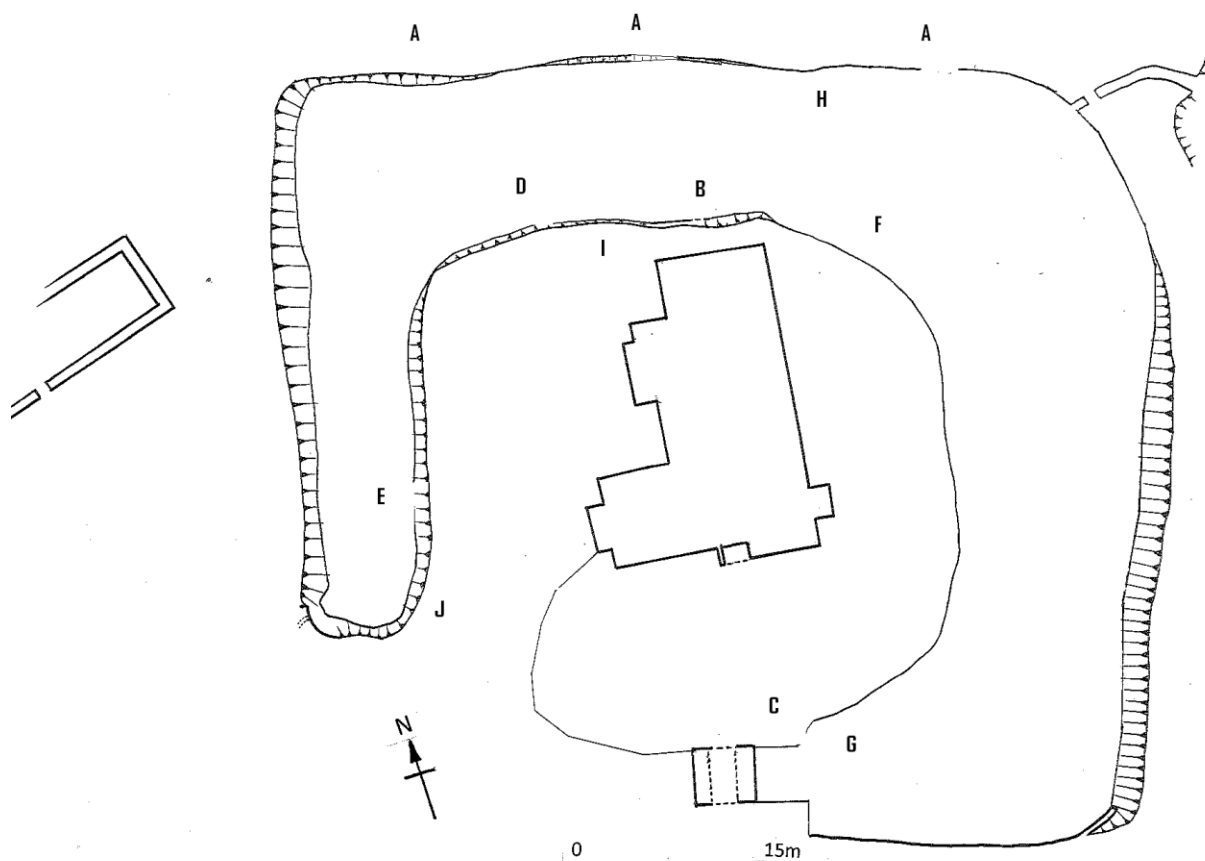
Figure 16: Location of potential archaeological works and remedial conservation actions

- 7.4 Better simple practical solutions need to be found elsewhere, as with the areas of collapse such as that at point H (figure 16). The question that will remain concerns the feasibility of repair and re-instatement of the walling along the rest of the northern inner bank and the western inner bank (point I to point J (Figure 16).
