Remedial rebuilding on the City Wall, Hereford.

Herefordshire Archaeology Report No. 303

NGR: SO 507 396
EHE 1909

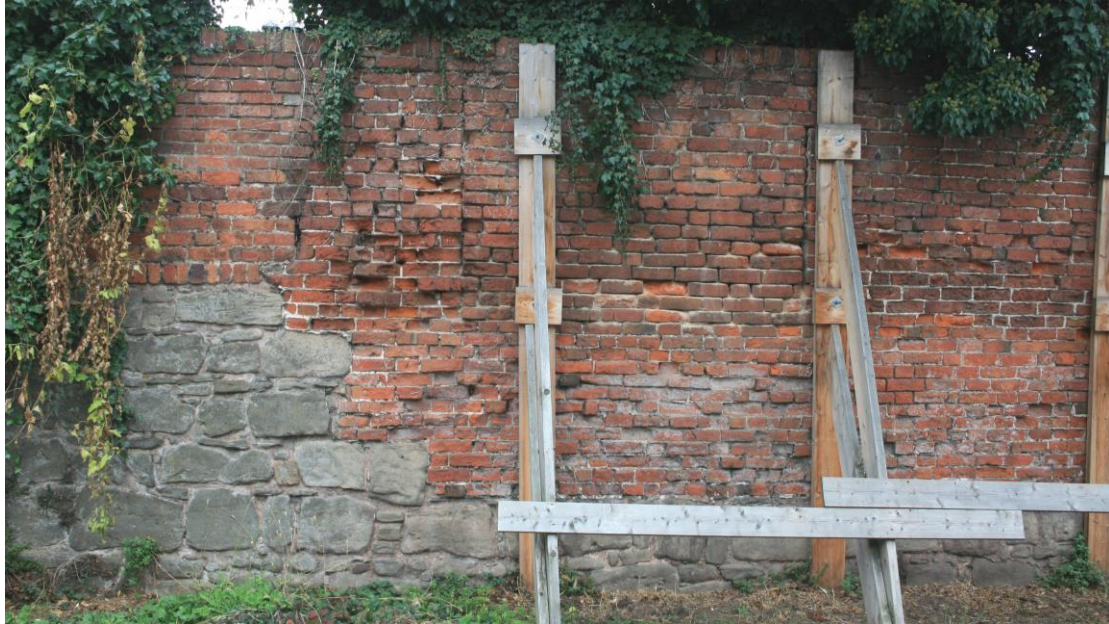
The city wall fabric here was recorded stone by stone in 1997 by Archaeological Investigations Ltd (Boucher and Shoemith 1997, sections N and O). The survey preceded local repairs by Hereford City Council in the SPAB tradition (voids filled by tile courses set back behind the main wall plane), though the repairs appear to have been confined to the stonework and the brickwork left unaffected. The brickwork itself is laid to an inconsistently applied Garden Wall bond, average brick size 6cm x 10.5cm x 22cm (c. 2.5 x 4 x 8.5 ins) and is of probable 18th- or early 19th-century date. At the northern end of the section the city wall fabric survives to a height of six main courses (c.1.6m high) visible externally. The surviving top of the city wall fabric then steps down, leaving only one to two main courses at the base of the propped brickwork. The point at which the stonework reduces in height approximately

coincides with a straight joint in the superincumbent brickwork, suggestive of a former property boundary. To the south, at the end of the propped section, the stonework returns to a height of about fourteen courses (c.3.8m), coincident with the Black Lion property and its last outbuilding, whose gable end is built into the wall.

Plate 1: Northern end of the wall section: the city wall fabric is reduced in height, coinciding with a straight joint in the brickwork above. Trench 1 lies behind the wall on the left hand (northern) edge of this photo.

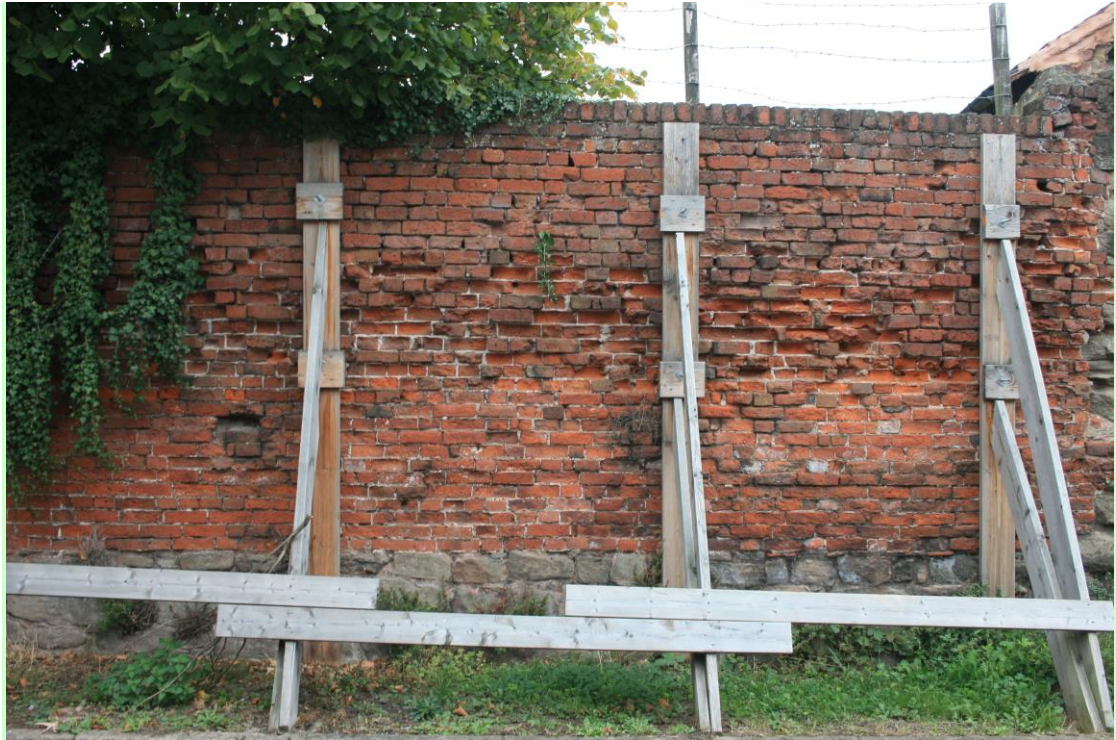
This section, currently distinguished by its propped brickwork, interrupts one of the best-preserved stretches of Hereford's medieval defences. The city wall fabric either side of the brick section consists of courses of large blocks of roughly square proportions separated by much thinner courses of flat stones, used for levelling up the main courses during the construction process. This fabric type can be identified on the adjacent bastion (Bastion 2), further north along the wall on Victoria Street (Bastion 4), and on the north side of the city facing New Market Street and Blue School Street, and is clearly 'primary build' masonry, undisturbed since it was built in the 13th or 14th century.

Plate 2: The central stretch of the propped brickwork with the city wall fabric reduced to two or three courses. The weathering of the brickwork approximately mid-height is particularly noticeable here

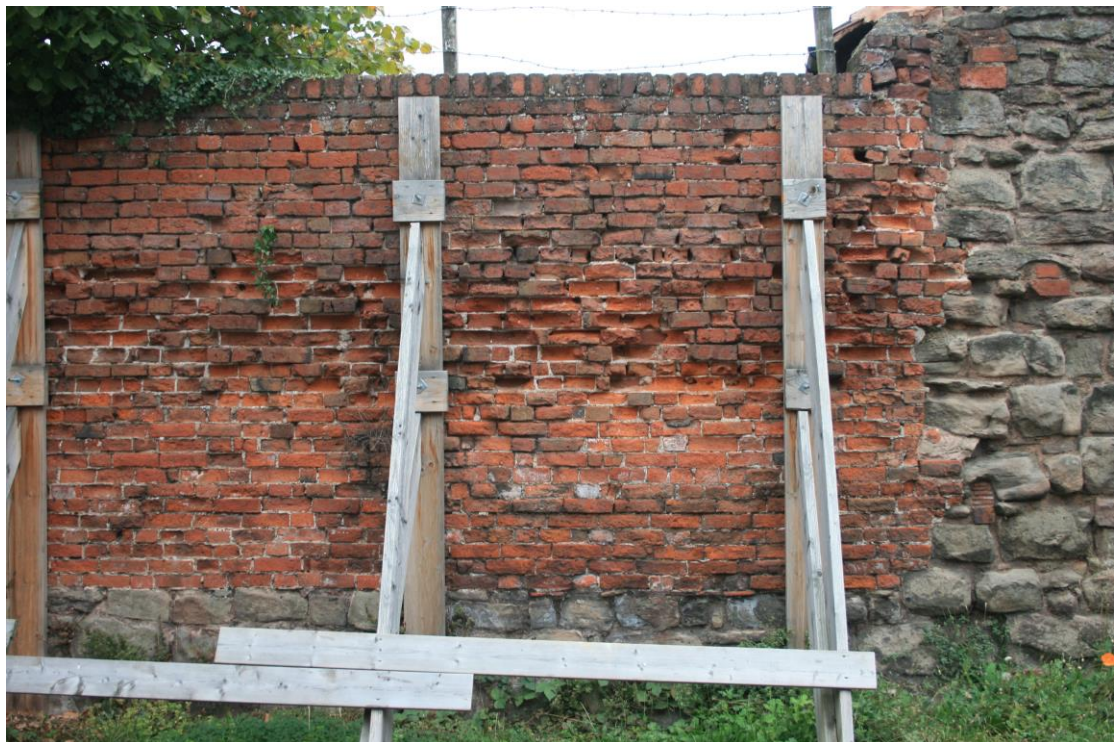
Plate 3: The southern end of the propped section showing its junction with the Black Lion outbuilding. Trench 2 lies behind the brickwork here

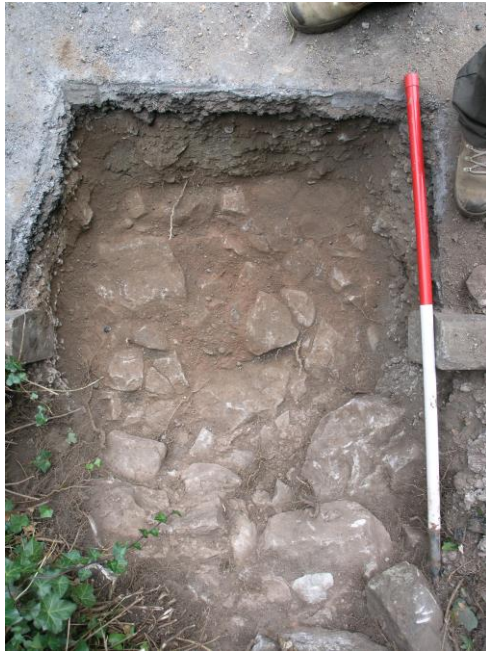
Upon the removal of the kerb and tarmac together with its underlying concrete and scalping levels, a layer of large stones became apparent, (see plate 4). After cleaning the stones resolved themselves into two distinct features. The stones within the western half of the trench (101) were bonded by a white, lime mortar containing small inclusions of crushed tile or brick. This represents the masonry remains of the top of the city wall which has been cut into in order to insert the modern kerb. The stones to the east of this (102) were set into a redder / buff coloured mortar and were generally less angular and more worn, they were also laid flat. Although not investigated, it would seem that these stones, (102), represent a well used area of hard standing / yard or floor surface, which butted up against the city wall. It would appear that this feature was utilised as a solid base for the construction of the present car park.

Plate 4: Trench 1 plan view, showing redder, more worn stones in top half of trench, compared to larger, more angular stone in lower half of trench.

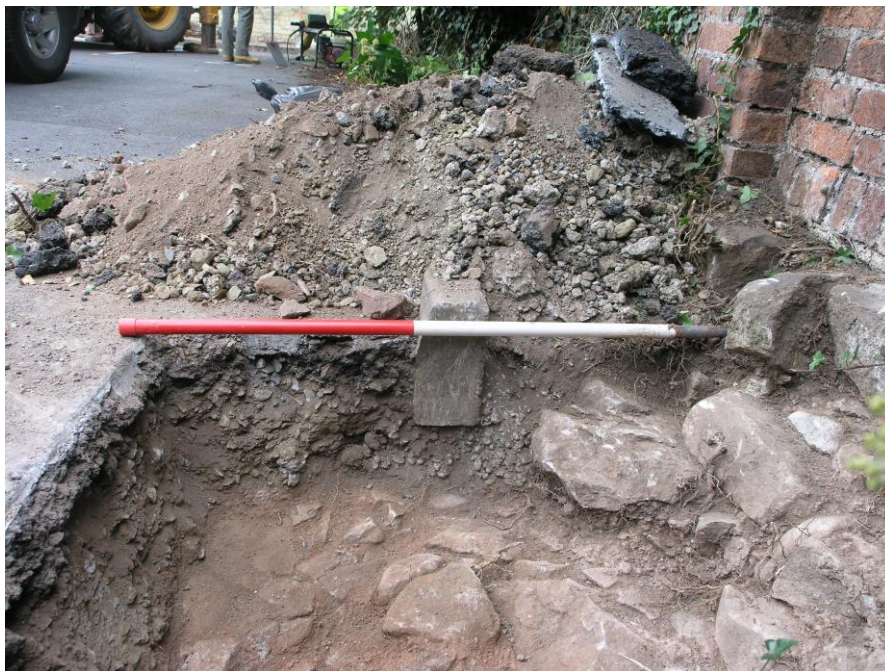
Plate 5: Southern section of Trench 1 showing city wall cut into by modern Kerb and associated levels.

The results from this evaluation trench would suggest that the city wall was approximately 0.8m in thickness at this point. The eastern half of the wall appears to have been cut out during the construction of the car park in order to create enough depth to insert the kerb. The area of hard standing (102) is of unknown date.

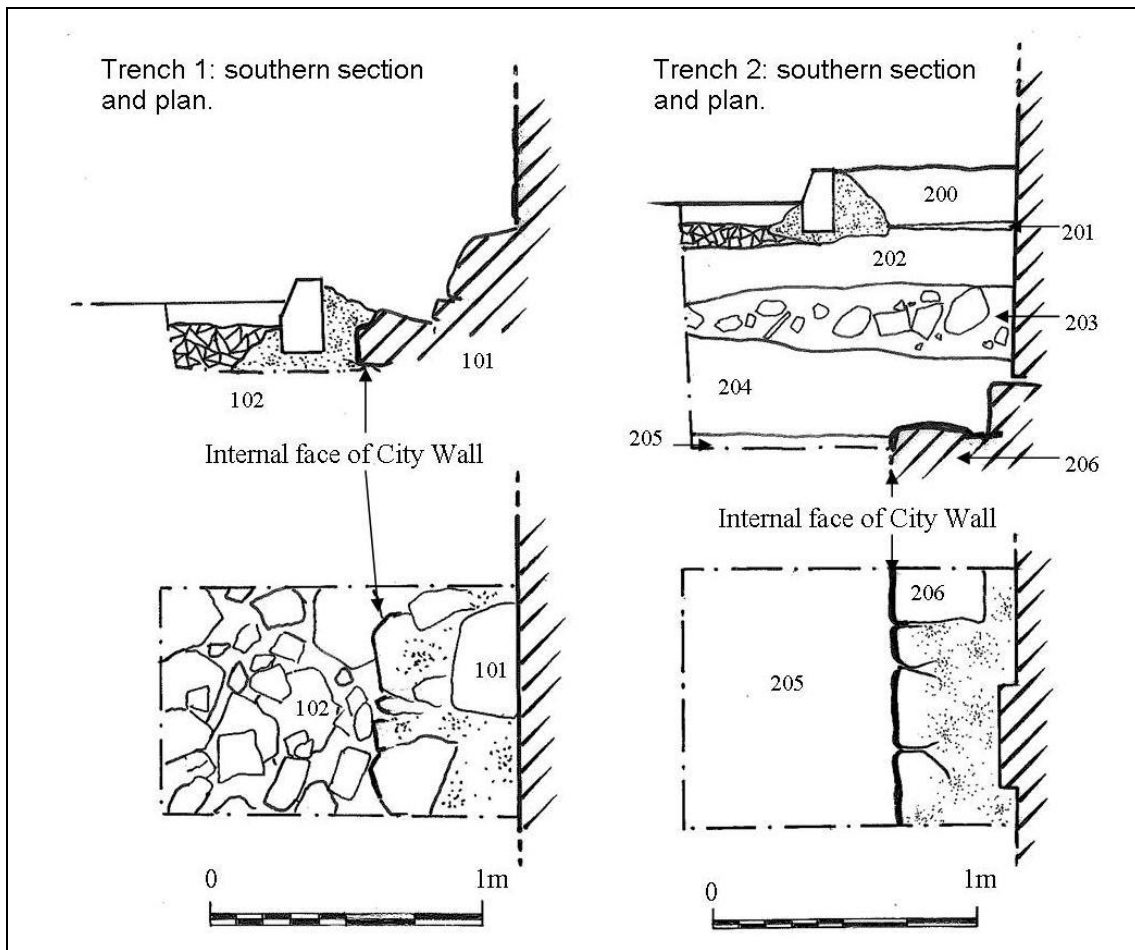
Figure 3: Southern sections (North facing) and plans of Trench 1 and Trench 2

The evaluation trenches have confirmed the thickness and depth of the city wall at two locations within the car park. The difference in depth of the historic masonry wall recorded in the two trenches corresponds exactly with the differences in its height visible in its external face. Within both trenches the wall appears of a similar thickness (0.7-0.8m) and to be bonded by a lime mortar. It would appear that the noticeable lean of the brick wall (particularly within Trench 2), is a direct result of the depth of material dumped behind it (layers (202), (203) and (204)), when compared to the thickness of the brick wall. The growth of two small trees in the gap between the inside face of the wall and the concrete car-park kerb is likely to have exacerbated the situation, root growth forcing the wall out further.

The test-pits were excavated as the first stage of the repair process for the failing brickwork. They demonstrate that the city wall masonry is in sound structural condition and that a new brickwork superstructure can be built off the levelled top of the medieval masonry, as has been done in the past. They also show that the deposits inside the wall overlying the top of the masonry are of little archaeological significance and can, under archaeological supervision, be removed as far back as the car-park kerb without loss of information and without compromising the monument.

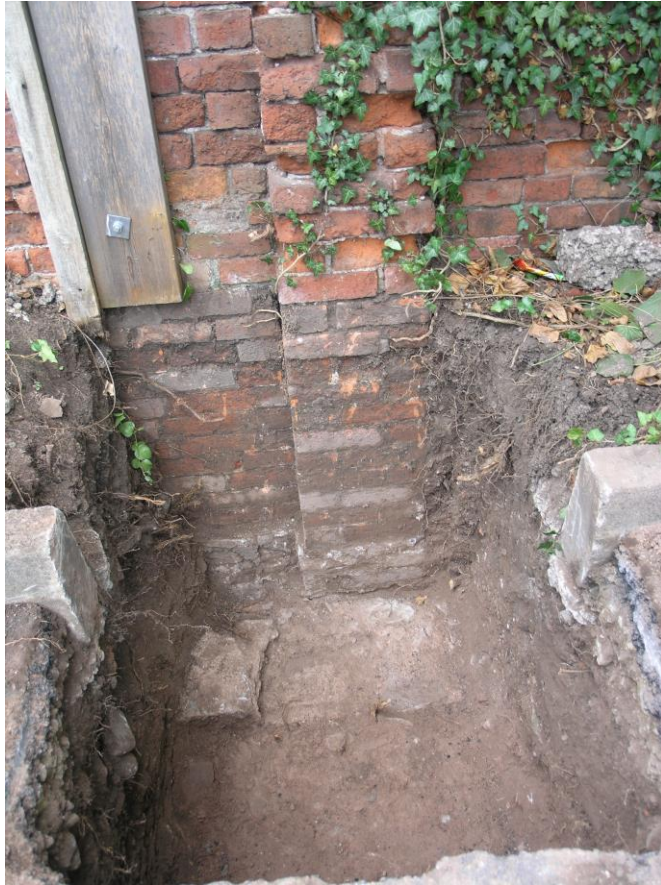
Below the kerb, tarmac and flower bed deposits, was a layer of gravel and ash (201). This overlay a series of 19th and early 20th-century layers of demolition debris and dark earth, (202), (203) and (204). These continued to a depth of 0.95m below the present tarmac surface, at which point the top of the historic masonry wall was recorded, (206). This appeared to be well coursed and bonded with a white / cream lime mortar similar in fabric to that recorded within Trench 1. The exposed wall top was flat, suggesting that its height had been reduced to a common stone course in order to construct the brick wall. The city wall appears to be approximately 0.7m wide at this location. Material to the east of the wall, (205), comprised a deposit of very well compacted gravel, similar to deposits recorded elsewhere on the city defences where it

has been identified as material used to construct the defensive ramparts. It would appear that the city wall has been cut into this deposit.

Plate 6: Looking west, showing intersection of the brick wall onto the top of the remains of the City Wall.

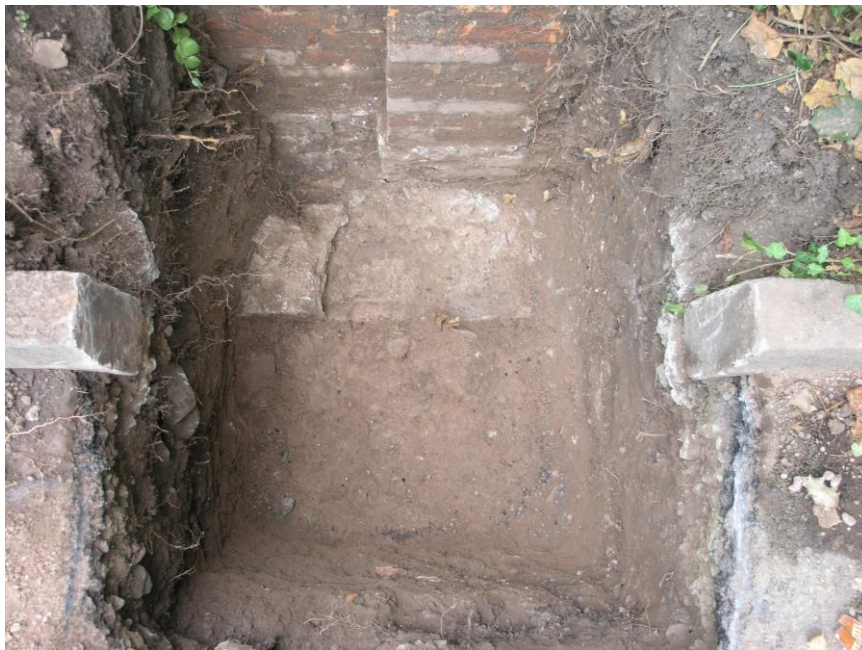
Plate 7: Plan view of Trench 2 upon completion of the excavation.

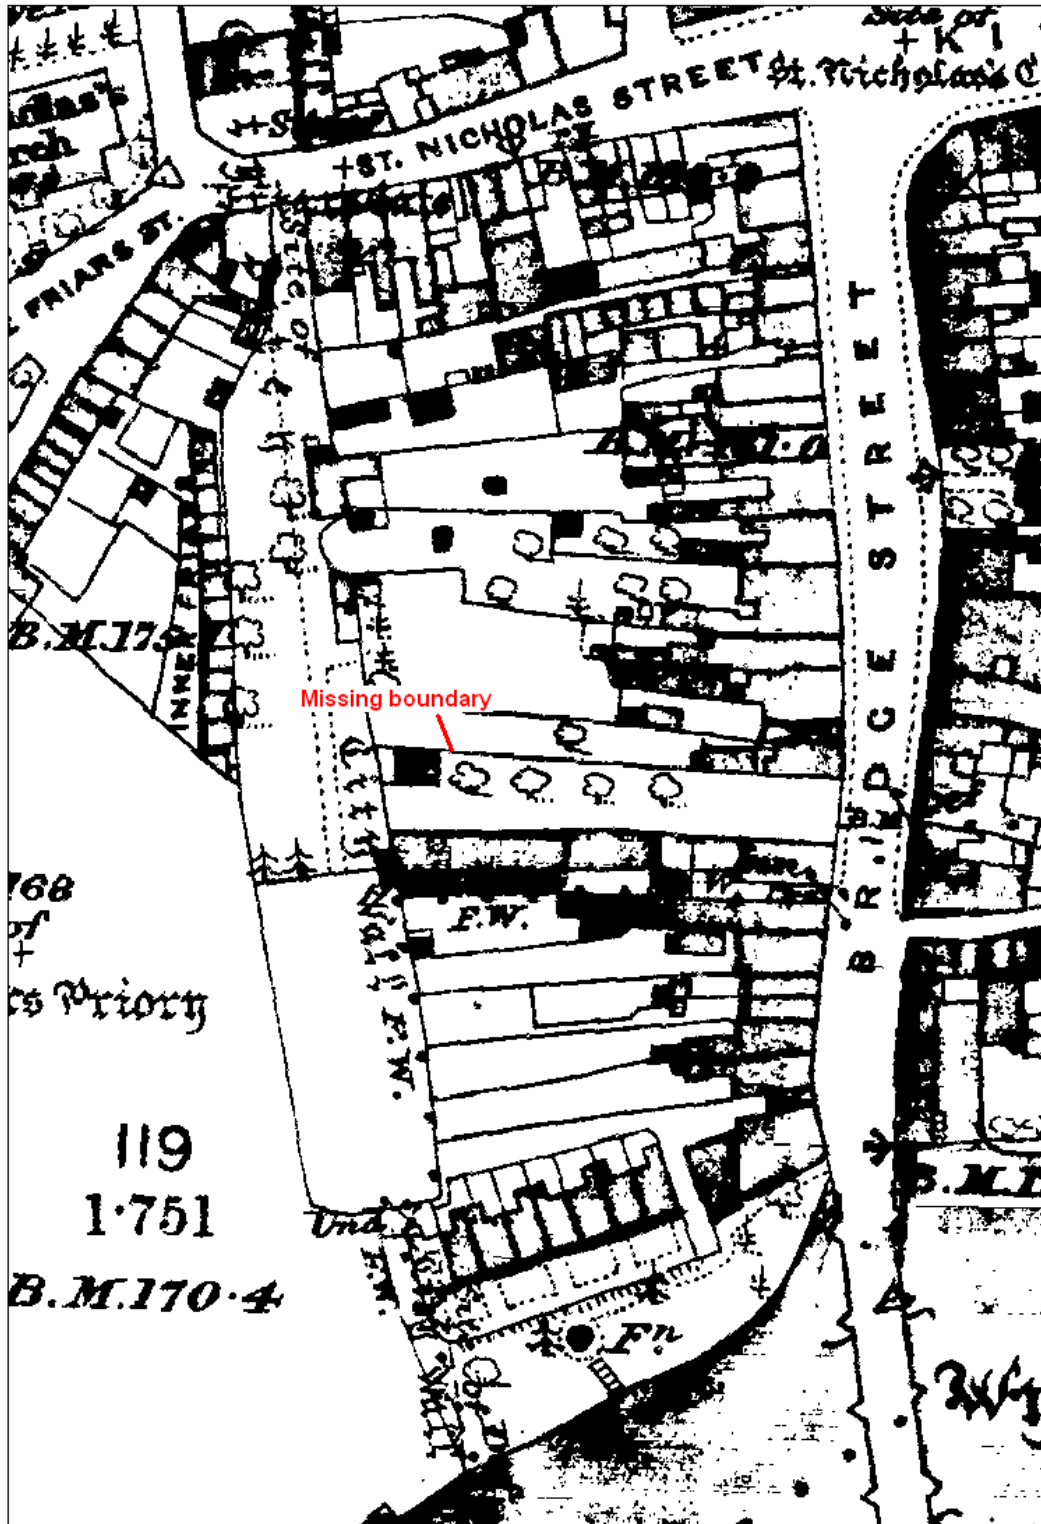
Figure 4: Extract from the first edition O.S. 1:500 plan of 1886 showing the now absent property boundary.

It is suggested that this structure is part of an out-house / lean too constructed against the internal face of the city wall. The line of the masonry wall corresponds with the now lost boundary shown on the 1st Edition Ordnance Survey Map of 1886, (figure 4).

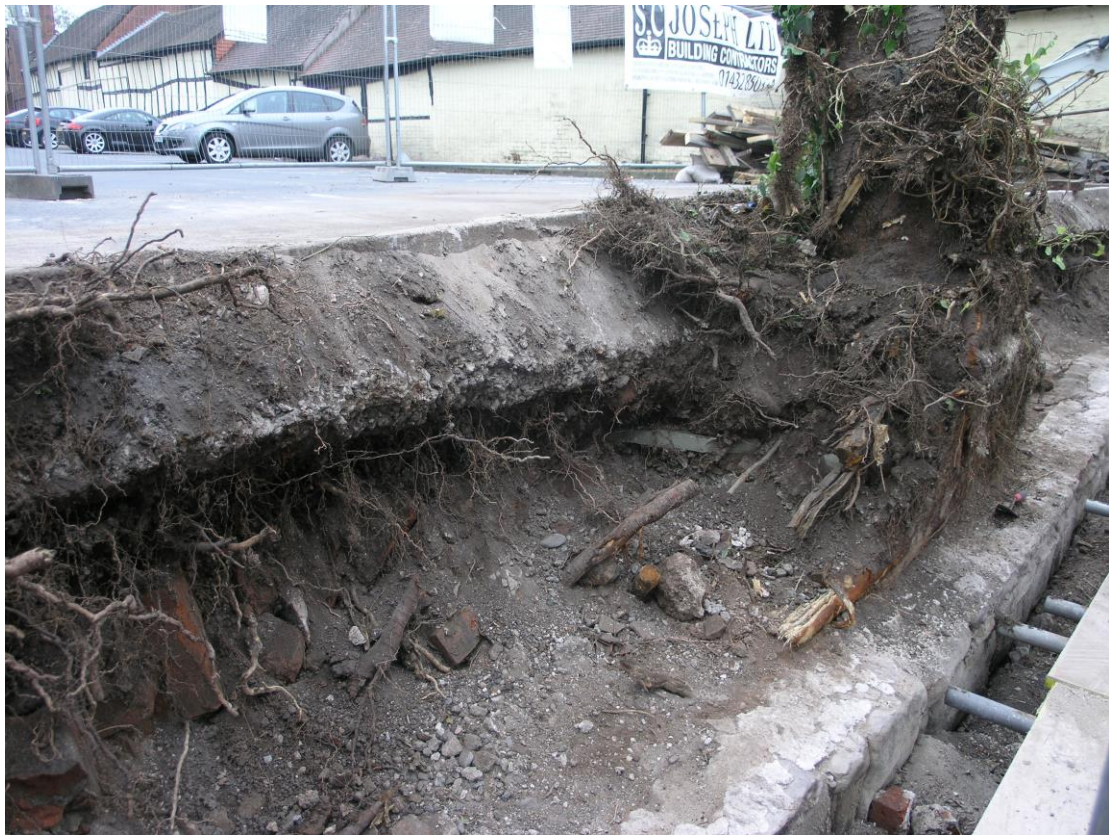
Plate 8: Southern-most tree stump to rear of wall

The stumps were removed under archaeological supervision and the exposed deposits investigated and recorded. The area immediately around the southern tree stump showed late post medieval make up containing broken tile, glass and scrap metal. The area immediately to the north of the northern-most tree stump, revealed a well built, stone wall bonded with lime mortar, (Plate 10). This survived to a height of 0.9m and was associated with a well preserved flagstone floor.

Work began in June 2013 and continued into the middle of July. This involved the erection of a scaffolding gantry along the external face of the wall prior to the removal of the brick elements. The brick wall was then removed and any suitable bricks retained for re-use within the replacement wall. After the removal of the brick wall, the material behind it was cut back by approximately 1 metre in order to clean off the top of the underlying masonry wall. This was undertaken by Mini-digger under close archaeological supervision. The presence of two large tree stumps and associated roots to the rear necessitated the excavation of additional material from the rear of the wall in order to remove the stumps without damaging the wall footings.

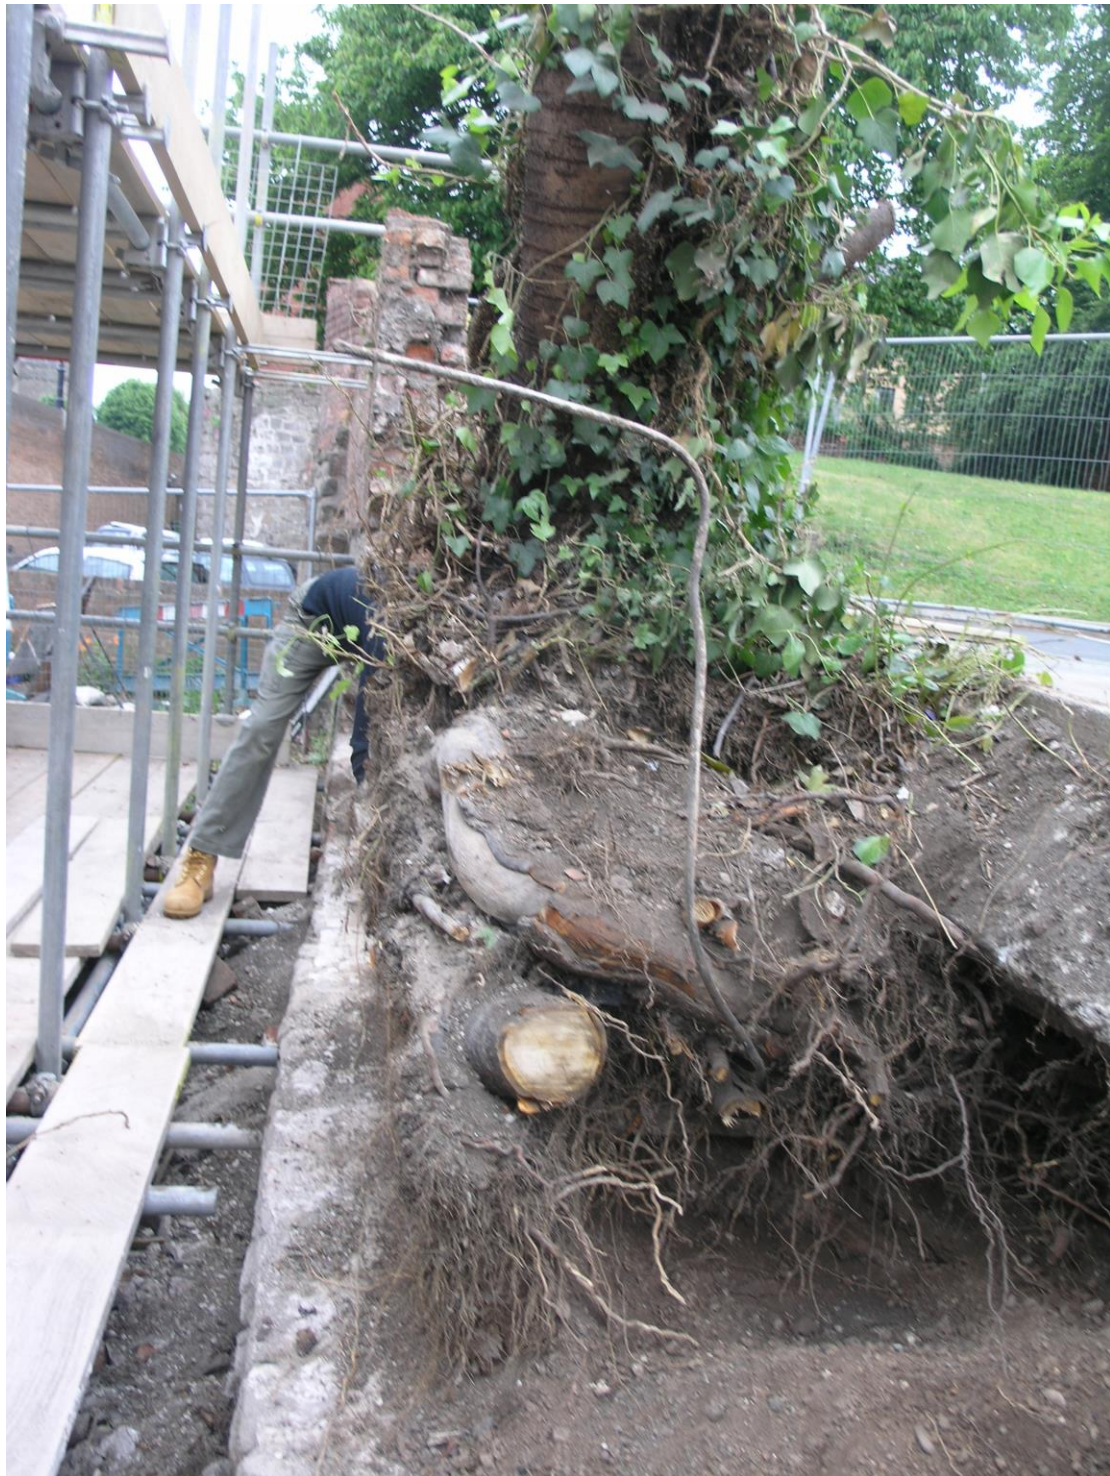
Plate 9: Northern tree stump.

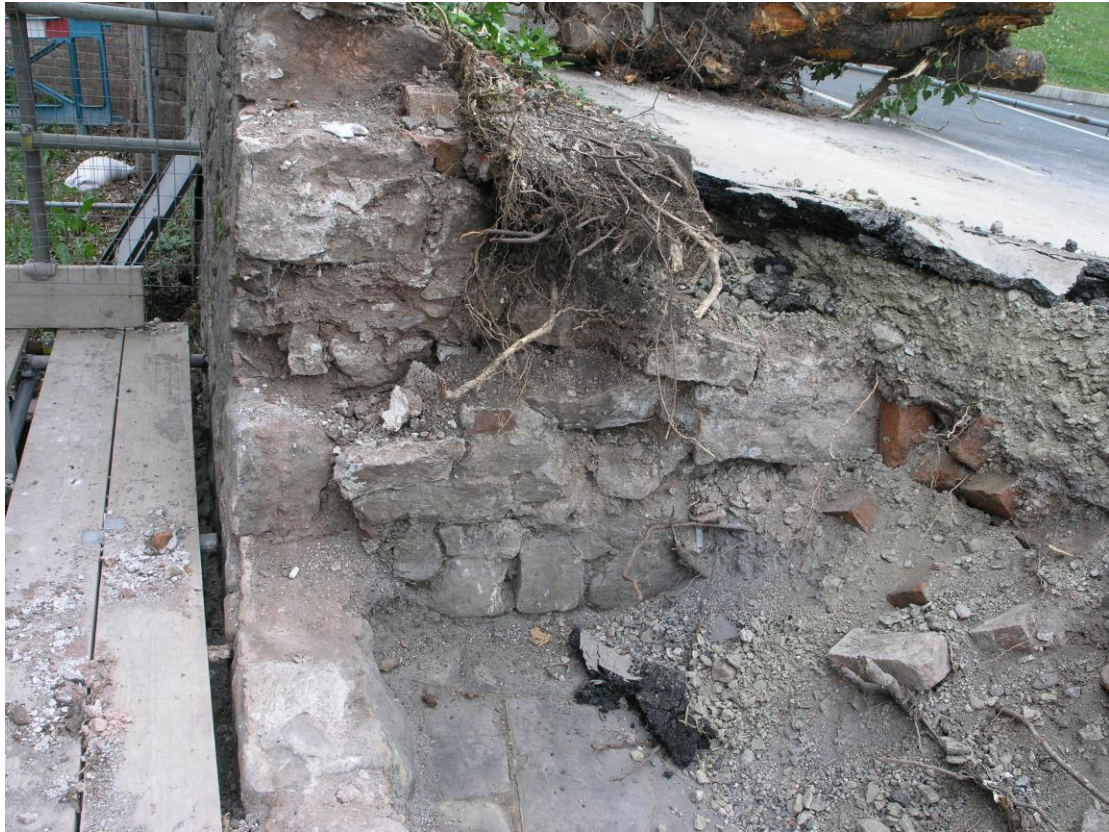
Plate 10: Masonry return and stone flagstones on line of now missing property boundary.
