Aylton Church, Herefordshire: An Archaeological Watching Brief.

Herefordshire Archaeology Report No. 366

**NGR: SO 658 377
EHE: 80122**

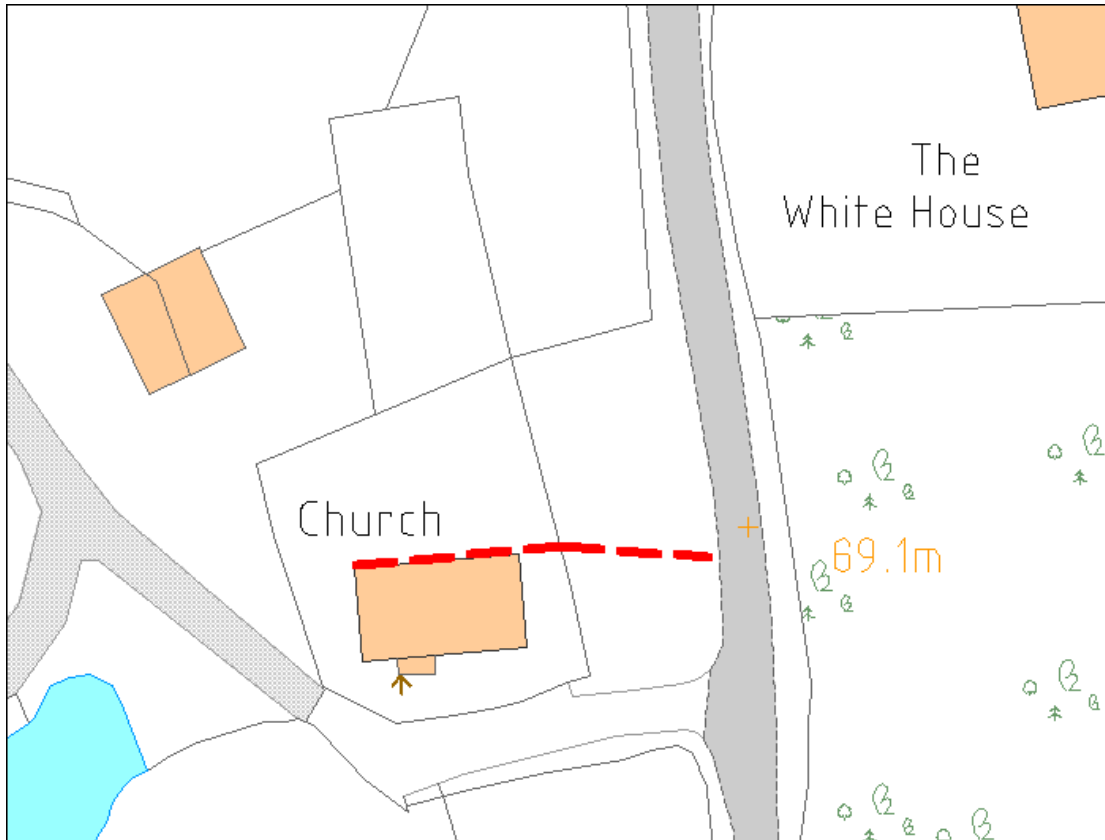
Figure 3: Plan of Aylton Church and churchyard, the drainage run is highlighted as the dashed red line.

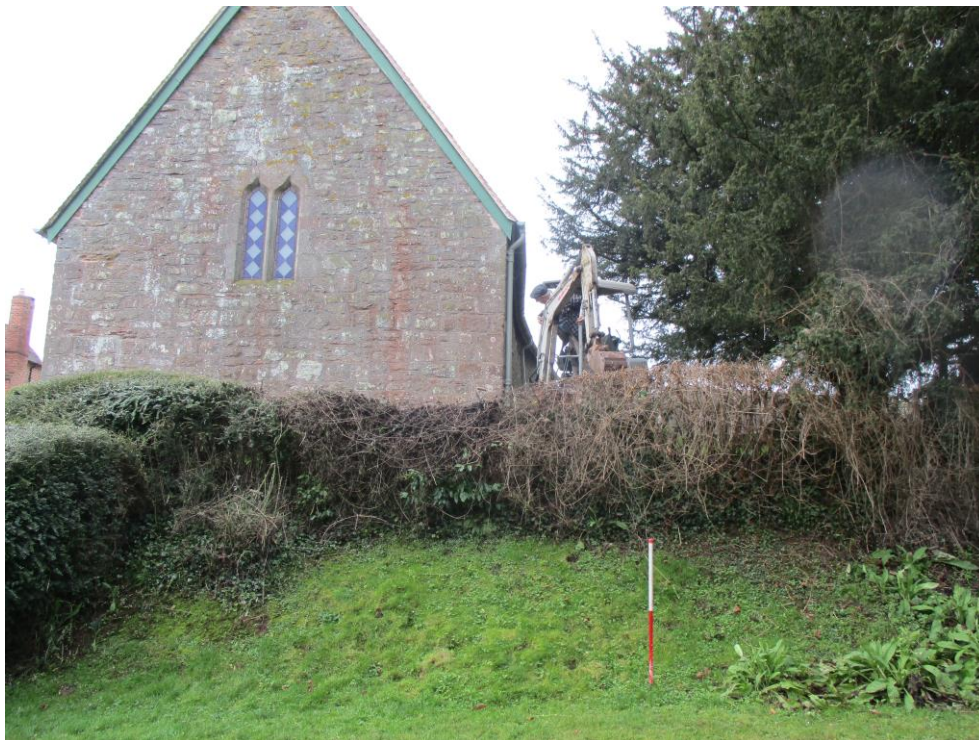
Plate 1: The eastern end of the church and its eastern boundary.

No features, deposits or artefacts of archaeological or historical significance were encountered during these works. This is largely due to the relatively shallow nature of the works and the re-use of an existing drainage run. The works did however confirm that there was no boundary wall along the eastern side of the churchyard.

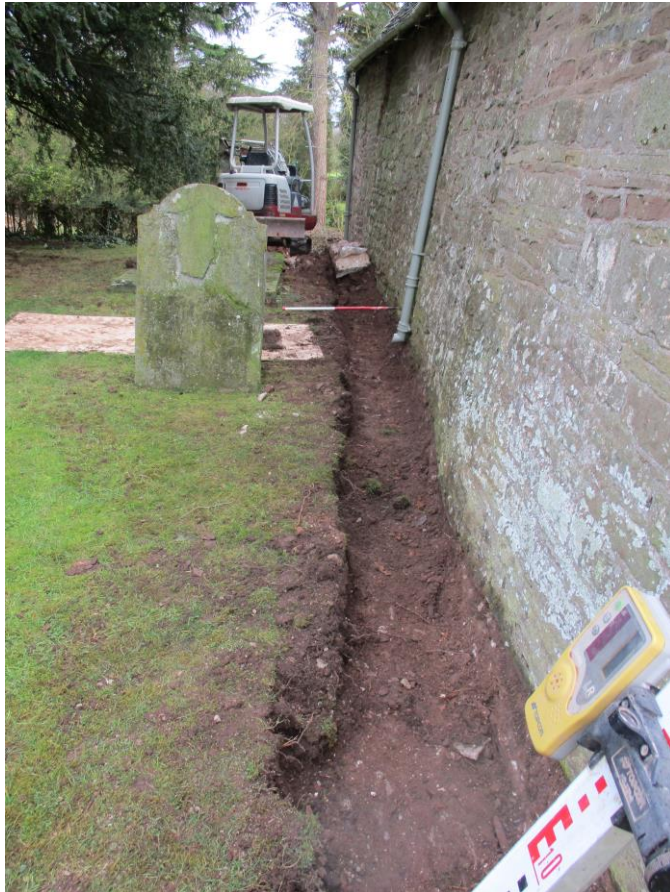
It rapidly became apparent that the required depth for the new drainage run could be achieved by removing the concrete gully which ran the entire length of the north wall. This terminated in a square drain hopper which was, in turn, connected to a series of 4" diameter terracotta pipes which took the water out of the churchyard. It is unclear to what extent the water was then piped away from the churchyard towards the road.

Plate 2: Drainage trench along north wall of Aylton Church, replacing concrete gutter.

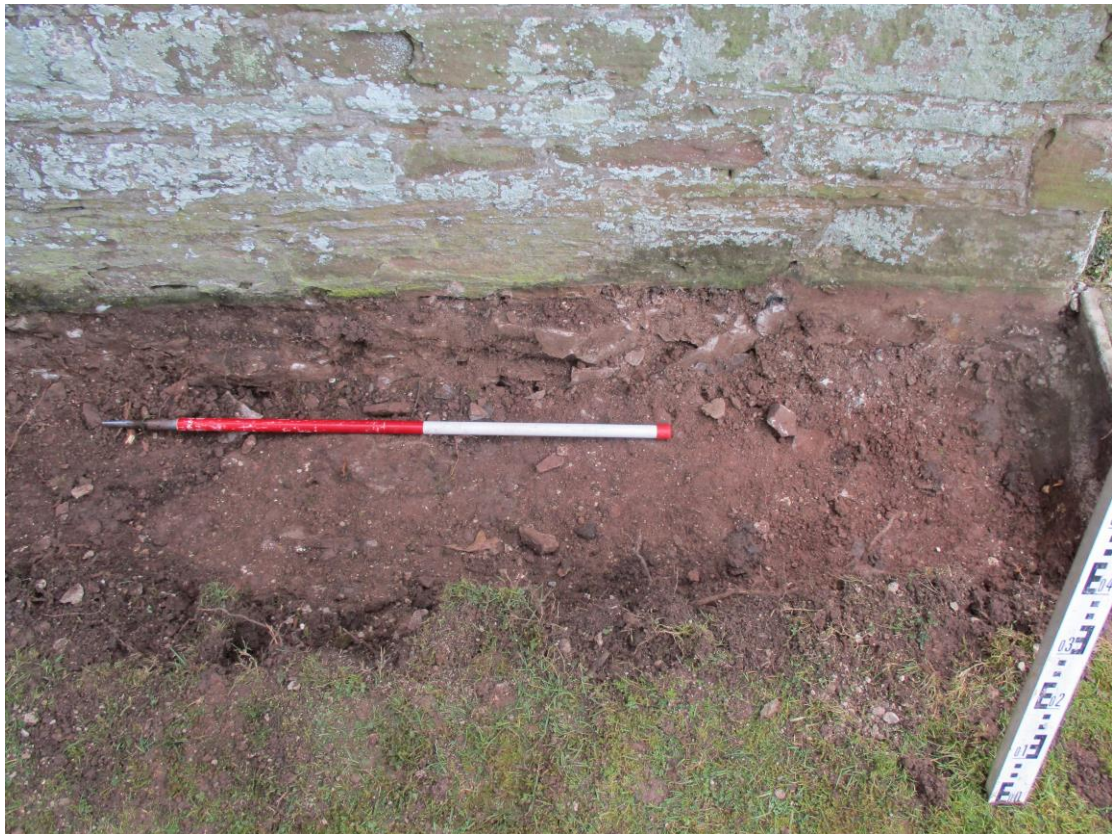
Plate 3: Detail of disturbed ground at the base of the drainage run.

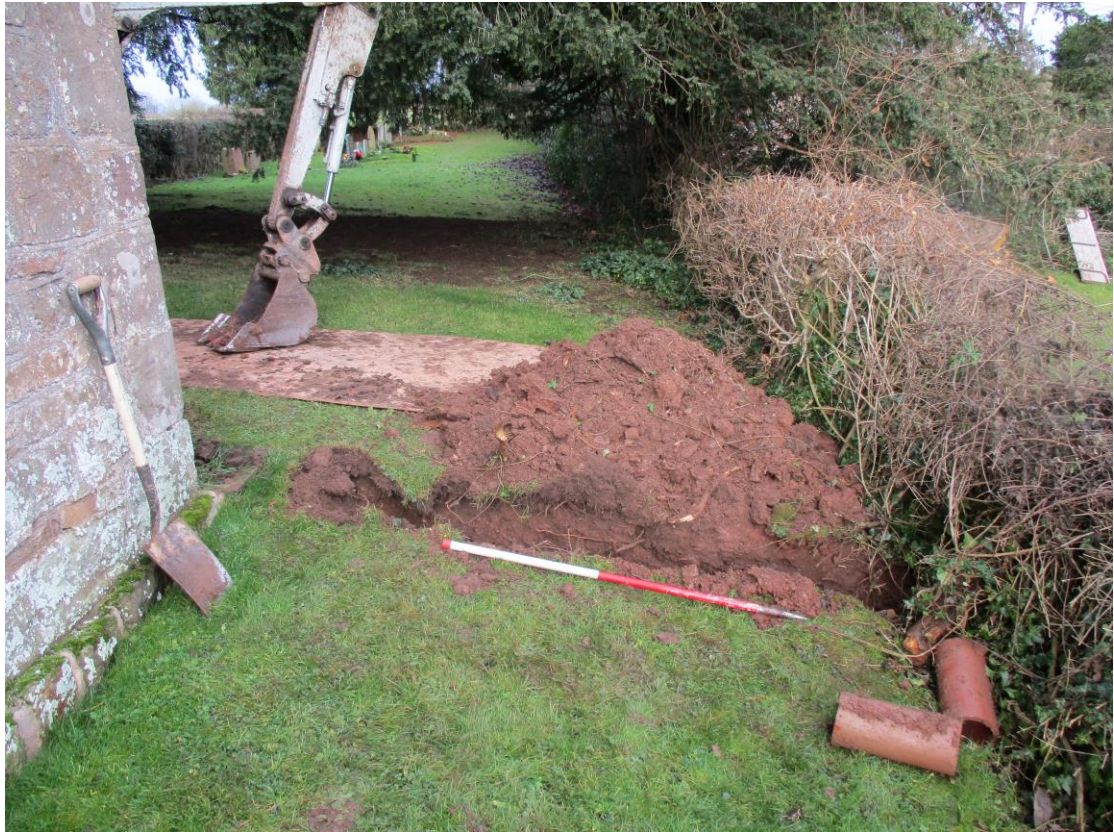
Plate 4: Drainage run at the north east corner of the church.

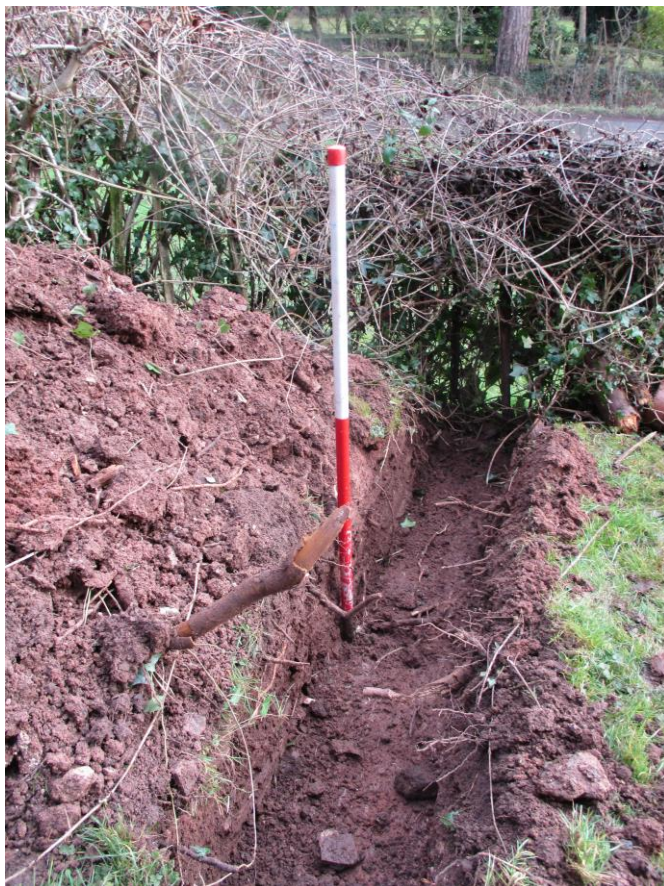
Plate 5: Drainage run at the north east corner of the church looking east showing finished depth.

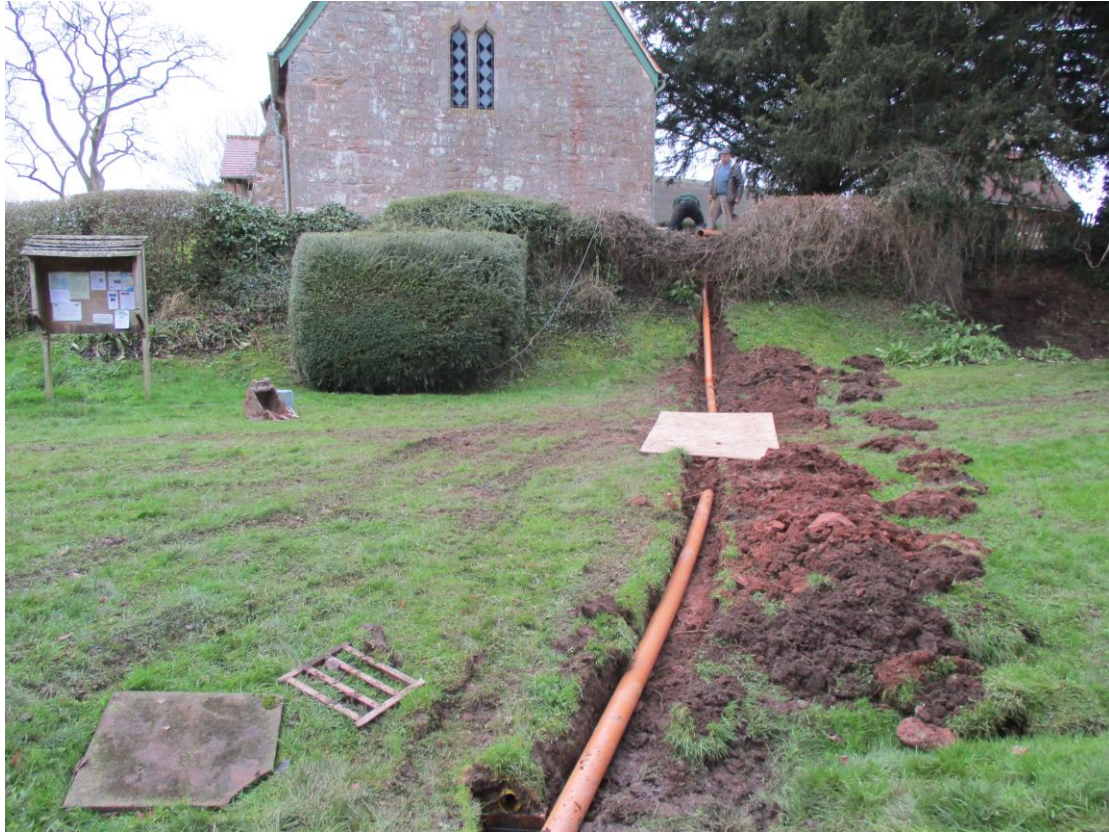
Plate 6: Drainage run from the north east corner of the church looking west from the junction into the existing drain. The old pipes from the old drain are visible at the bottom centre of the photograph.
