Aylton Church, Herefordshire: An Archaeological Watching Brief for Drainage and Lightning Conductor Works.

Herefordshire Archaeology Report No. 368

**NGR: SO 658 377
EHE: 51675**

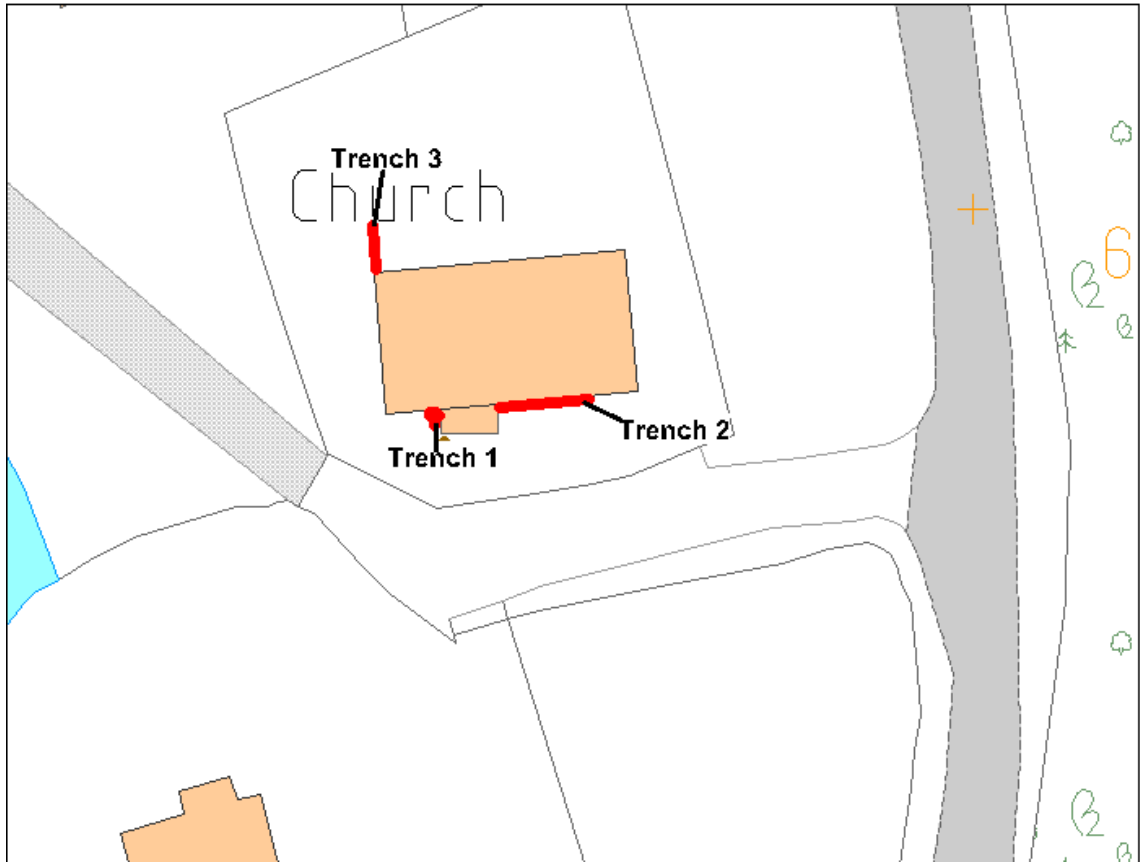
Figure 3: Plan of Aylton Church and churchyard showing the extent and locations of the trenches.

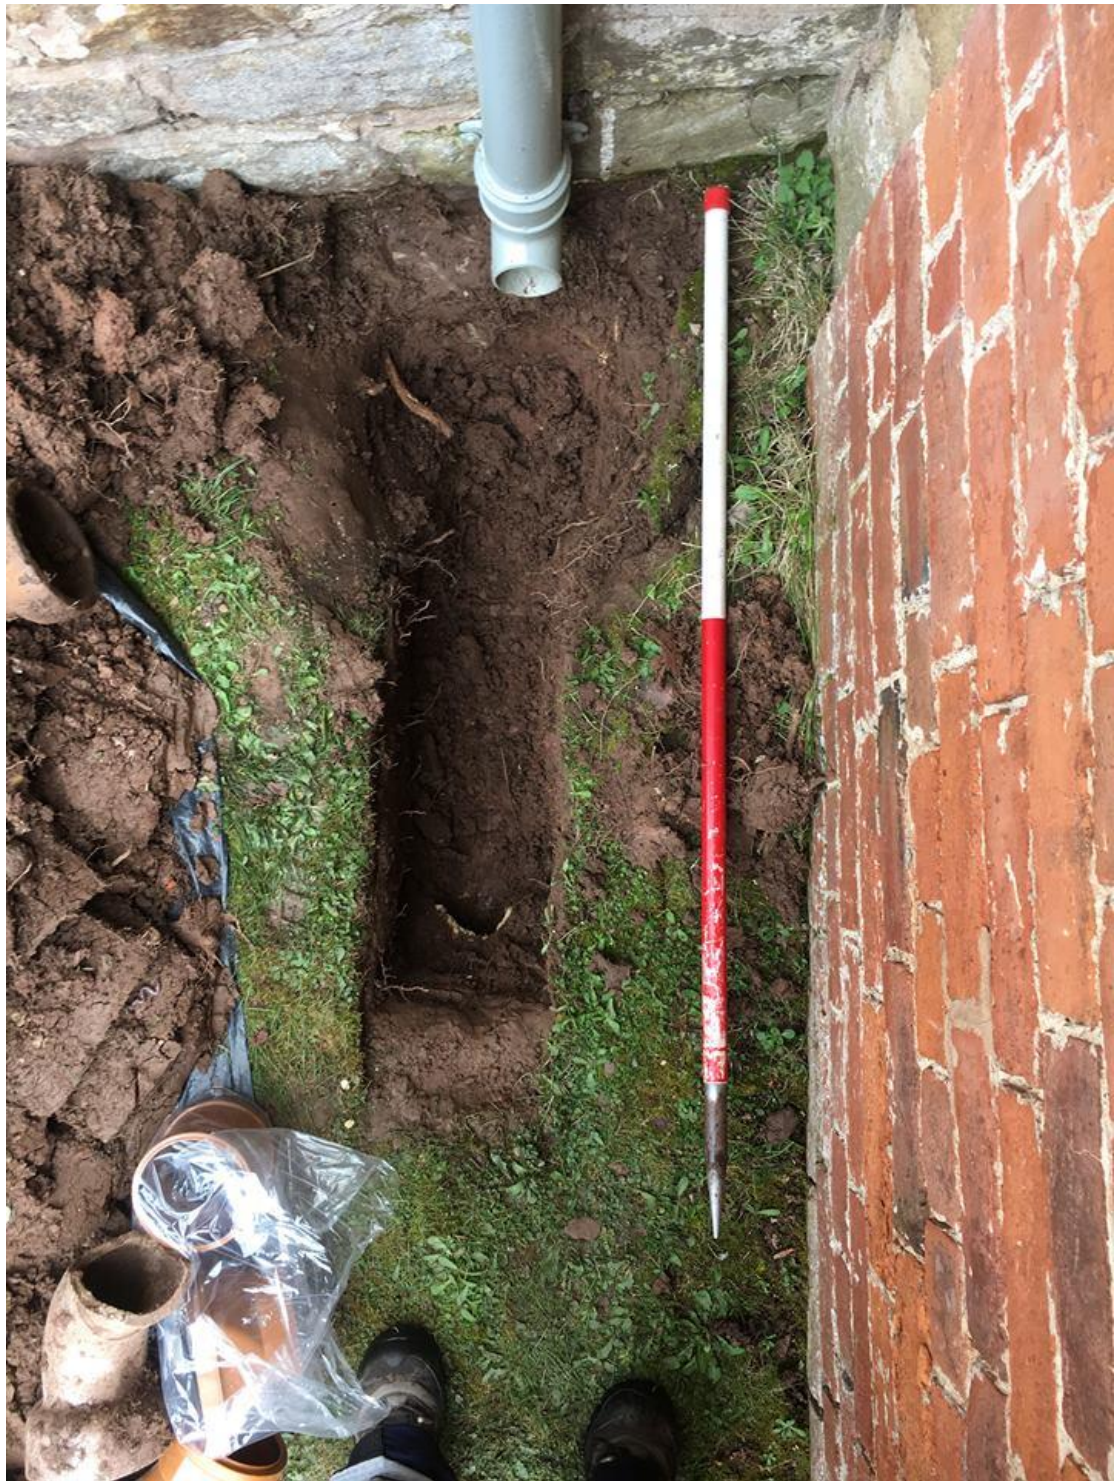
The first trench, (Trench 1), was situated along the outside of the South wall of the church on its west side directly parallel to the entrance of the church (see figure 3 and Plate 1). The trench was opened in order to ascertain and remove a blockage within the existing drain. The trench was T shaped with a maximum width of 0.50m and 0.23m at its thinnest point. The trench was approximately 0.99m long and was excavated to a maximum depth of 0.35m. No archaeologically significant finds were encountered during the excavation of this trench.

Plate 1: Trench 1 showing its location in relation to the southern wall of the church and the western wall of the porch..

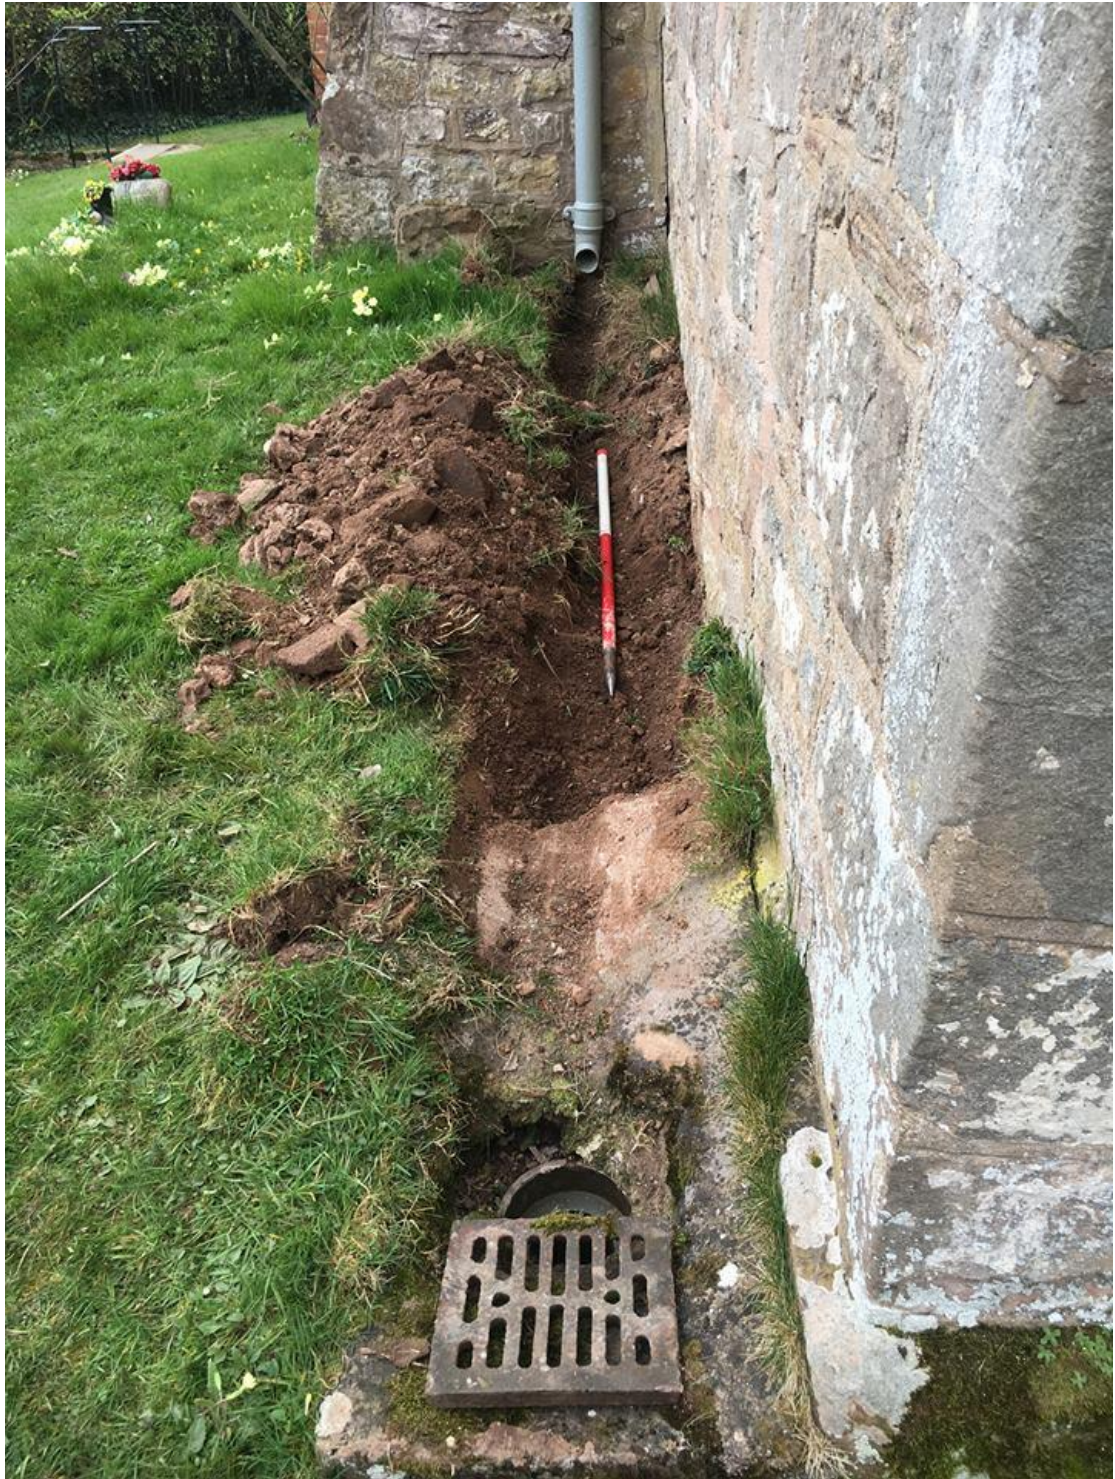
Trench 2 consisted of a drainage run along the outside of the South wall of the church from the porch towards the south-eastern corner of the church, (see figure 3 and Plate 2). The works were required in order to update and improve the drainage of roof water from the church into the existing soak away pipe. These works in part comprised a direct replacement of a concrete

and ceramic pipe drain which had become blocked and was no longer serviceable. The aim here is to replace the existing concrete drainage with plastic pipes which are easier to maintain and update. The works were carried out by hand. Trench 2 was approximately 2.90m long and 0.32m wide and was excavated to a maximum depth of 0.20m. No archaeologically significant finds were encountered during the excavation of this trench.

Plate 2: Trench 2 looking west.

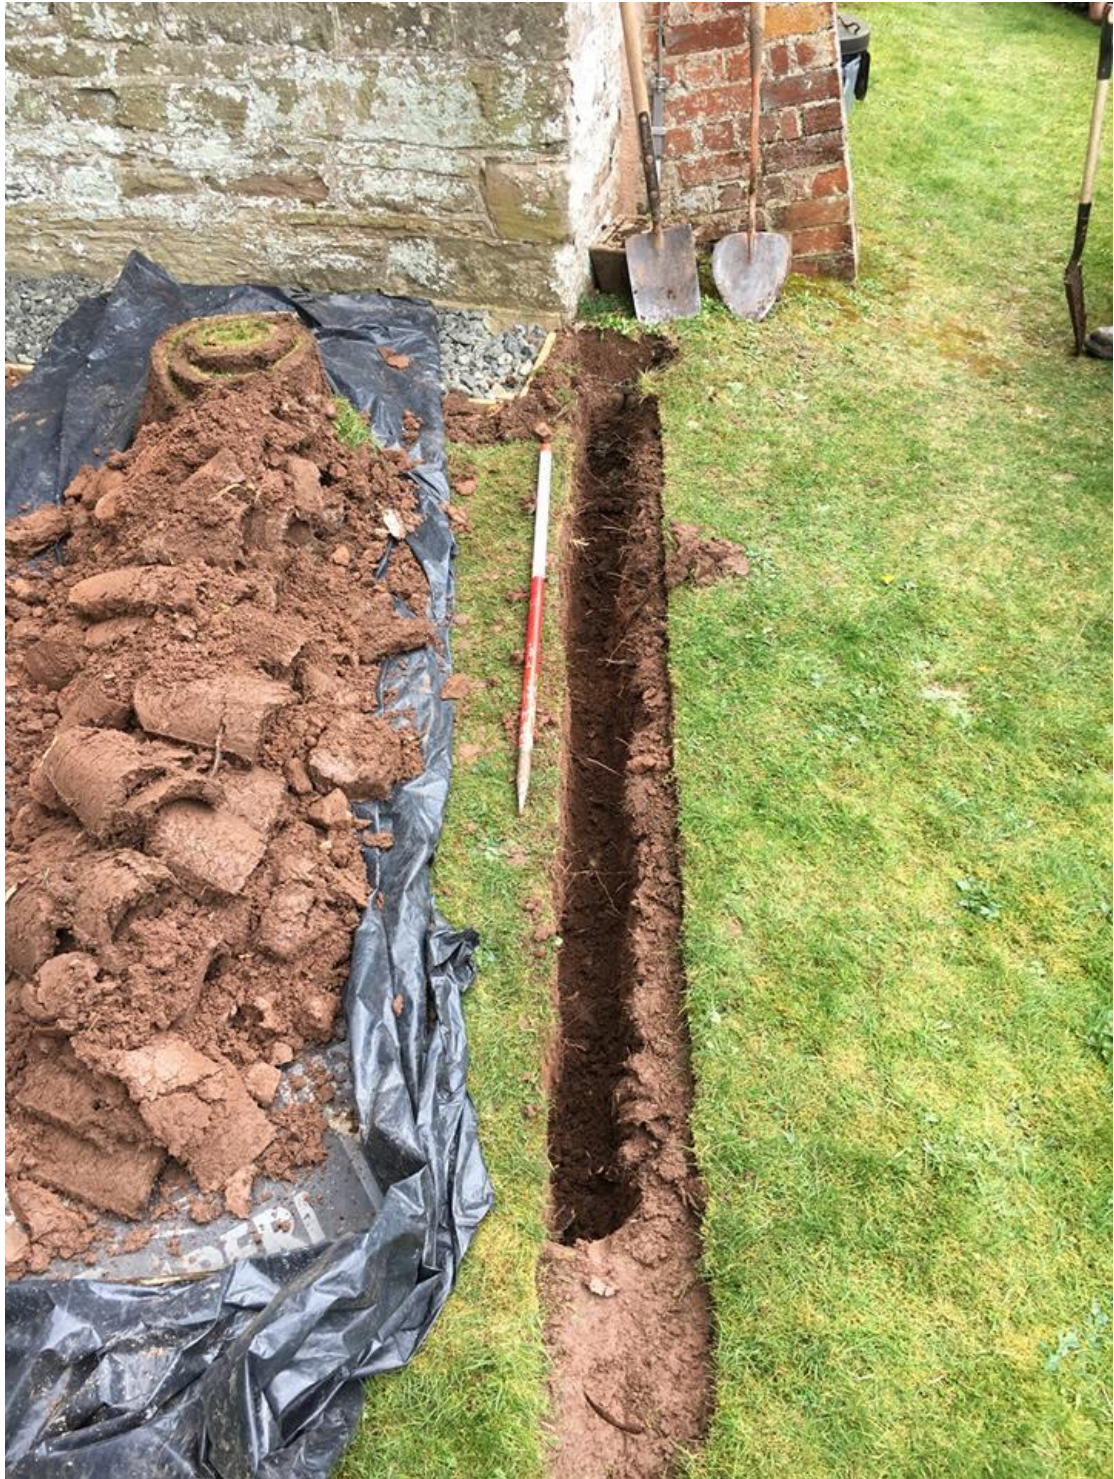
Trench 3 ran from the north-western corner of the church northwards, (see figure 3 and Plates 3 and 4). The location of the trench provided the most direct and least visually intrusive route for the lightning protection system to be installed. Trench 3 was approximately 2.60m long and 0.18m wide and was excavated to a maximum depth of 0.40m. The location and procedure adheres to Historic England policy that seeks to minimise any damage to the historic fabric of the building and observes the principles of minimum intervention and reversibility where possible (Historic England, nd). No archaeologically significant finds were encountered during the excavation of this trench. A cut feature was observed within the trench at approximately 0.94m along on the east side. The feature was square in shape and measured 0.20m wide and 0.29m deep. The feature was a slightly different colour to the surrounding acidic loamy soil, it was a light pink/orange in colour and was cut from immediately below the turf suggesting that this feature is relatively modern, probably connected to building work within the last 20 years.

Plate 3: Trench 3 looking south.

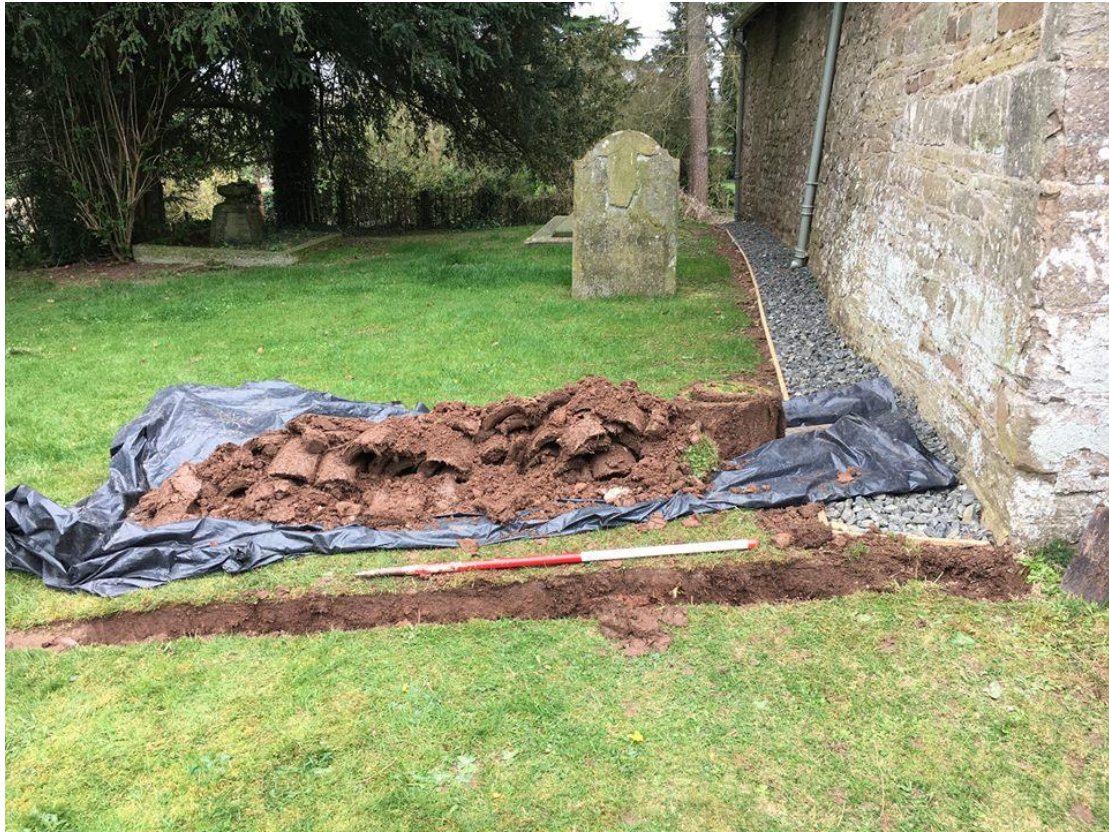
Plate 4: Trench 3 looking east.
