# **The archaeological monitoring of building repairs at Clifford Castle, Herefordshire, 2017 (Appendix 1: Illustrations)**

**Report prepared by: Dr. Nigel Baker BA PhD FSA MCIfA**

**Herefordshire Archaeology Report No. 372**

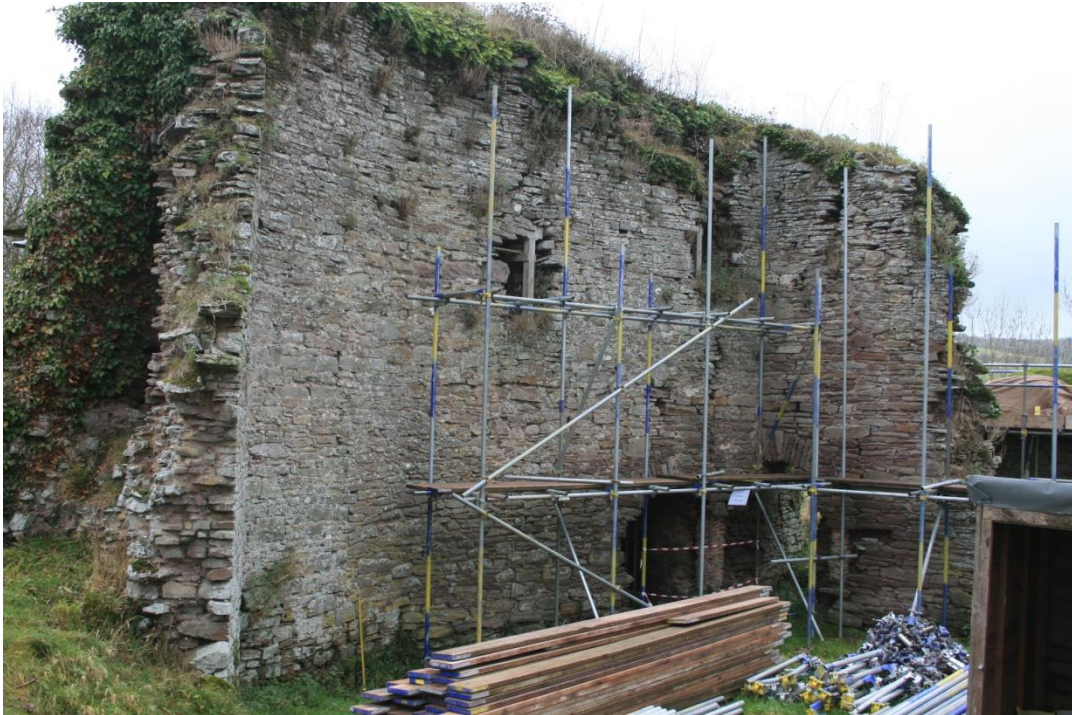
(3) The west curtain wall, looking NW, before repairs

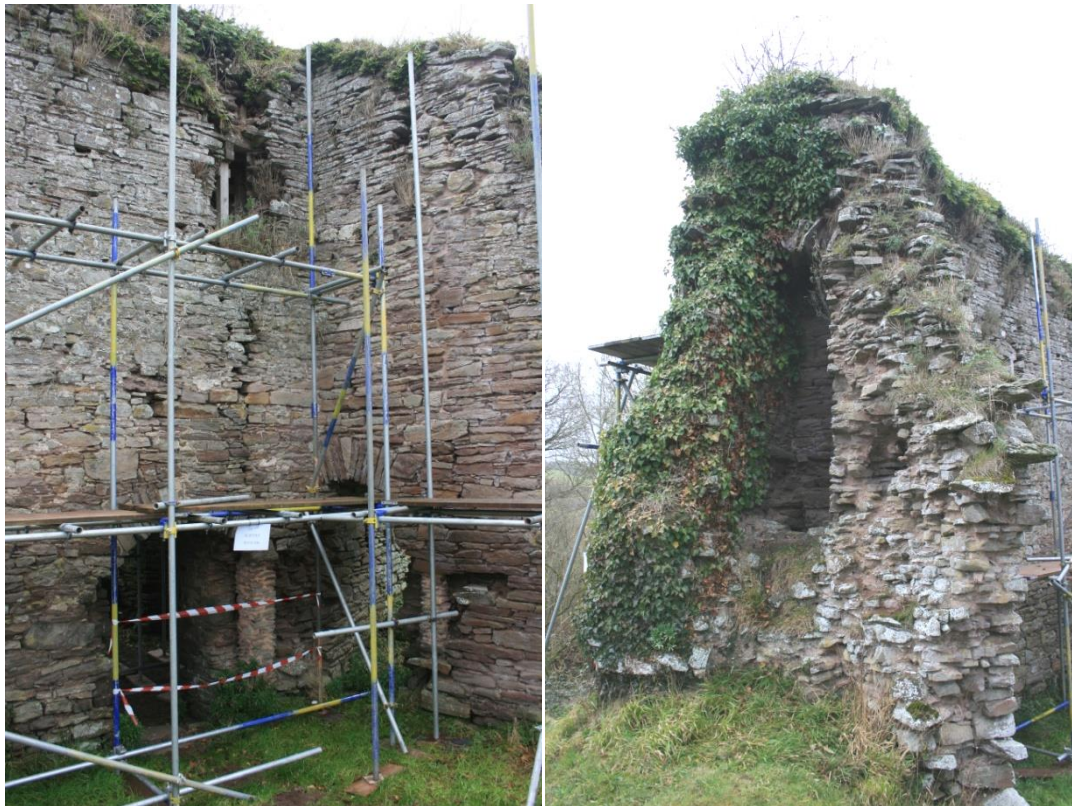
(4) Above left: junction of the curtain wall with hall south wall. (5) Above right: stub-end of wall with garderobe chamber off former SW tower

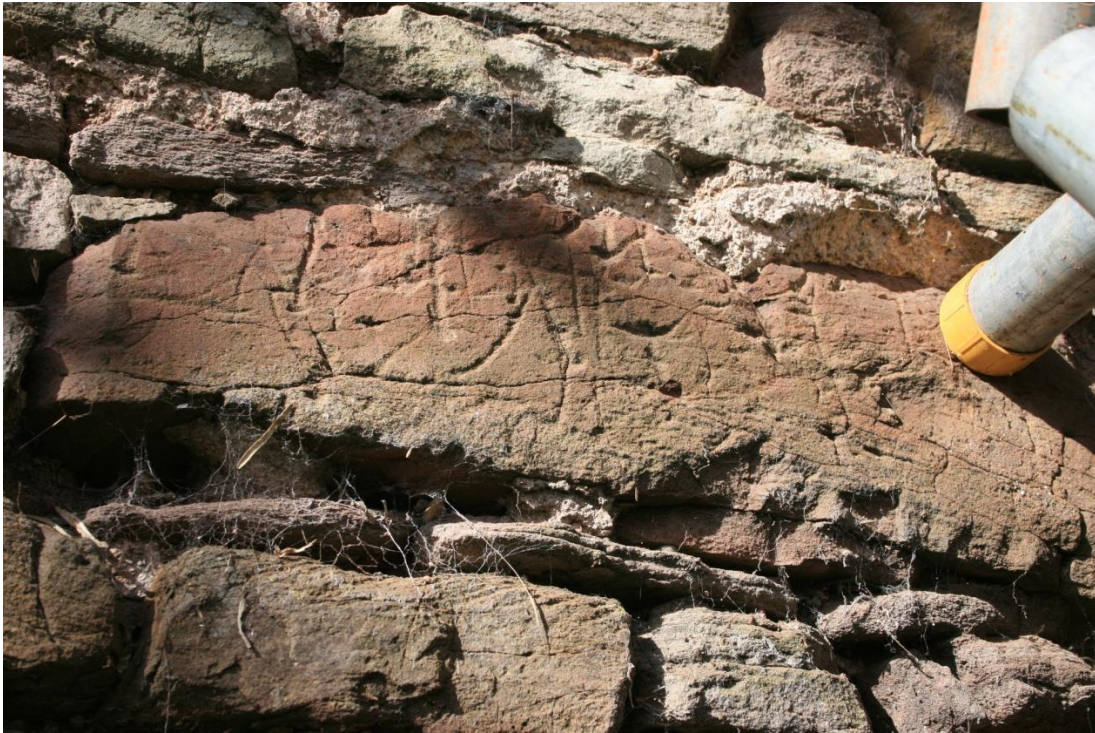
(6) West curtain wall: scratched/inscribed stone over doorway to NW tower

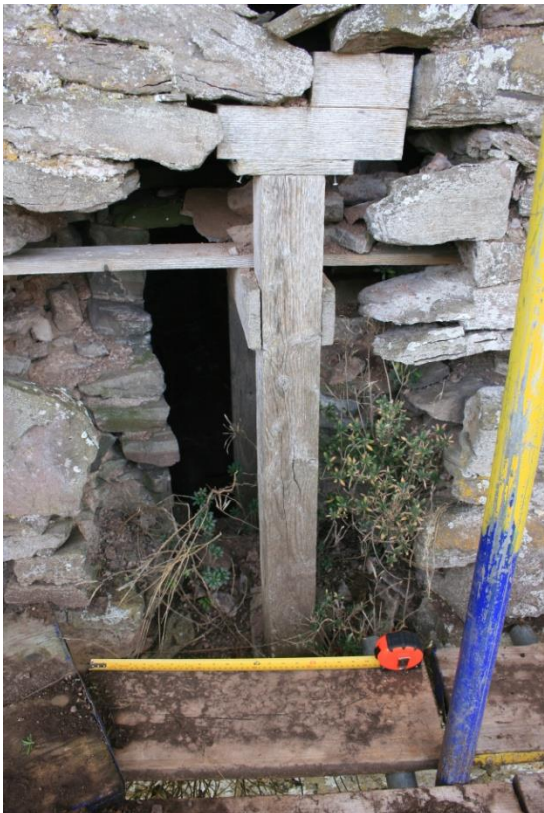
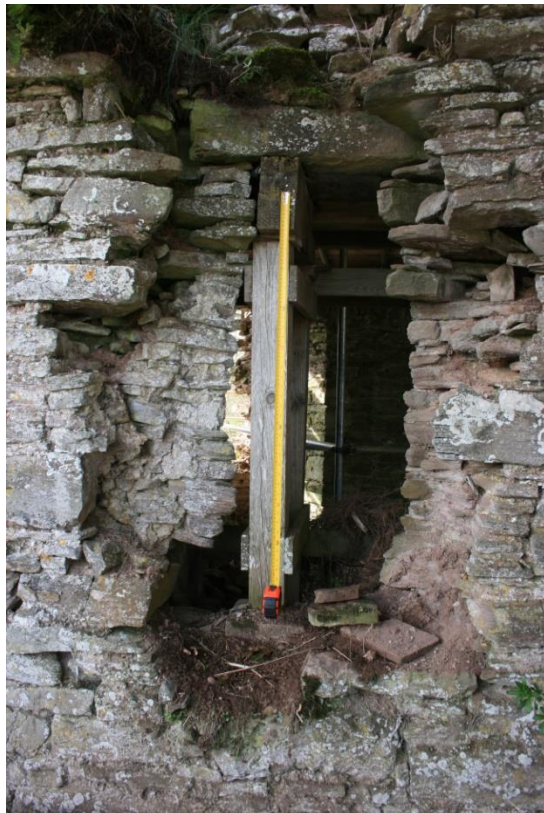
(7) Left: Damaged/propped opening into first-floor garderobe chamber. (8) Right: damaged/propped opening into first floor of tower

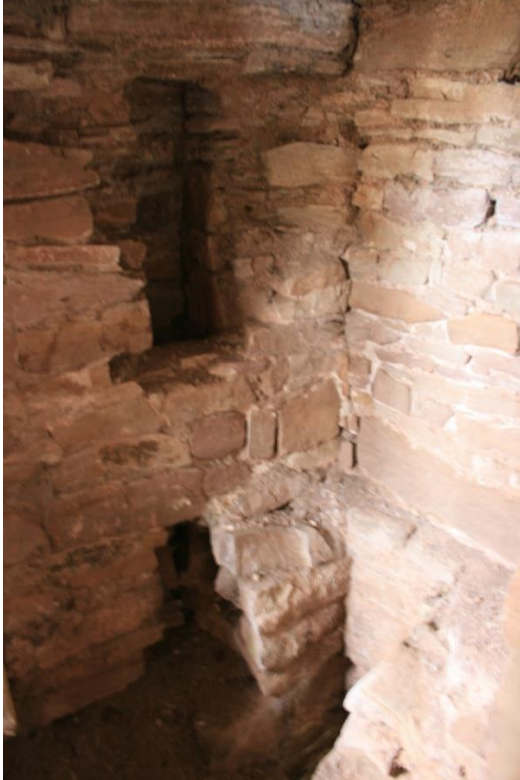
(9) Garderobe chamber in W wall, first-floor level. Looking SW at bench and opening of main chute (bottom right) with holes knocked through the south wall at two levels into incomplete garderobe chute behind

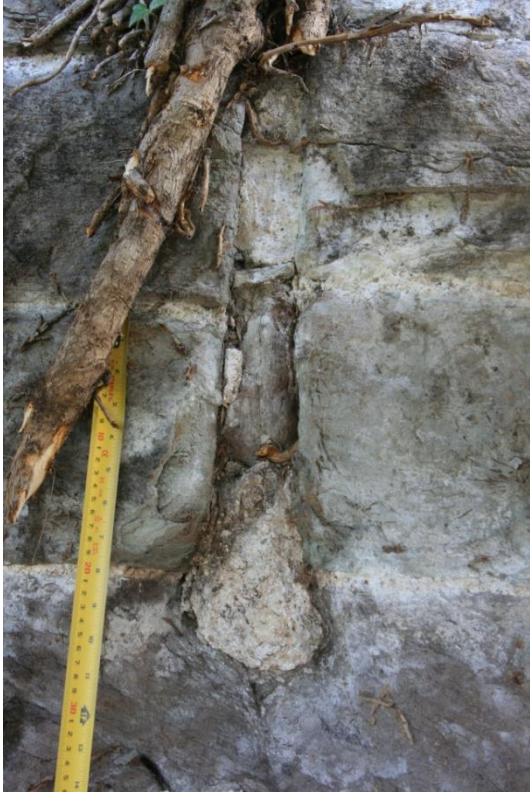
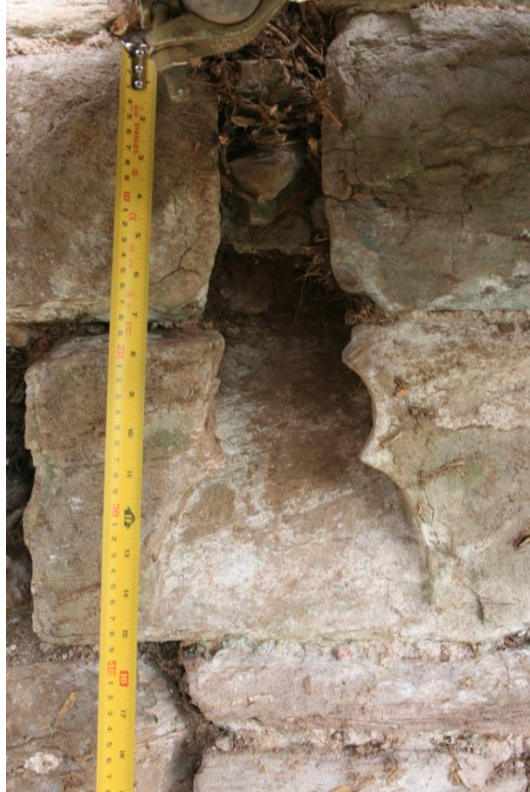
(14) Left: NW tower, first floor, loop window facing NW, detail of eroded loop terminal and its blocking; (15) Right: NW tower, first floor loop window, detail of loop terminal

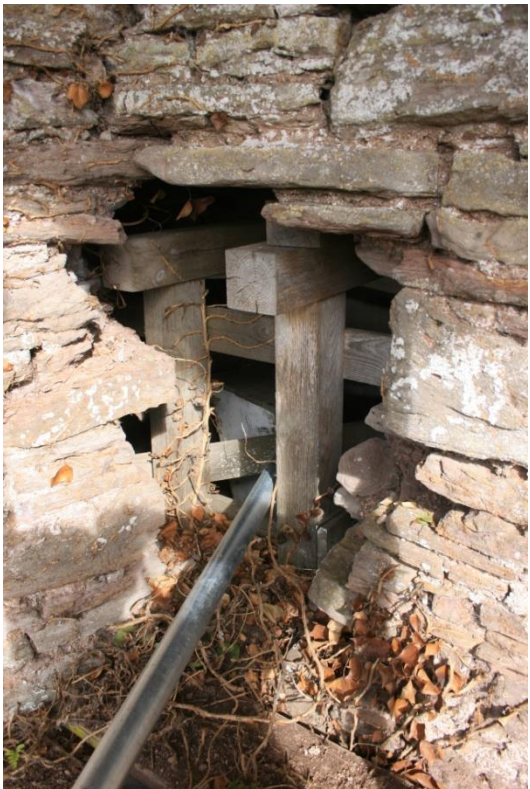
(16) West elevation: hole at first-floor level at the junction of the NW tower and main west wall face, showing propping within garderobe passage

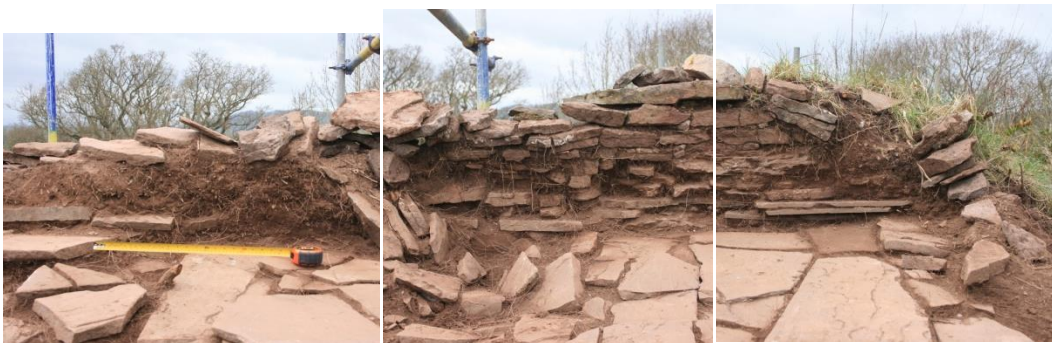
(22) Composite photo of inside (east) face of the parapet wall, as first exposed, with S wall of tower extreme right, damaged area to slabbed surface centre

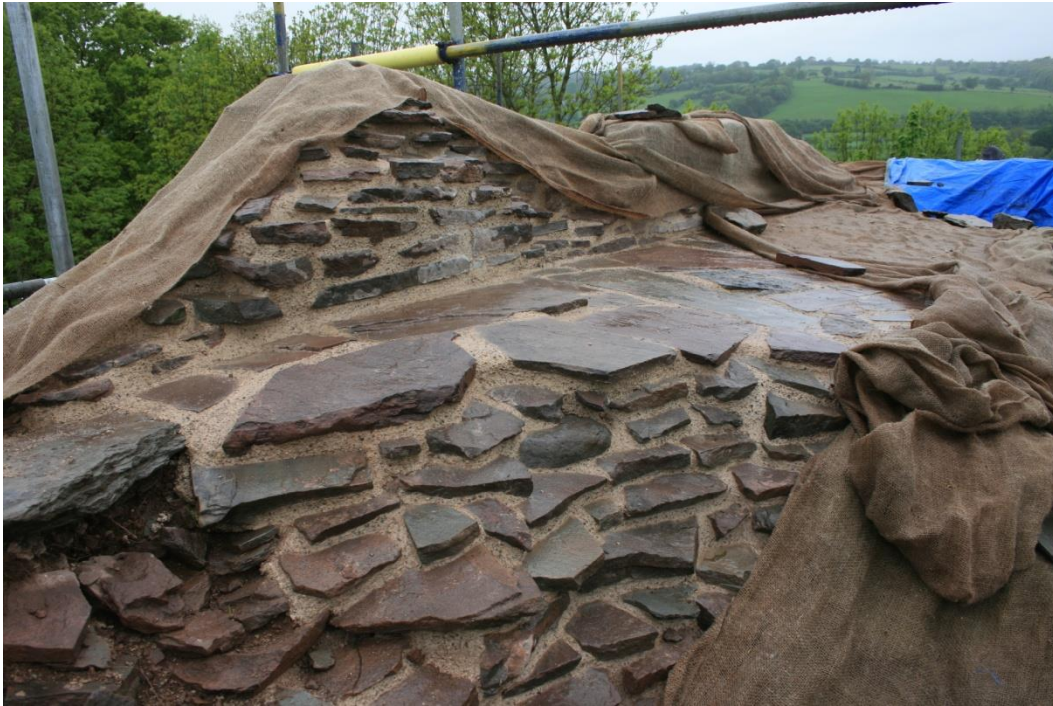
(24) The parapet wall and wall-walk as consolidated prior to soft capping

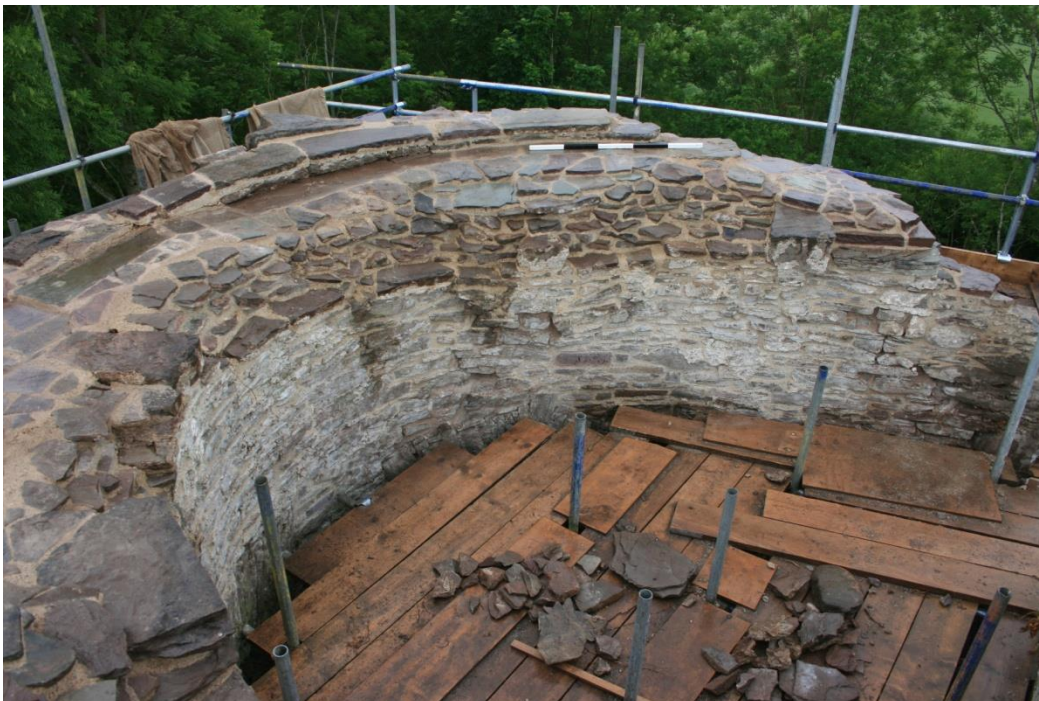
(30) The NW tower wall top, NW quadrant, after consolidation and prior to soft capping. The 1m scale lies on core-work slabs below the wall-walk slabs; very little survives of the parapet wall beyond

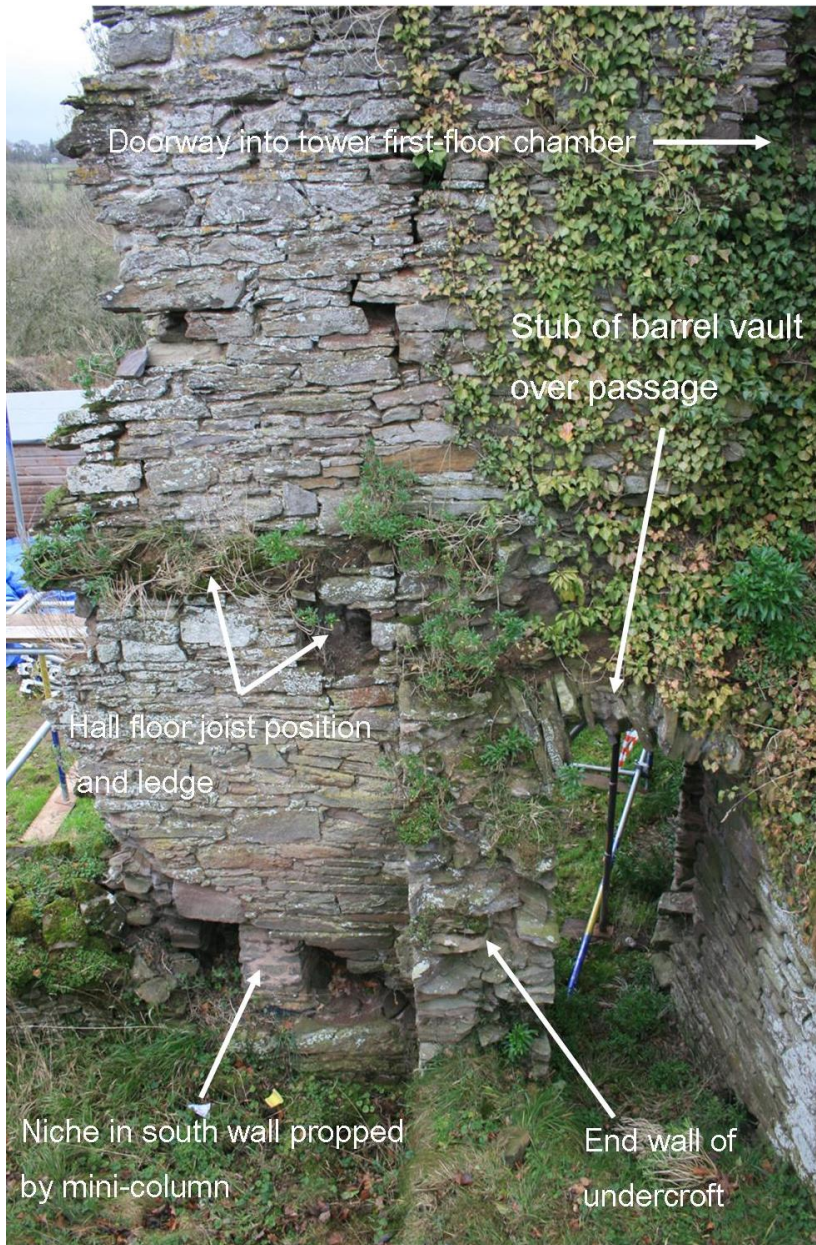
Previous page: (31) Main picture: inside face of the stub of the hall south wall before repair, with doorway from courtyard into hall end-passage. (32) Inset: Trench 1 (Sept. 2017) approximately placed to show continuations of the walls on each side of the passage

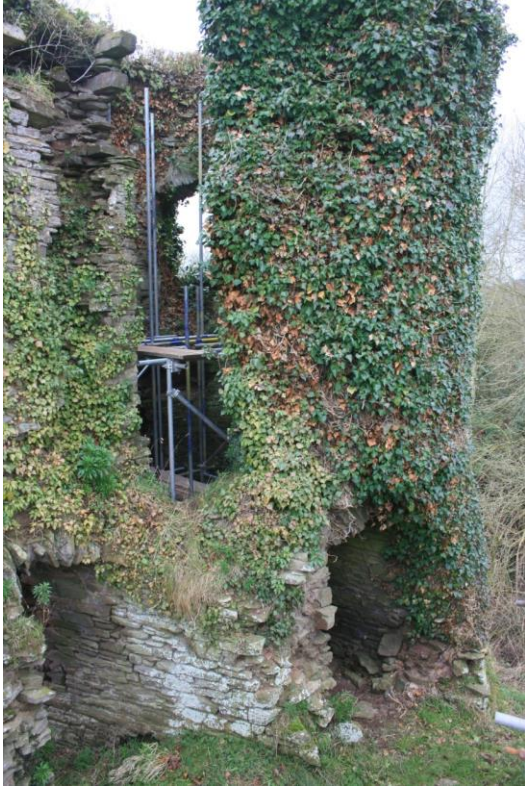
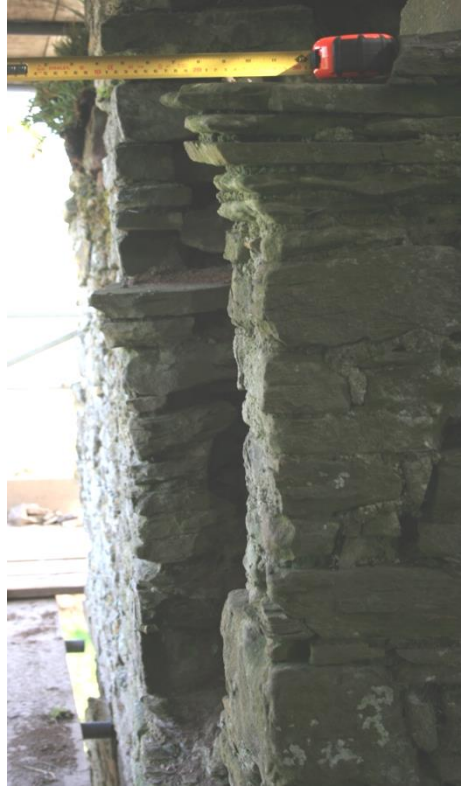
(33) Left: SE side of the NW tower showing first-floor doorway to hall with damage above and to its left, passage below and N-facing window embrasure in tower base;  
(34) Right: S side of doorway from tower first-floor chamber

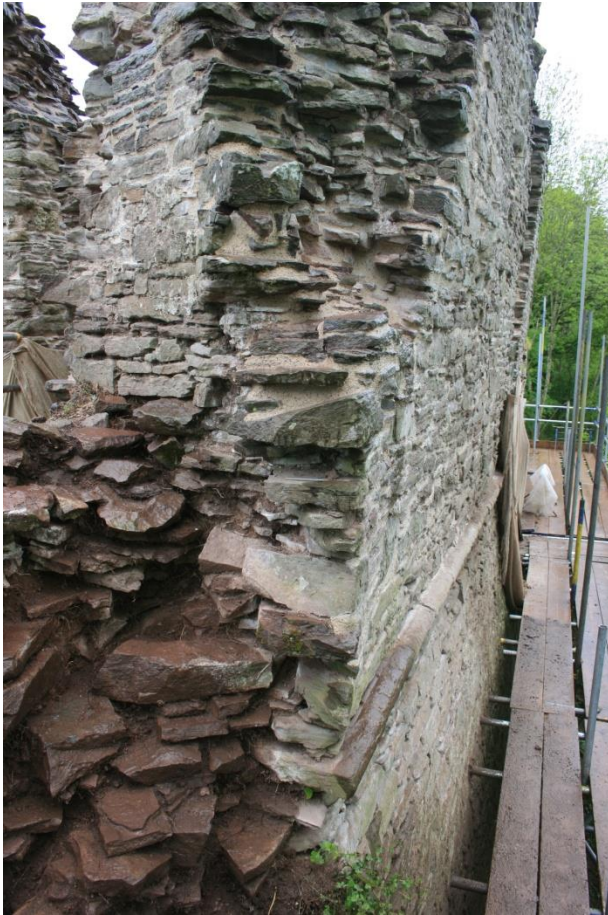
(39) North wall of the hall, external, looking west from damaged area at NE corner of chamber to east of the hall. Note string course slabs are integral to wall fabric

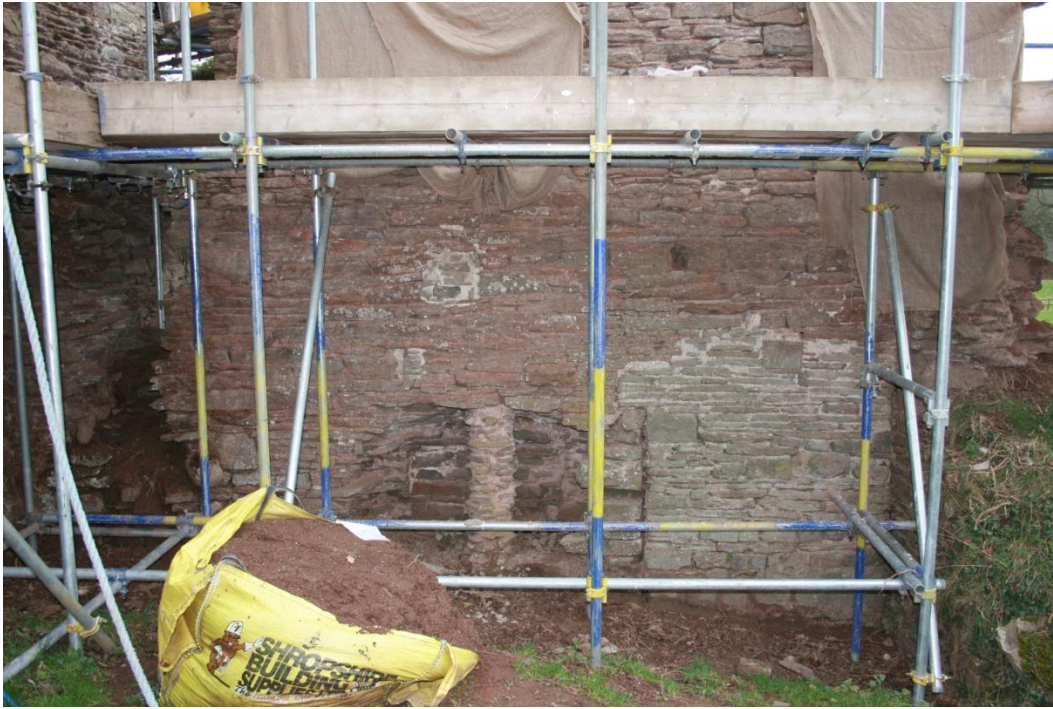
(41) E end wall of hall, internal, pre-repair showing propping in niche and blocked opening to its right

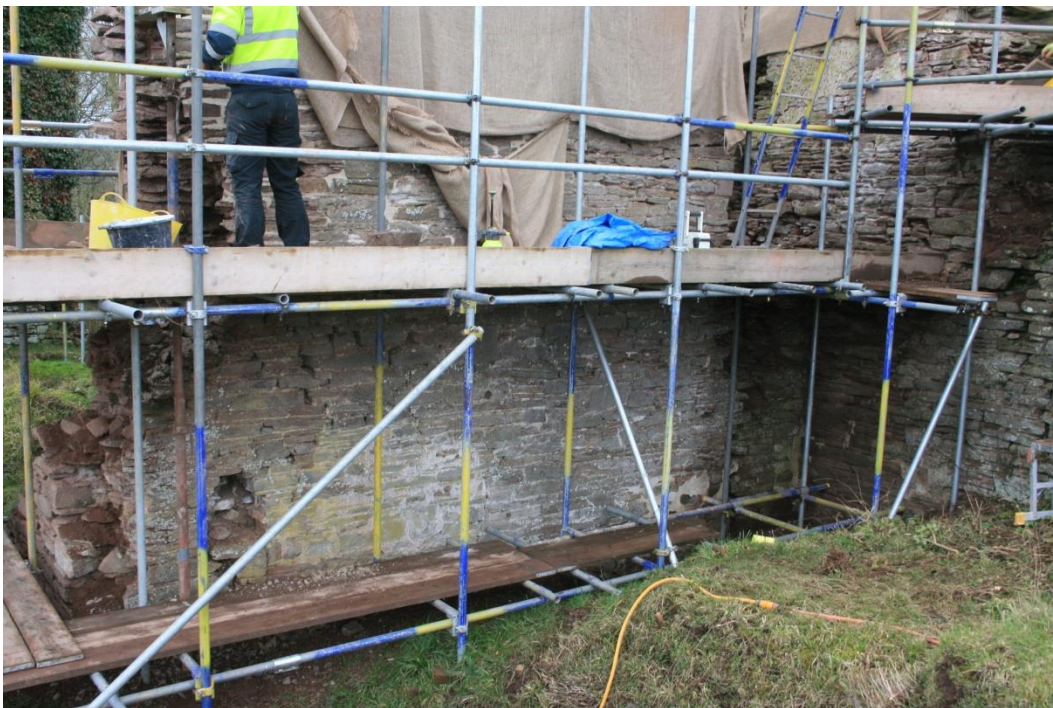
(42) E end wall of hall, external, during re-pointing

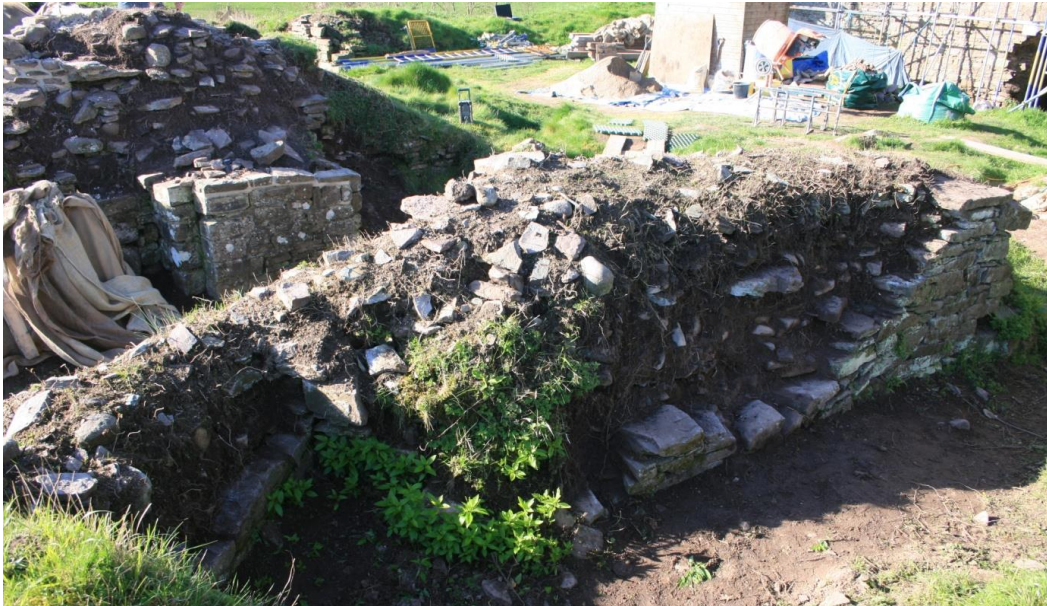
(46) N wall of gatehouse passage/S wall of NE tower, commencement of gardening process showing limits of survival of facing stones in entrance to NE tower

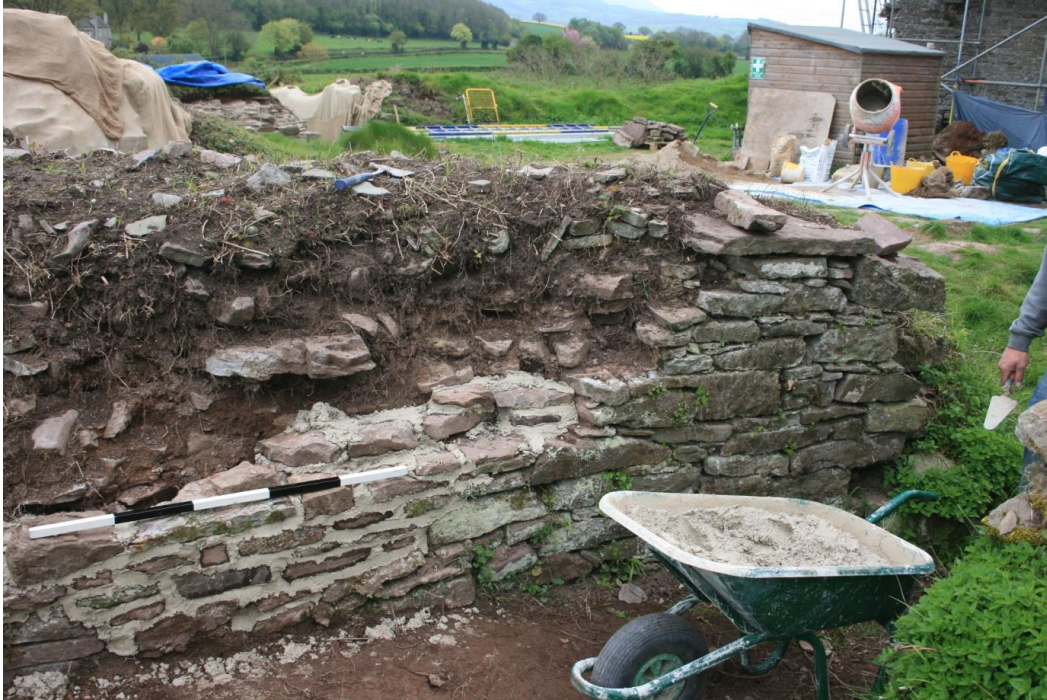
(47) N wall of gatehouse/entrance NE tower: consolidation in progress
