HEREFORDSHIRE ARCHAEOLOGY

A Programme of Archaeological Observation and Recording Snodhill Castle, Peterchurch, Herefordshire

March 2018

> Herefordshire Archaeology Report No. 374 Event No. EHE 80341

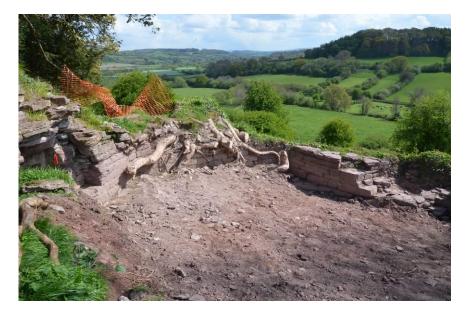
Prior to the consolidation works it was noted that a series of unbonded flat stones forming a rectangle had been laid upon the top of the south bastion wall, it was speculated that they may represent civil war fortification of the structure (See figure 3).

Plate 1: Trench 1, facing south-east, showing excavated south bastion, before removal of vegetation.

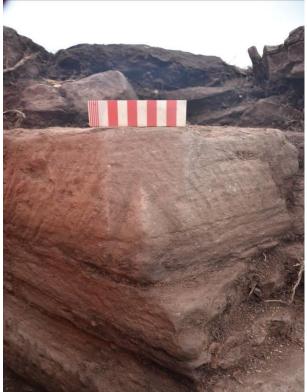
Located towards the south of the south bastion evidence was observed for a large splayed window with later blocking, the window had had the cill/floor removed, examination of the wall face indicated that the east splay had been cut back (see plate 2, figure 3). Within the west a single stone jamb remained illustration the style of decoration applied to the window jambs, this comprising of a chamfered jamb with lozenge stop end (See plate 3 figure 3).

Plates 2, facing southwest, showing splayed

window with later blocking.

Plate 3, facing southwest showing chamfered stop on window jamb.

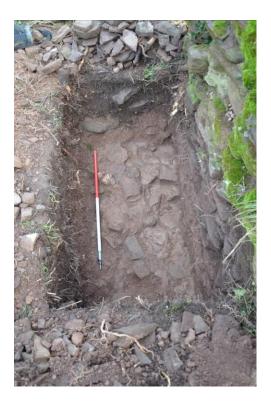
The stratigraphic sequence consisted of a dark brown top soil (201) with an average depth of 0.45m overlaying a reddish brown gritty/silty deposit (202) containing large amounts of mixed stone and rubble, overlaying the possible remains of the footings (203) of the wing wall projecting from the keep. (See Plate 5). No indication that the wing wall was keyed into the south curtain wall was observed.

Plate 5: Trench 2, facing east, showing curtain wall detail.

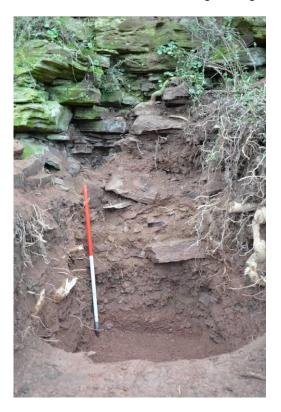
Trench 3 was located on the external wall of the south bastion to investigate an area of collapse (See figure 2, plate 6), measuring 1.00m by 1.00m the trench was excavated to a depth of approximately 1.00m below present ground level. No indication of a foundation footing was identified indicating the that area of collapse was complete to footing level.

Trench 3, facing north, showing foundation level.

Trench 3 was located on the external wall of the south bastion to investigate an area of collapse to the south bastion. The excavation identified that the area of collapse was complete to footing level, suggesting that a major fail of the south bastion wall had happen either through natural subsidence or human action.

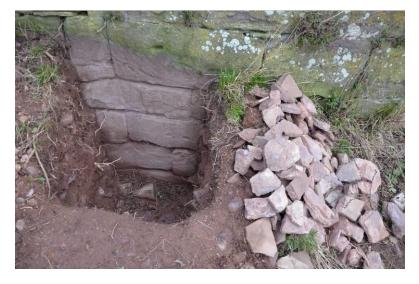
The stratigraphic makeup consisted of rubble and stone layer in a red brown topsoil deposit (401) overlaying a red brown subsoil with inclusions mixed flat rubble (402). Excavation stopped at 1.20m below the present ground due to health and safety concerns, no indication of a foundation level was observed at this depth.

Plate 7: Trench 4, facing north, showing dressed masonry details at the junction between the south bastion and the south curtain wall.

Trench 4 was located at the junction between the south bastion and the south curtain wall to investigate the level of preserved masonry and identify footing levels. The trench was excavated to a depth of approximately 1.20m below present ground level however no indication of a foundation level was observed at this depth.

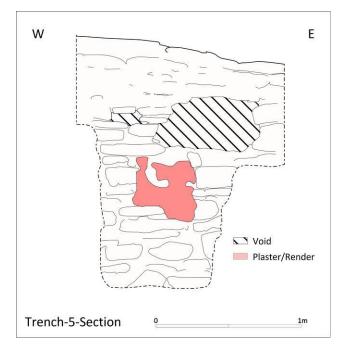
Plate 8: Trench 5, looking east, showing level of collapsed masonry.

Trench 5 was located abutting the internal face of the southern wall of the keep to evaluating the build-up of collapsed masonry within the internal area of the keep. The trench was excavated to a depth of approximately 1.00m below the present ground level, no indication of a floor level within the keep was observed suggesting that the internal depth of the keep is substantial.

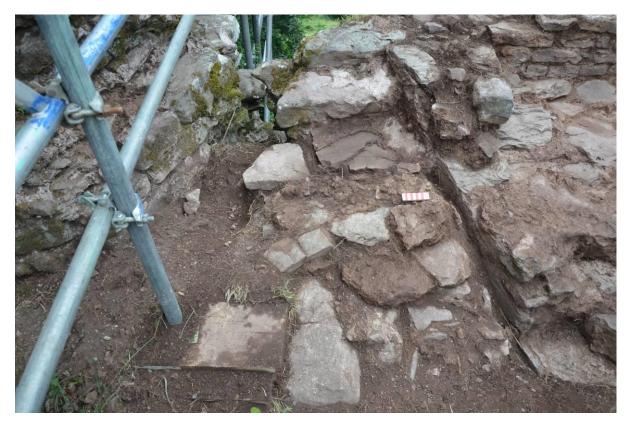
Originally a splayed window opening had been formed in the south wall of the keep. (See figure 6) it is interesting to note that the splayed opening is not cut through the full width of the wall and reflects the same depth as the later cupboard or niche. Within the blocking of the window it was observed that the original splayed opening was finished with a thick (approximately 0.015m) plaster finish, however no decoration or surface finish was detected on the surviving plaster.

Plate 9: Trench 6, facing south, showing splayed window construction , note amount of wall movement.

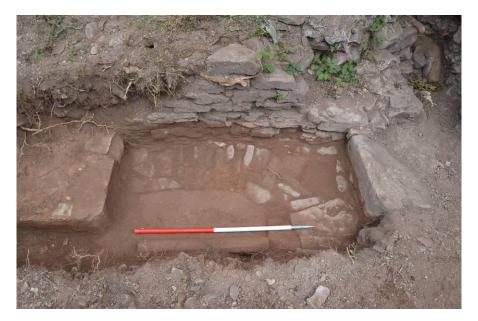
Within the trench 7, a right-angle turn, aligned north south, in the internal wall alignment was observed and at approximately 0.70m below the present ground level a solid stone surface was encountered. An extension to trench 7, aligned east west and measuring approximately 2.5m by 1.00m was excavated to identify the purpose of the right-angled turn in the wall line.

Plate 10: Trench 7, facing north, showing exposed fire place and hearth with chamfered surround.

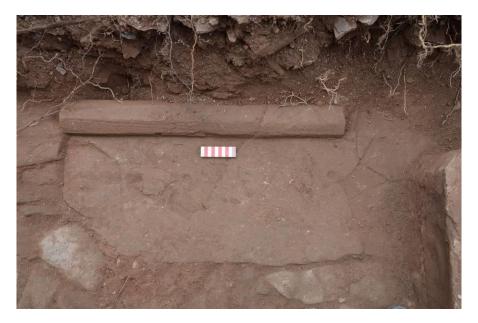
Plate 11: Trench 7, facing south, showing chamfered fireplace surround.

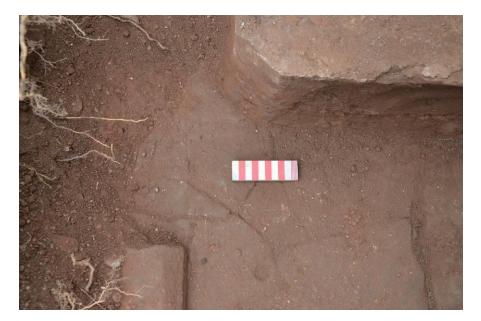
Plate 12: Trench 7, facing west, showing damage to the chamfered fire place surround and chamfered jamb

Plate. 12 Trench 7, facing west, showing damage to the chamfered fire place surround and chamfered jamb.

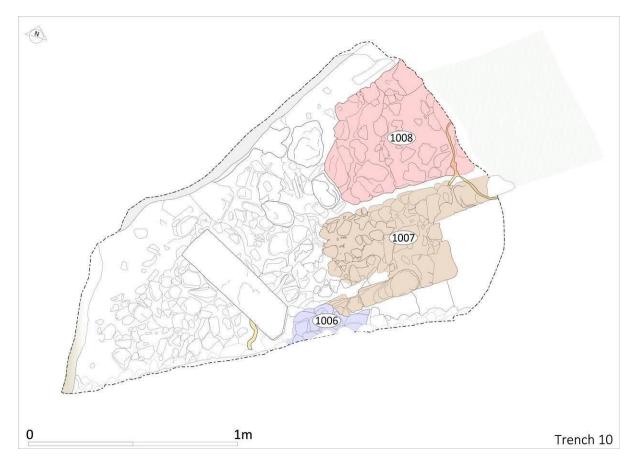
The excavation identified a sequence of evens within the construction of the keep wall and fireplace structure identified in trench 7. (1008) formed the north wall of the keep the structure was bonded with a creamy yellow mortar, however the section that would have formed the return to the gatehouse tower had collapsed leaving only loose rubble present (1009) in the south end of the trench.

The fireplace structure previously observed within trench 7 was fully exposed within trench 10 where it was noted that the fireplace structure was not bonded to the external wall of the keep, (See figure 15, plate 16) a gap of approximately 0.15m separated both (1008) and (1009) possibly indicating the presence of a beam slot or construction timber. A second possible beam slot or construction timber void was also noted within the fabric of the fireplace construction (See plate 18).

Figure 15: Trench 10, showing changes in wall construction.

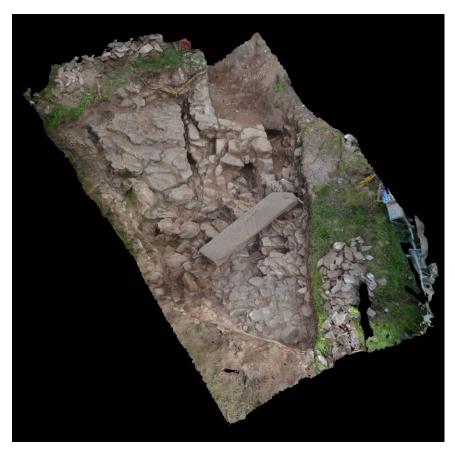
Within the loose rubble a large architectural carved stone was observed (See plate 17, figure 15) possibly relating to the fireplace or a large window cill or lintel. The detail on the stone comprise of a chamfered edge with angled stops although one of the angled stops appeared to be unfinished. A further carved stone architectural object was observed within the north section comprising of a column fragment. Both architectural stone objects were left in situation.

Plate 14: Trench 10, showing changes in wall construction and possible fireplace mantle stone

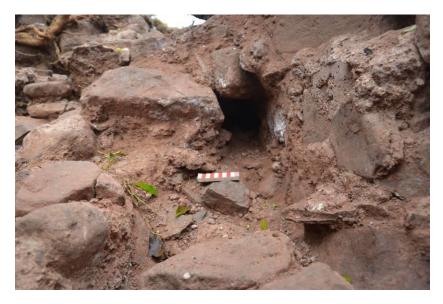
Plate 16: Trench 10, showing possible beam slot within the fireplace construction.

The fireplace structure previously observed within trench 7 was fully exposed within trench 10 where it was noted that the fireplace structure was not bonded to the external wall of the keep, (a gap of approximately 0.15m separated both the fire place and the north keep wall that may indicated that a timber (now rotted) had been present either for construction or setting out purpose. A second timber slot was noted within the masonry of the fireplace structure.

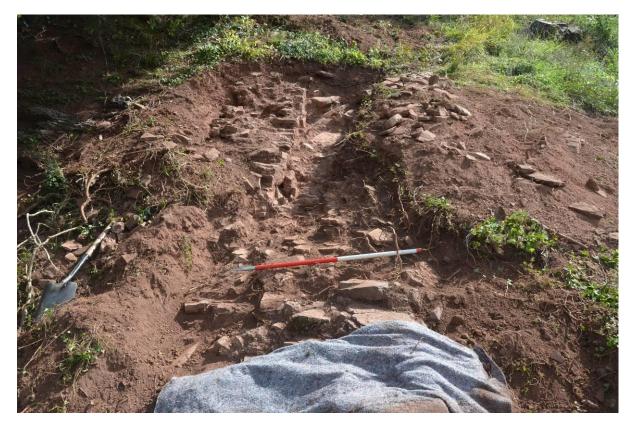
19) the area of transition between wall thicknesses had been severely damage, presumably through the collapse or demolition of the north flanking wall.

Plate 19: Trench 11, facing south-east, showing change in the north flanking wall thickness.

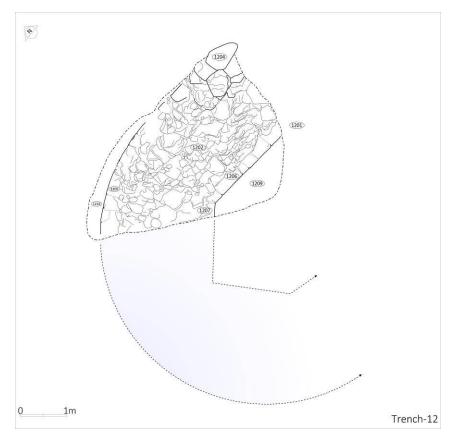
The excavation identified that dressed face stones on both internal and external elevations survived (1205, 1206 & 1207). the bastion tower wall at this level had an approximate thickness of 3.00m and illustrated that the internal arrangement of the tower consists of straight walls with angled joints set in a circular tower, this is a stylistic characteristic seen elsewhere at Snodhill castle for example the south bastion and the keep. (See, plate 20 figure 16)

Figure 16: Trench 12, showing excavated area of tower base with projected tower base.
