Moccas Park: Archaeological recording of a sluice

Herefordshire Archaeology
Report No. 196
August 2005

Report prepared by
Tim Hoverd & Chris Atkinson

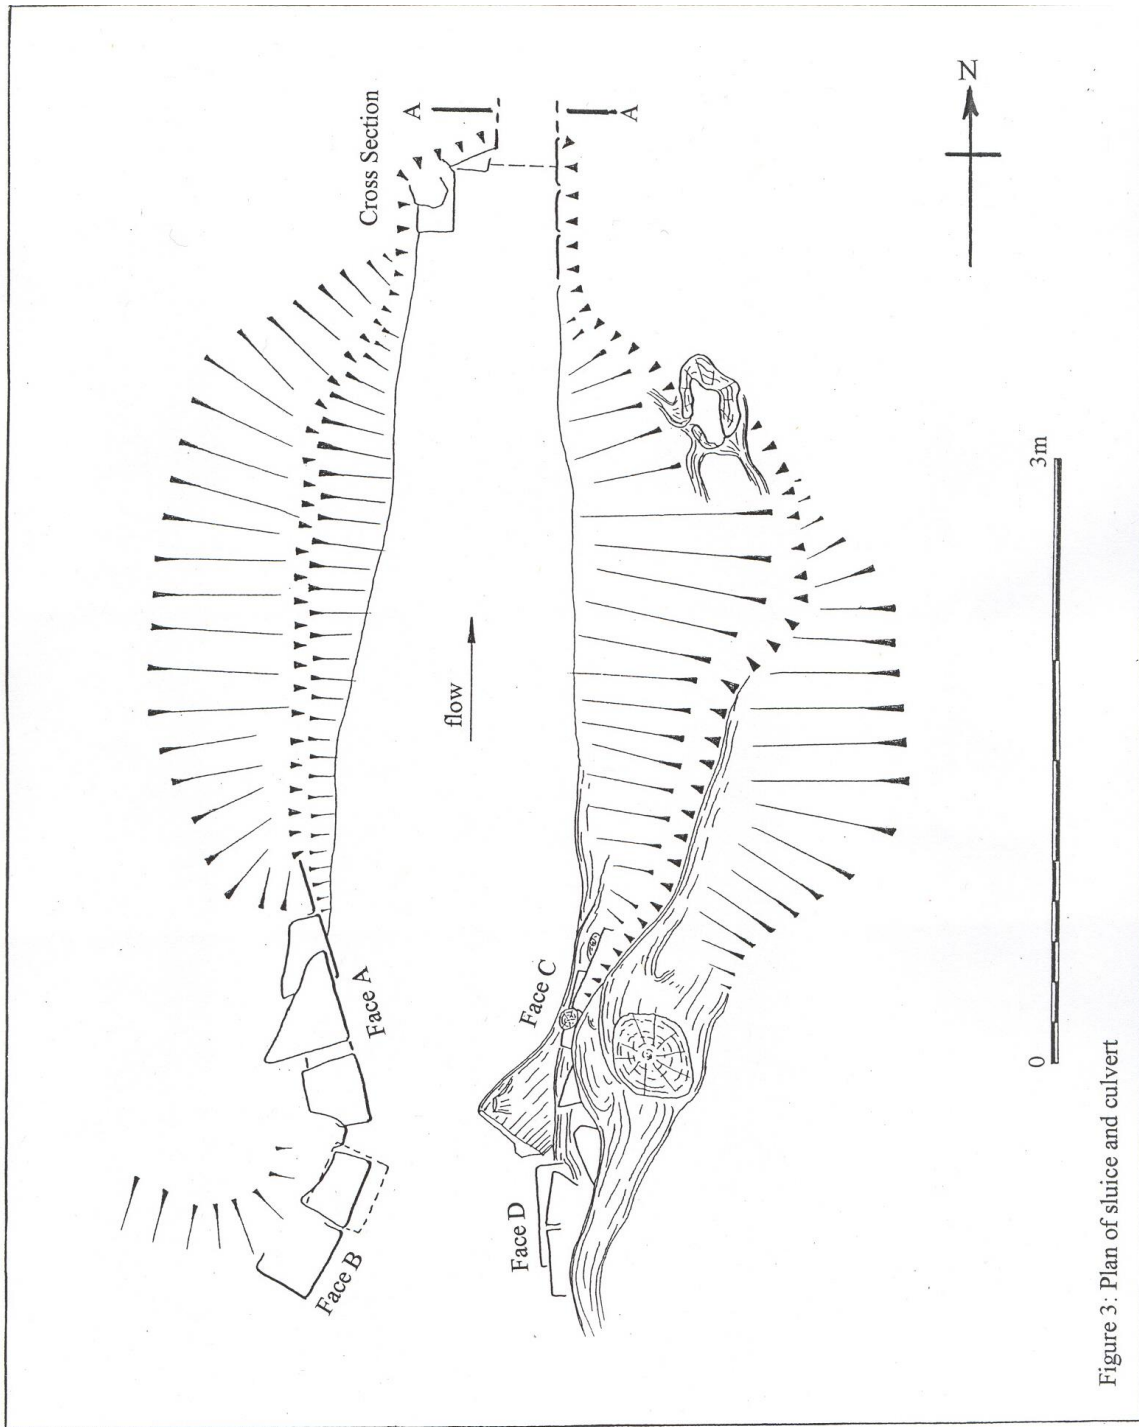
Figure 3: Plan of sluice and culvert

For the purpose of this report the structural remains of the sluice have been divided into two main elevations; the western elevation and the eastern elevation. Each elevation has been further divided into faces A & B and C & D respectively, (see figure 3). The description of each face will include its build, evidence for bonding, structural integrity and condition.

The wall is generally structurally sound and erosion of most of the face appears to have stabilised. However, the wall top is prone to further erosion as indicated on plan (figure 3) which shows the dotted outline of a displaced stone.

Whilst equally well squared masonry has been used for both faces of this elevation, it is difficult to comment further on its build due to the considerable amount of stone displacement, (both vertically and horizontally), caused by roots from a large sycamore tree. It is suggested that the lowest course has suffered minimal displacement, however as is evident on plan, (figure 3), Face C bears little resemblance to its opposite number, Face A.

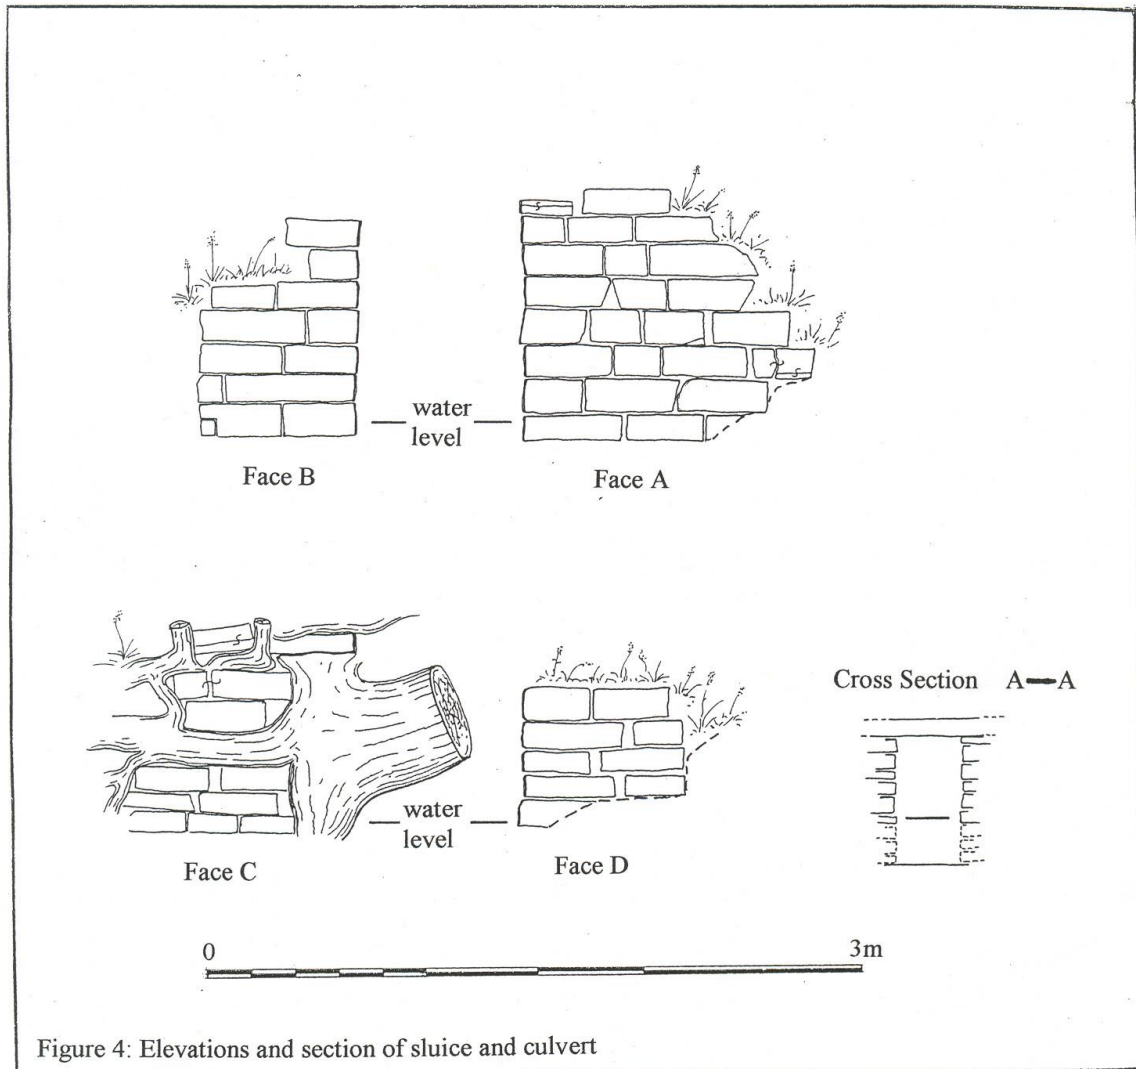
Figure 4: Elevations and section of sluice and culvert

The culvert is constructed of two stone walls capped by stone flags, it is suggested, (by probing), that the original base of the culvert also comprises flagstones. The culvert is approximately 0.3m wide and 0.55m in height and does not appear to have been bonded by mortar and was probably built “dry”, (see Figures 3 & 4 cross section A-A and Appendix 1, Plate 9). Rubble immediately to the south of the present mouth of the culvert suggests that it continued for possibly as much as 1.0m further south.

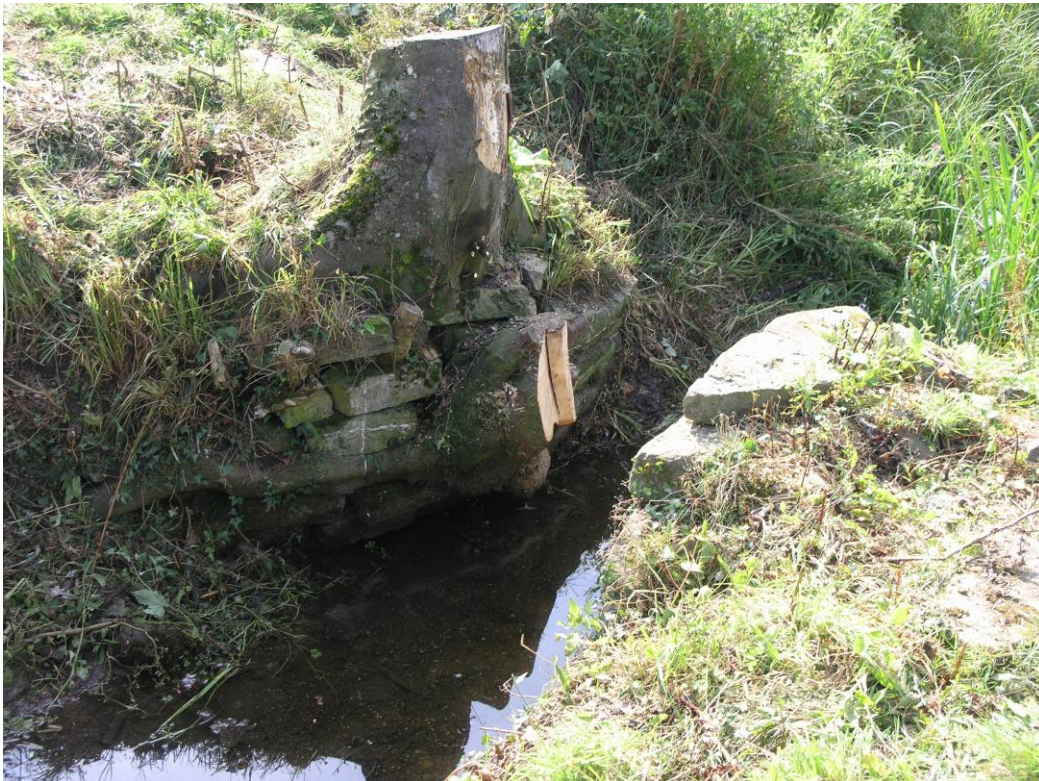
From this survey it is clear that both the sluice elevations and the culvert mouth are in need of conservation and consolidation if further collapse and erosion is to be avoided. Whilst the western elevation is in relatively good condition and appears to be relatively stable, the eastern elevation has been subjected to almost total displacement by massive tree root intrusion which is continuing.

Plate2:
General view
of eastern side
of sluice
showing root
damage.

1. The removal of the sycamore tree is necessary in order to conserve and restore the eastern portion of the structure. This will inevitably result in major disturbance of much, (if not all), of the eastern elevation.
2. The works need to be carried out by a builder who can demonstrate experience and competence within the field of conservation and restoration of historic structures.
3. All masonry that relates to the structures should be retrieved during the works and where practicable re-used during the restoration.

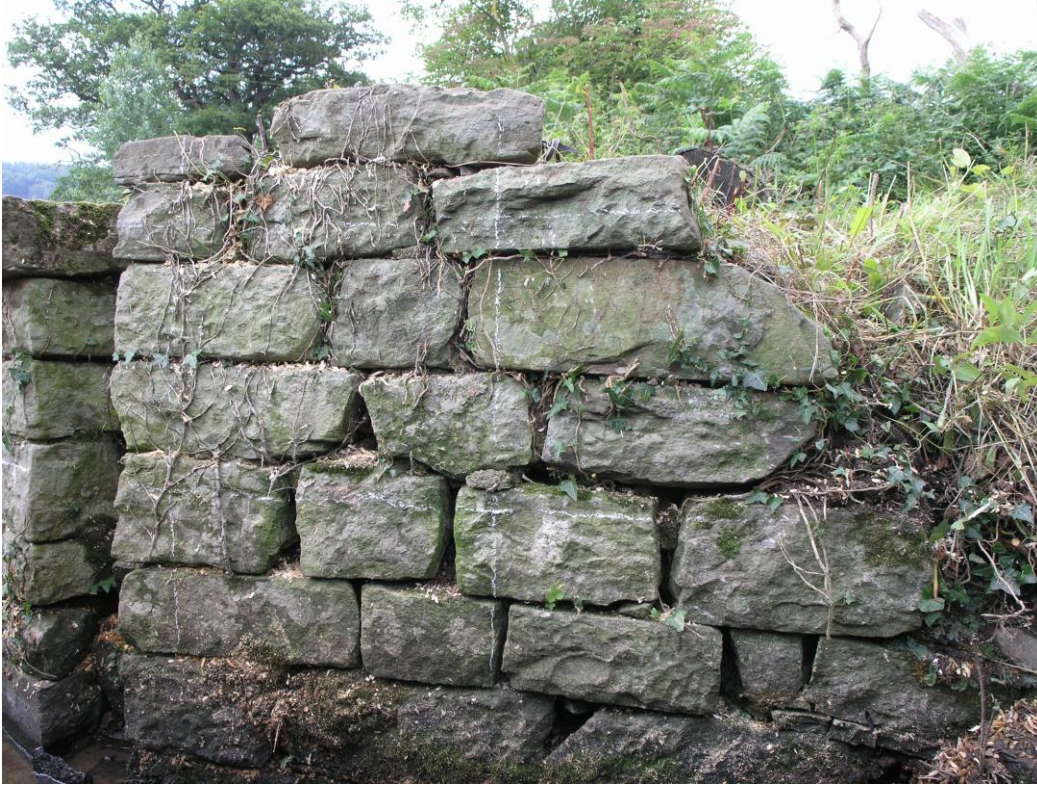
This comprises a well coursed wall approximately 1.2m long and surviving to a height of approximately 1.2m above the height of the present drain base. The masonry is squared with some evidence of tooling on the exposed face and the jointing appears to be quite tight. There is evidence within the central area of this face of a strong, lime mortar bonding, however all but one small patch has been eroded out of the joints.

The wall is generally structurally sound and erosion of most of the face appears to have stabilised. However, the wall top is prone to further erosion, (as indicated by the lamination of the southern-most top stone), and stone displacement as is its northern extent, (at the point where it runs into the present bank), as tree roots have already led to the fragmentation of the northern-most stone.

Plate 3: Western elevation, face A

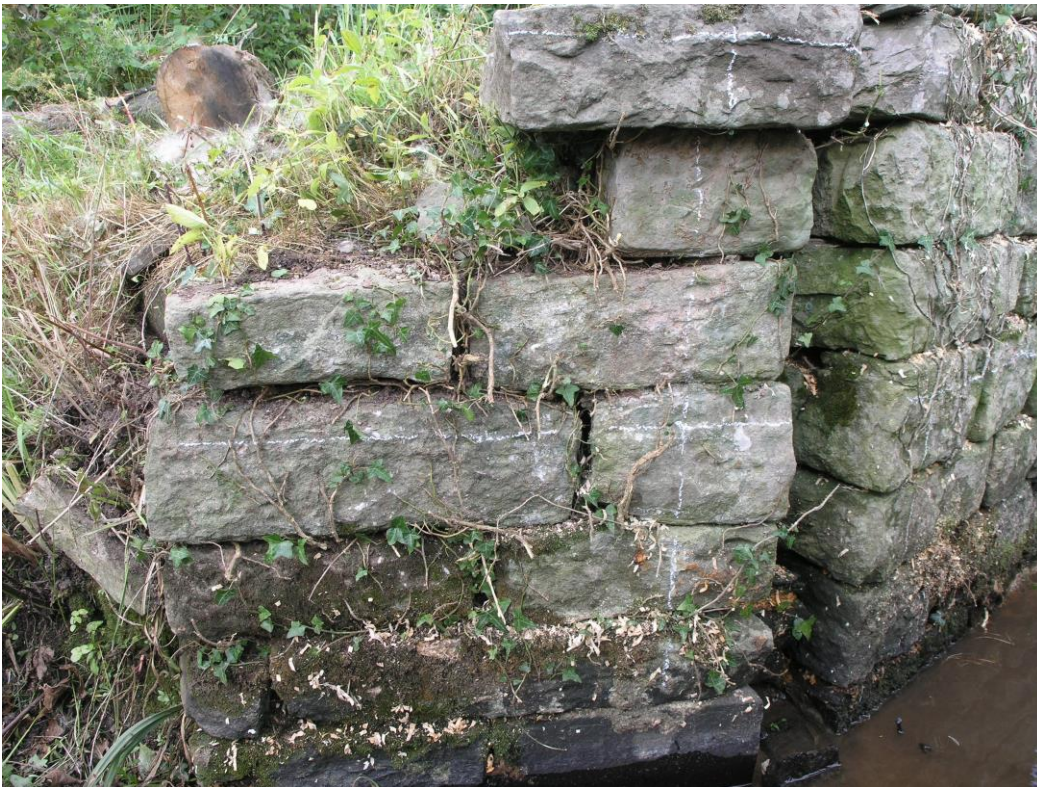
This comprises a well coursed wall approximately 0.8m long and surviving to a height of approximately 1.15m above the height of the present drain base. The masonry is squared with some evidence of tooling on the exposed face. The coursing does not run through to Face A for at least the lowest two courses. The presence of the carefully cut, square stone on the lowest course of the wall's southern extent together with the vertical edge of this wall; suggests that this was the original extent of this wall face.

Plate 4: Western elevation, face B

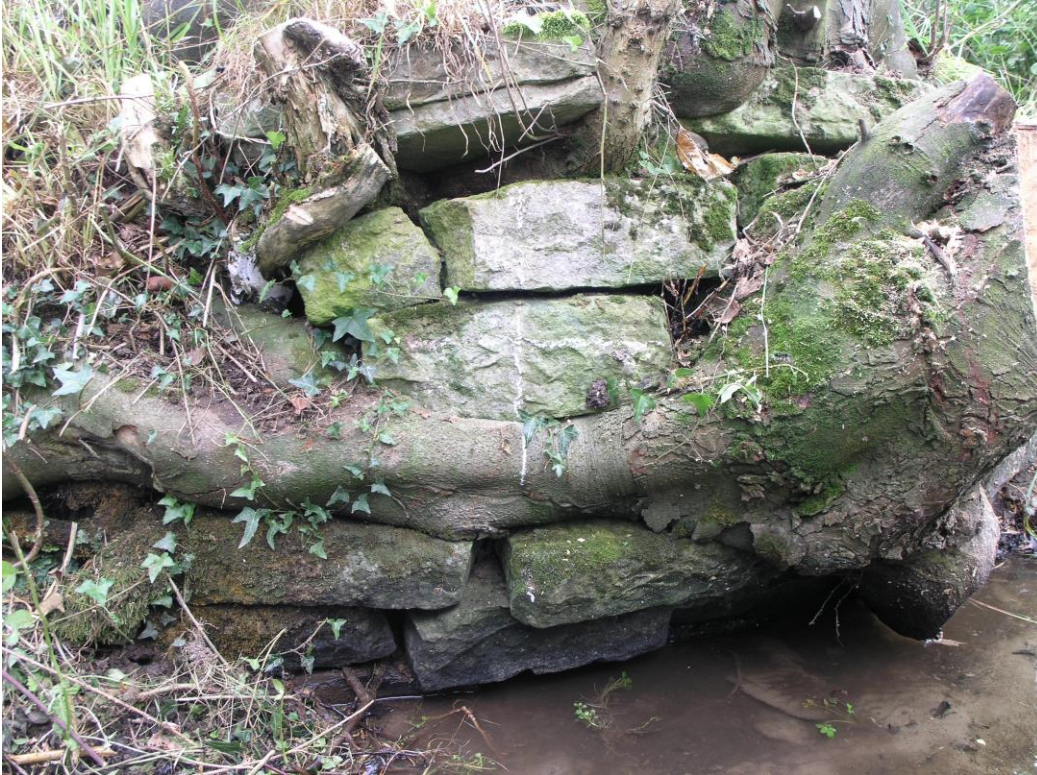
Plate 5: Eastern Elevation, face C

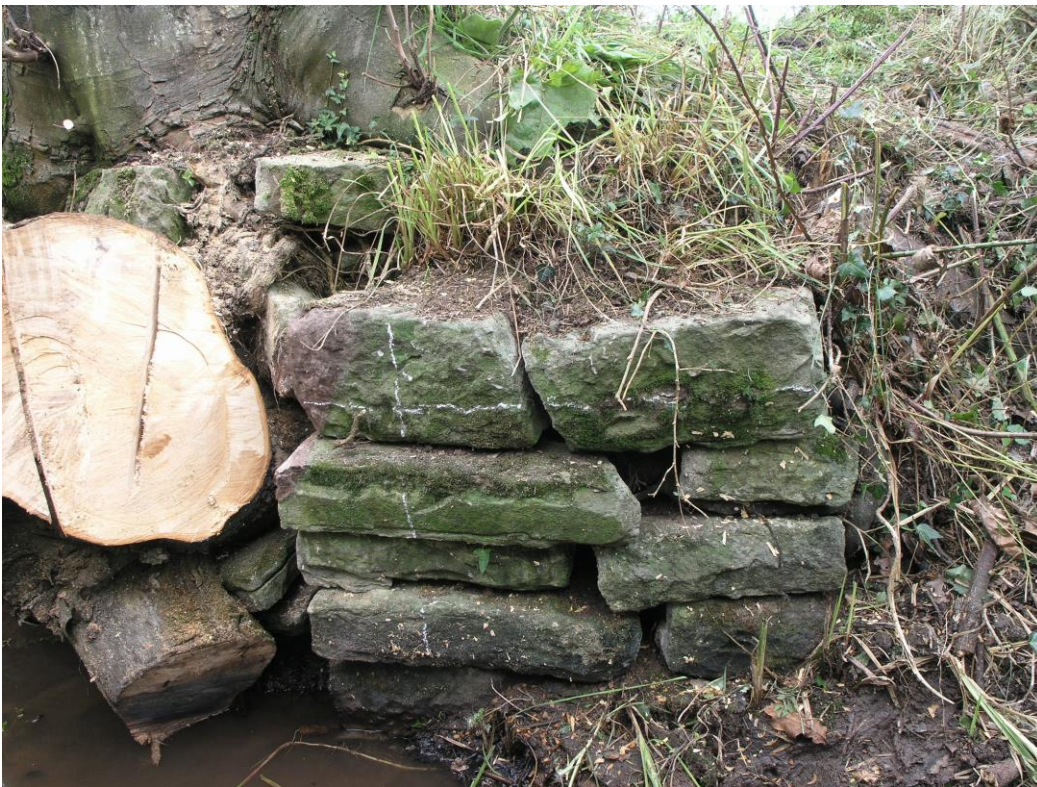
As with Face C, Face D has suffered from considerable stone displacement through sycamore root action. Whilst the masonry is more visible and despite root intrusion, still well coursed, all recorded courses have been displaced horizontally by roots behind the wall face.

Plate 6: Eastern Elevation, Face D

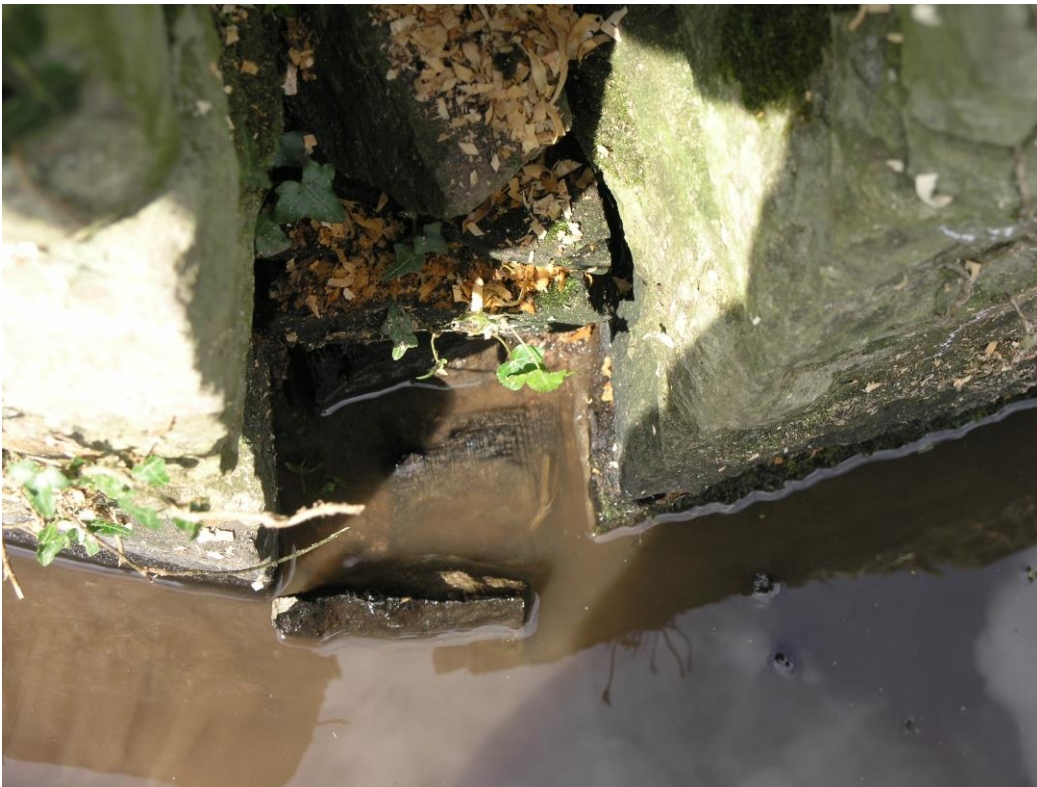
Between Faces A and B there is a 0.2m wide (at face) and 0.25m deep recess. This held a vertical wooden post which in turn would have held the sluice gate. The remains of the post survive below water level, (see plate 8, appendix 1).

Plate 8: Detail of recess in Western Elevation showing remains of timber post.

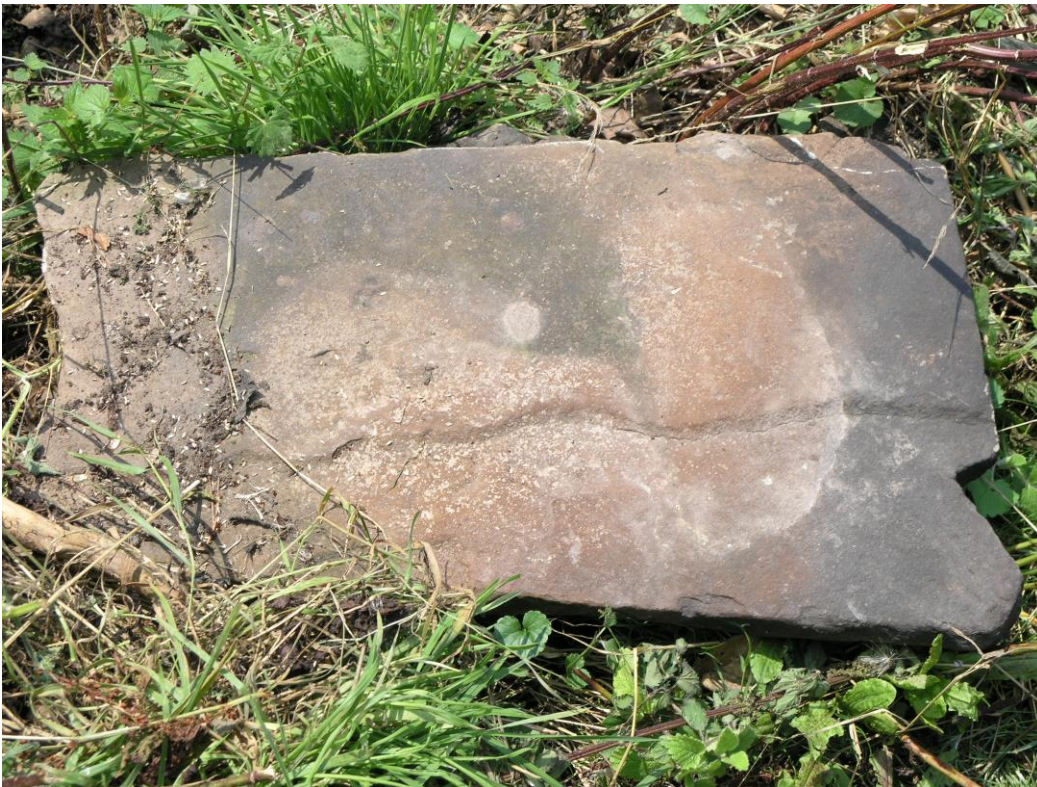
A flagstone fragment (Appendix 1, Plate 10), was recorded during the survey. This appears to have a notch carved into one end. The water staining in the fragment suggests that it was part of a capstone for the culvert. It is suggested that the notch may be for securing the iron grille (Appendix 1, Plate 11), to the culvert mouth to prevent detritus or livestock entering the culvert.

Plate 10: Slab with notch cut into one edge possibly for holding an iron grille

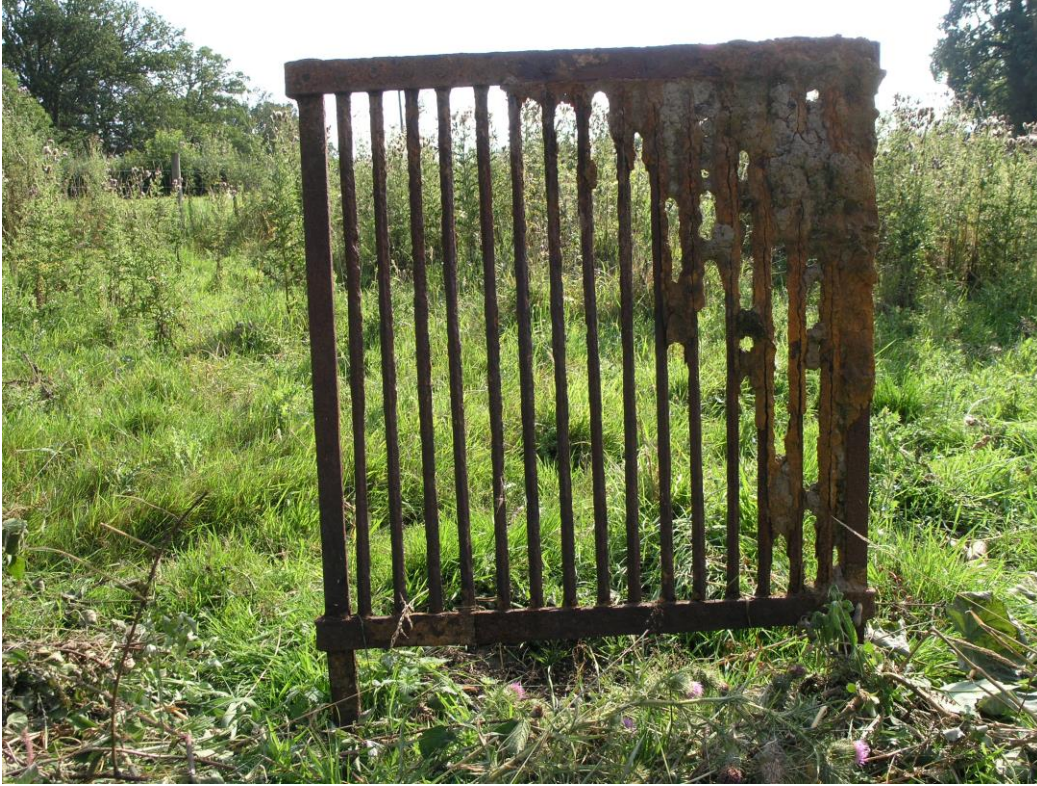
Plate 11: Iron grille originally located at mouth of culvert.
