A Programme of Archaeological Observation, Investigation and Recording at the Church of St. Dubricius, Hentland, Herefordshire

August 2020

**Herefordshire Archaeology Report No. 390
Event No. EHE 80443**

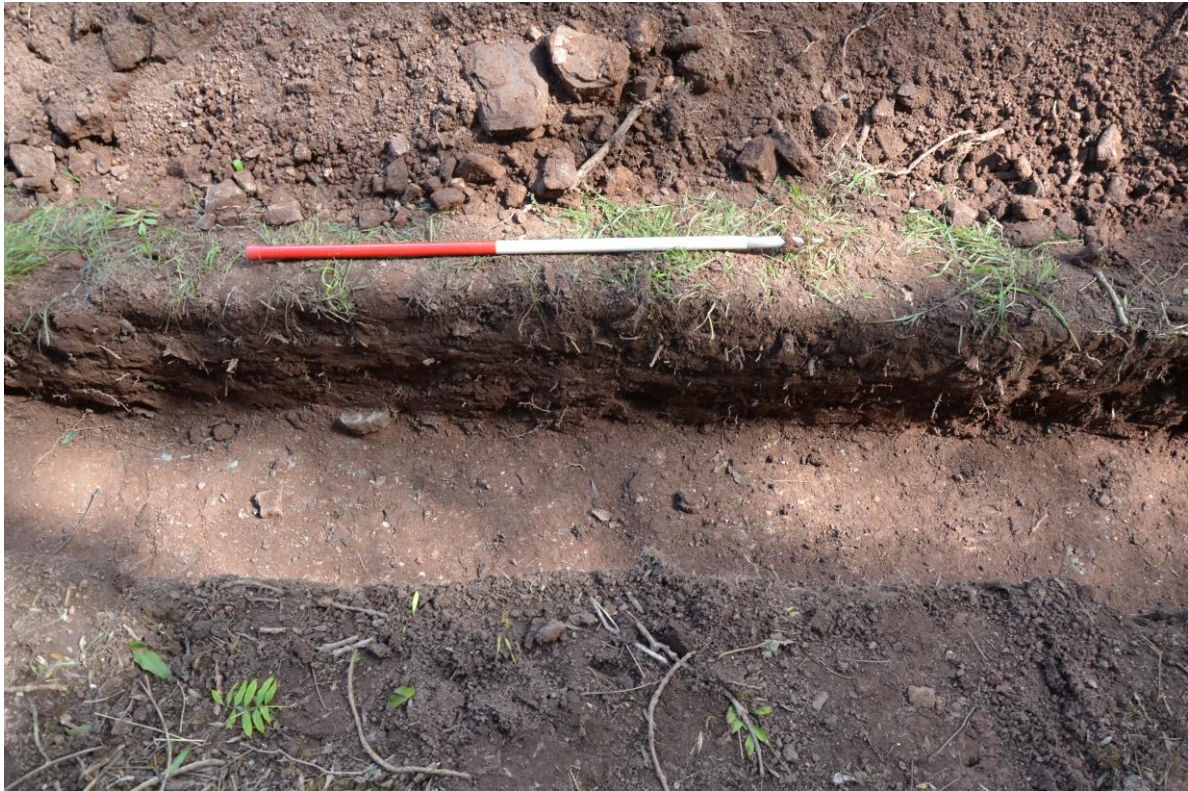
The general stratigraphic sequence of the site comprised a well mixed, mid brown, stony, dark earth. This became more compacted with depth and contained fragments of eroded / degraded Old Red Sandstone.

Plate 1: Typical section of drainage trench

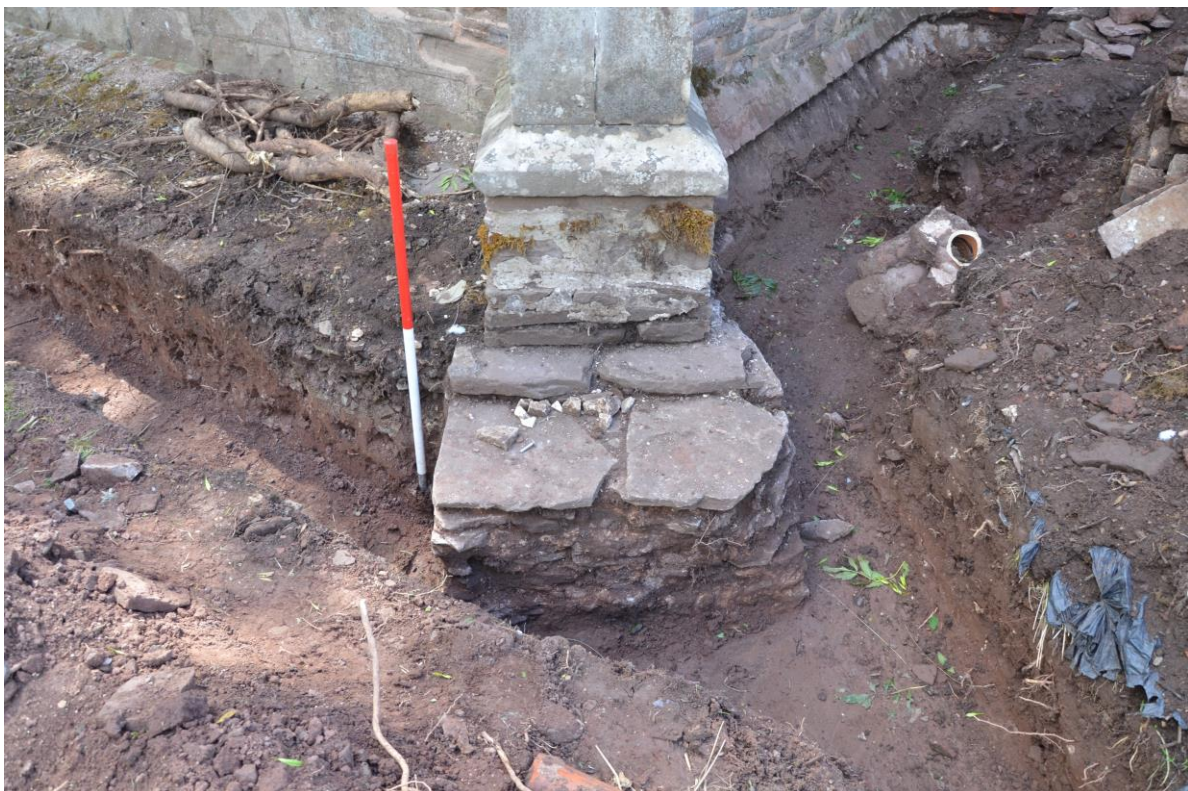
Due to the route of the drainage trenches the original foundations of the buttresses were exposed. These were significantly larger than the present buttresses, possibly suggesting that the medieval buttresses were considerably larger than the present ones, (see figure 2).

Plate 2: Detail of foundations for the north-western corner buttress for the chancel.

The foundations of the buttresses appear to predate the present buttresses. The foundations are larger and the present buttresses are not constructed in the centre of the foundations. The foundations are bonded with a white, lime mortar which is different from

the mortar used in the upstanding masonry. This suggests that the medieval buttresses may have been wider than the present ones which form part of Seddon's major rebuild in 1853.

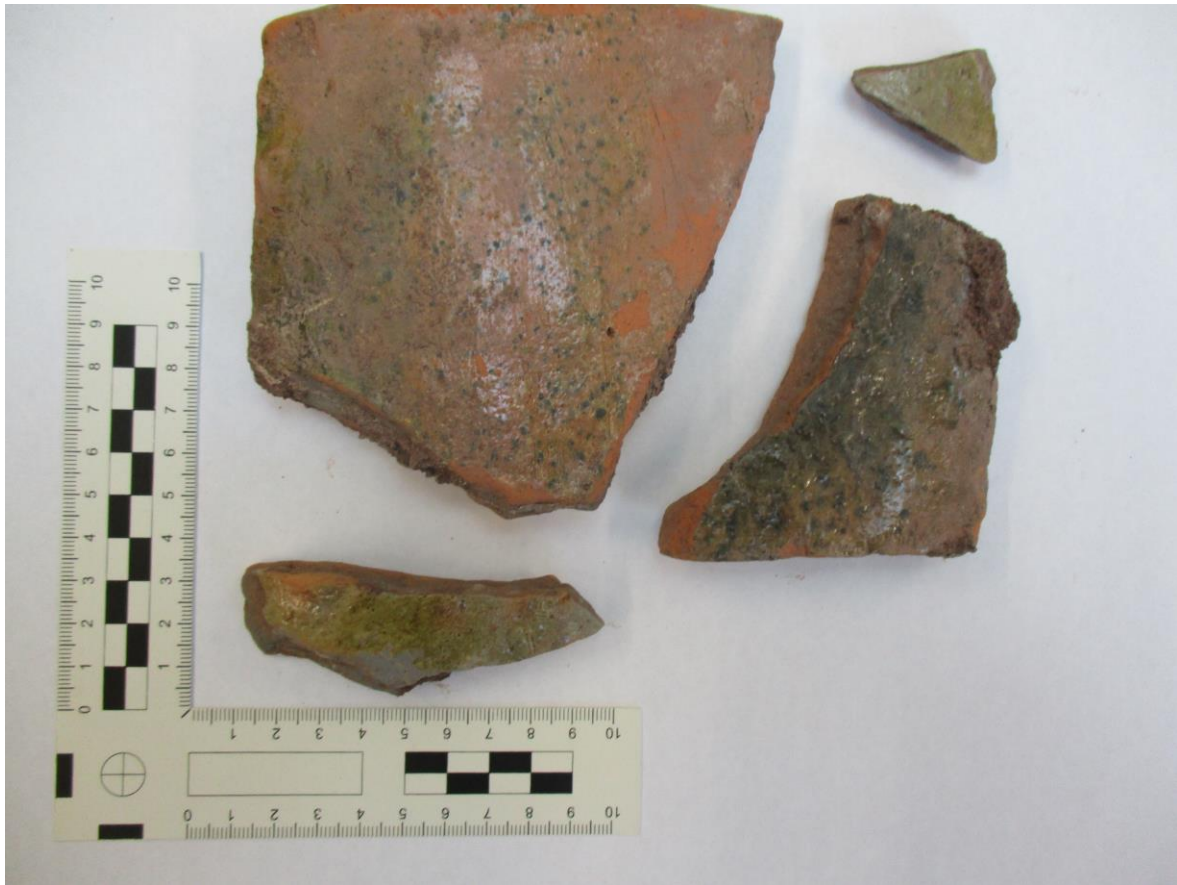
A number of sherds of glazed roof tile were recovered from the drainage runs. This comprised crested ridge tile as well as glazed rectangular roofing tiles and are of a fabric type which dates from the late 13th to early 15th centuries.

Plate 3: A selection of glazed roof tile recovered from the excavations.

The recovery of the glazed roof tile fragments from the trenches in close proximity to the chancel indicates that the church roof, (or at least the chancel roof), was tiled during at least part of the medieval period.

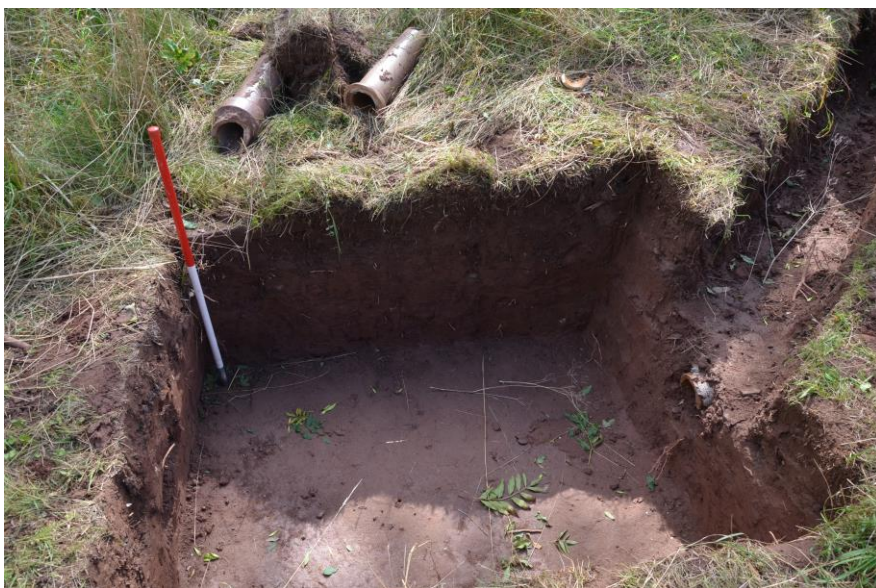
The soakaway off the north-western corner of the chancel, (plate 4), was excavated in a gap between standing headstones, currently used as wide pathway leading to the western edge of the churchyard. The soil profile comprised a red, sandy but well mixed subsoil containing small stones and occasional bone fragments. At a depth of 0.95m a coffin handle was observed together with the top of a semi-collapsed skull. It was agreed that the burial should remain undisturbed and in order for the soakaway to be of the required volume the excavated area should be made 1.4m wide by 1.6m long.

Plate 4: North-western soakaway

The excavation of the soakaways has shown that articulated burials occur less than 1m below the present ground surface. The burial with coffin handle within the northern soakaway appears to have been relatively modern (18th or 19th century). It is assumed that any headstone belonging to this burial was removed either when the earlier drainage was undertaken or to make room for the pathway.

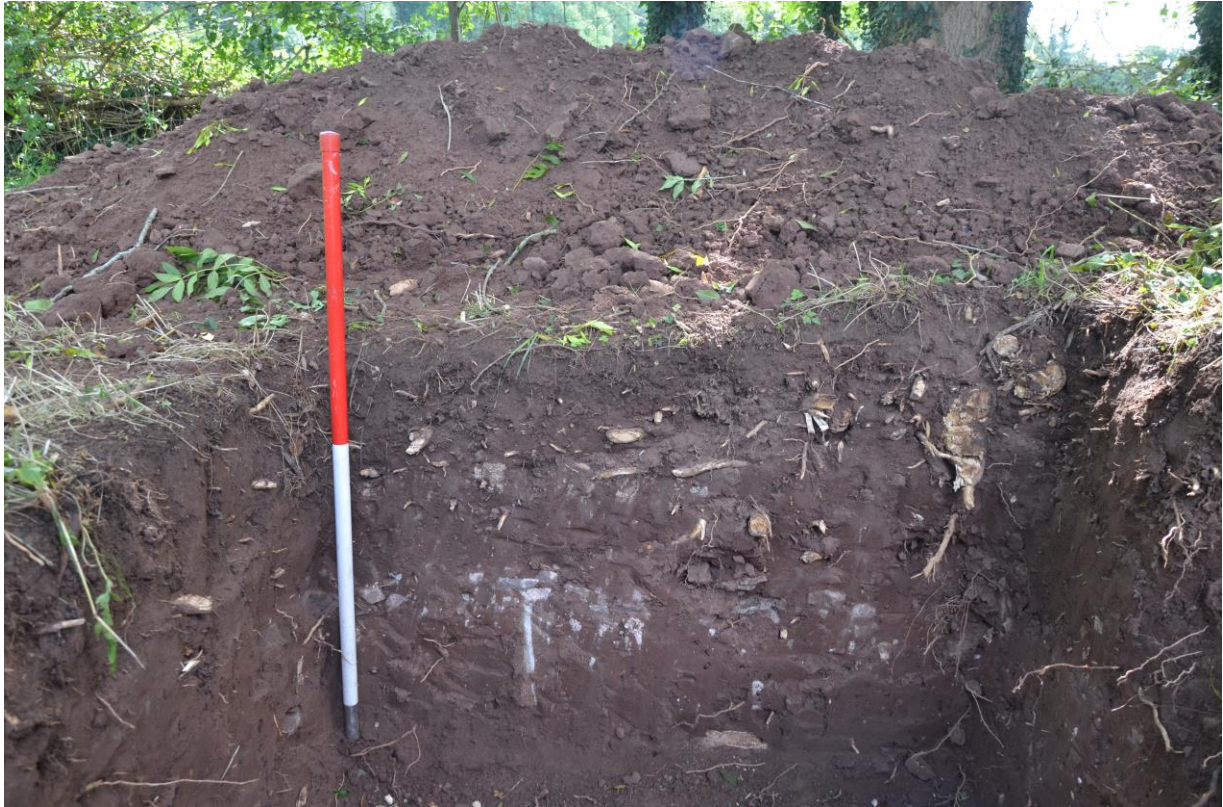
The soakaway off the south-western corner of the chancel comprised a 1.4m square trench that was excavated to a depth 1m. The soil profile comprised a well mixed, red sandy clay with frequent with significant tree roots to a depth of 0.6m. Below this there was a 0.2m thick layer of small stone fragments within which was the edge of what appears to have been a vertically set stone. At a depth of 0.85m the edge of a pelvis was noted within the southern section of the trench (see plate 5).

Plate 5: the southern section of the south-western soakaway showing the extent of root disturbance, the layer of stone and the vertically set stone.

The excavation of the southern soakaway revealed a stony layer comprising small, angular fragments of sandstone. It is possible that this represents debris from a phase of re-building but whether this was from the Seddon works or earlier is unclear. Within this layer is a vertically set sandstone fragment. It could not be established whether this formed part of a grave – either as the base of a marker or part of a cist, or whether this formed part of the “debris deposit” and its vertical appearance is pure chance.

The pelvis which was noted below the stony layer may relate to an *in-situ* burial, however it was not disturbed as it was only just showing in the southern section of the soakaway. The difference in depths between the pelvis and the vertical stone suggest that they are not related.
