Documenting and recording of unauthorised metal- detecting, Goodrich Castle, Herefordshire

October 2019

**Herefordshire Archaeology Report No. 388
Event No. EHE 80417**

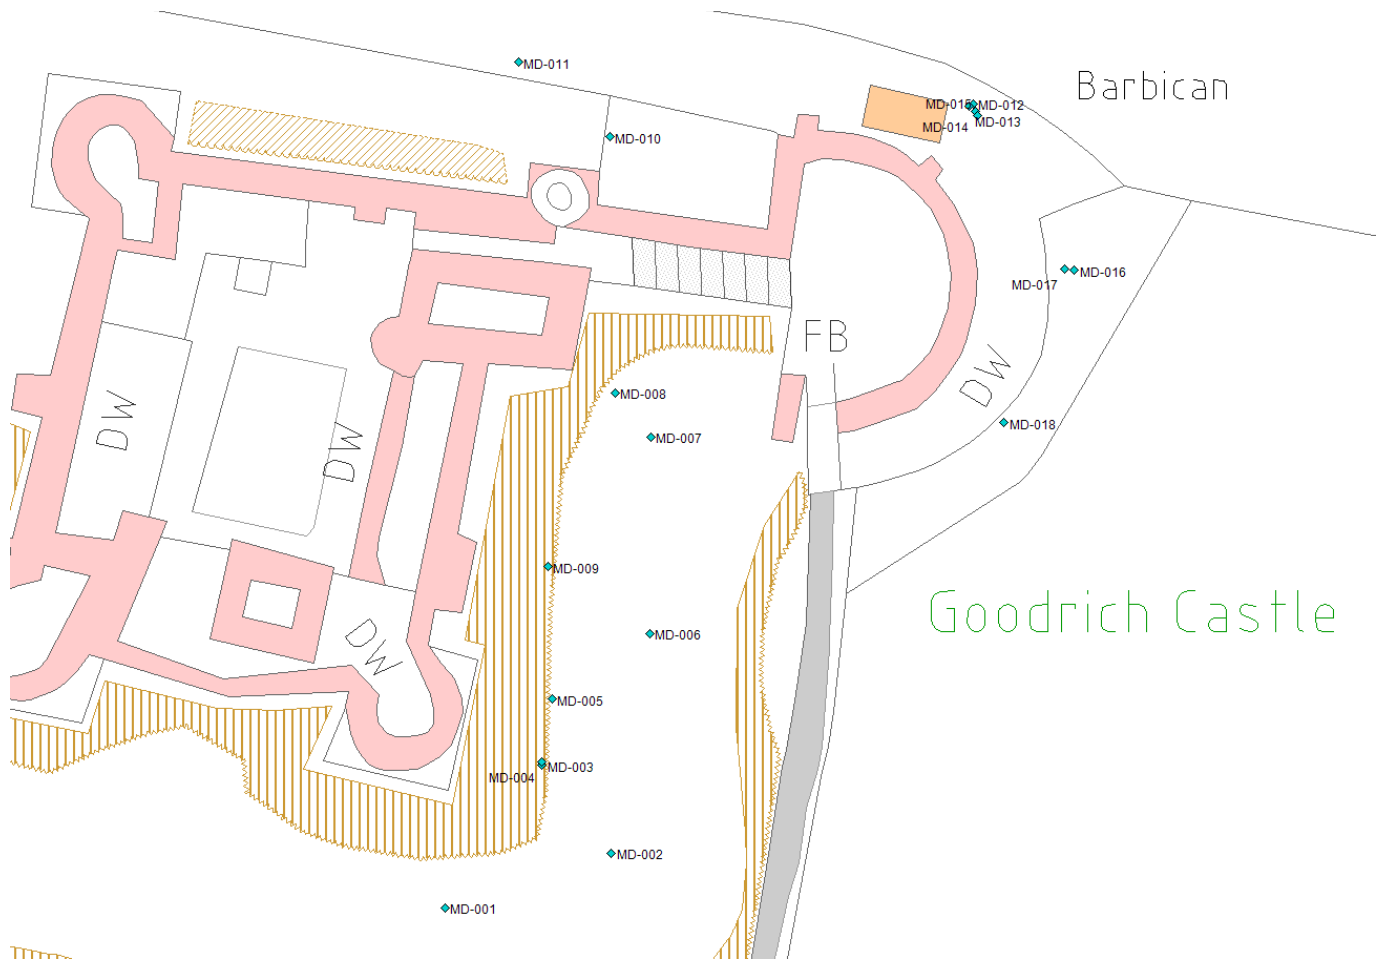
Figure 1: Location of metal detecting disturbances

In Figure 1, each dot with MD followed by a dash and a 3 digit number relates to a separate, single, area of disturbance / damage. These were typically holes approximately 15 to 20 centimetres square, some (MD011) were larger. MD011 and MD009 both had material which was the origin of the signal discarded next to them. In the case of MD011 this comprised a large lump of iron ore and in the case of MD009, this comprised a crushed piece of tin foil. These finds have been recorded photographically and retained in sealed and labelled finds bags.

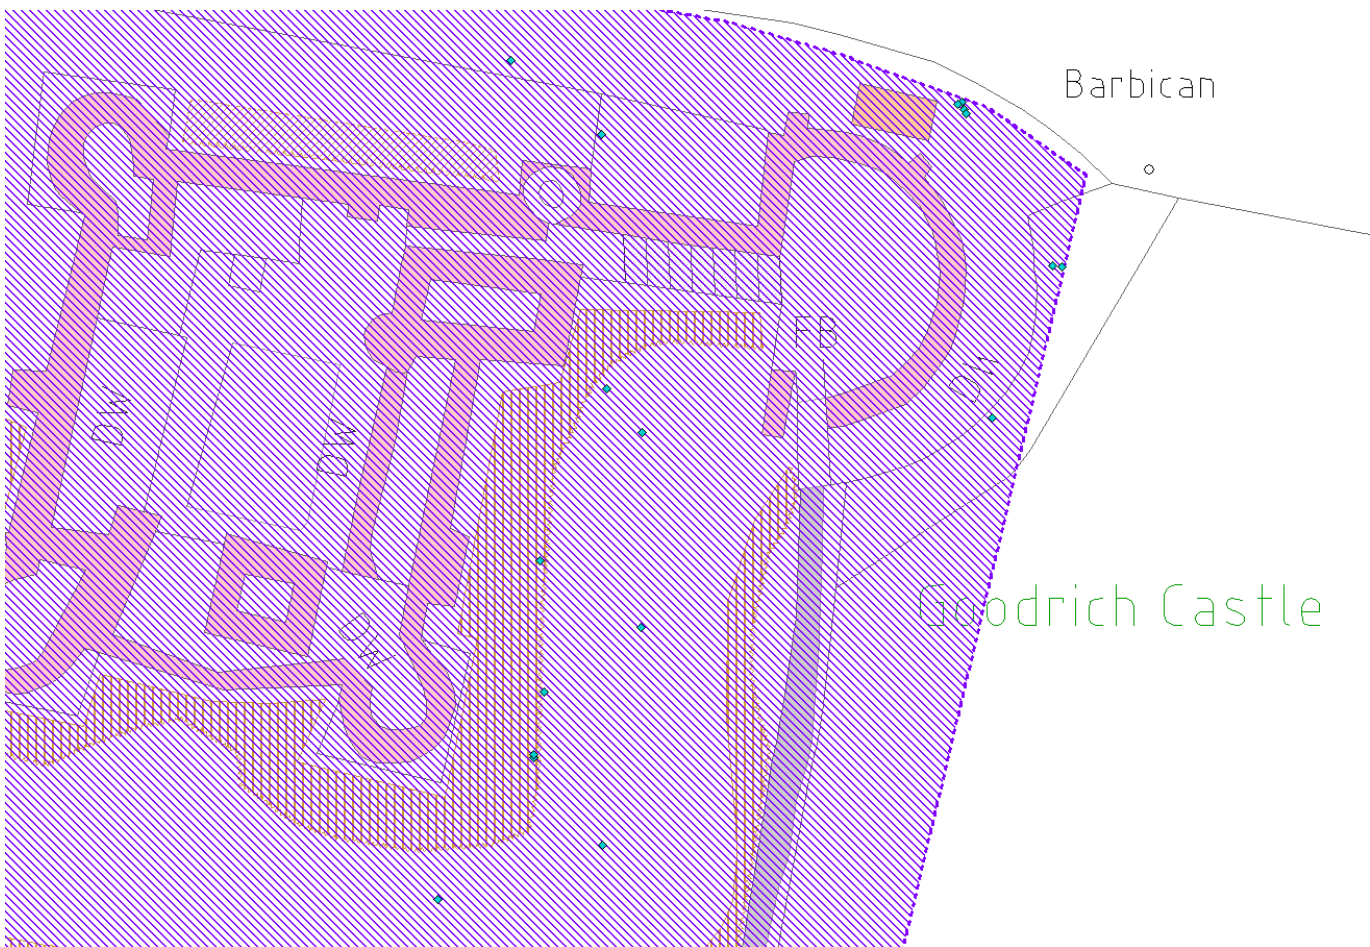
Figure 3: Location of metal detecting disturbances in relation to the Scheduled Area. (Scheduled Area is cross hatched in blue).

Figure 3 locates the eighteen areas of disturbance / damage in relation to the mapped area designated as a Scheduled Ancient Monument.

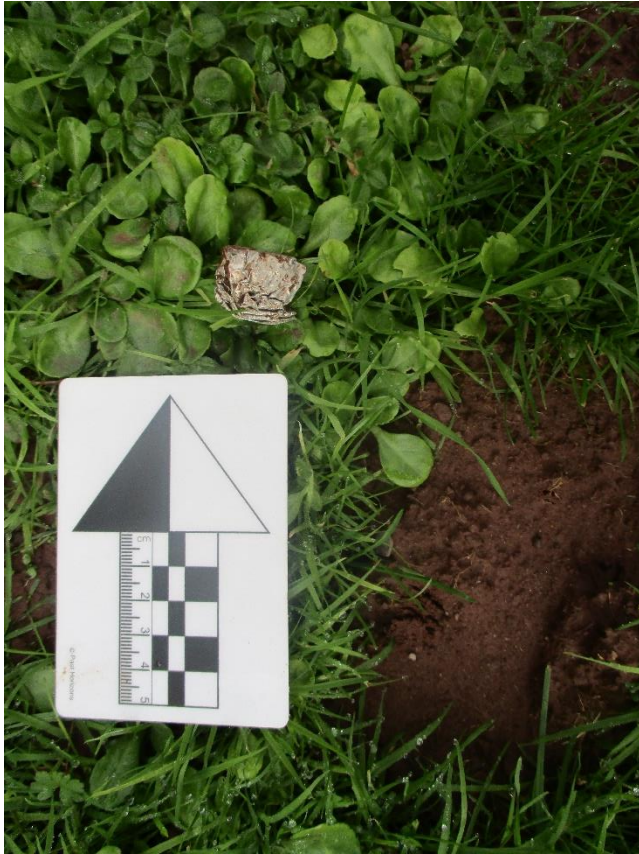
MD009B (detail showing silver foil)

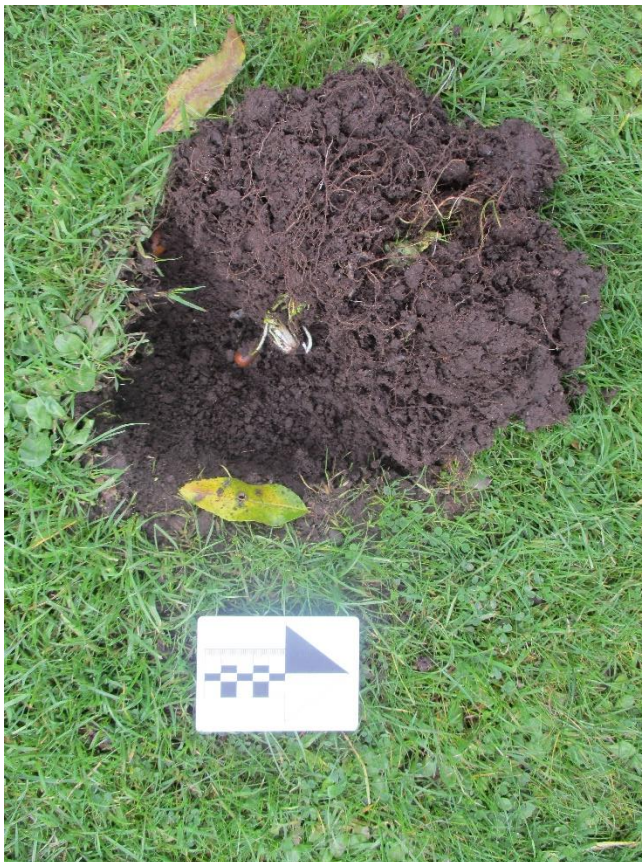
MD010 Turf lifted

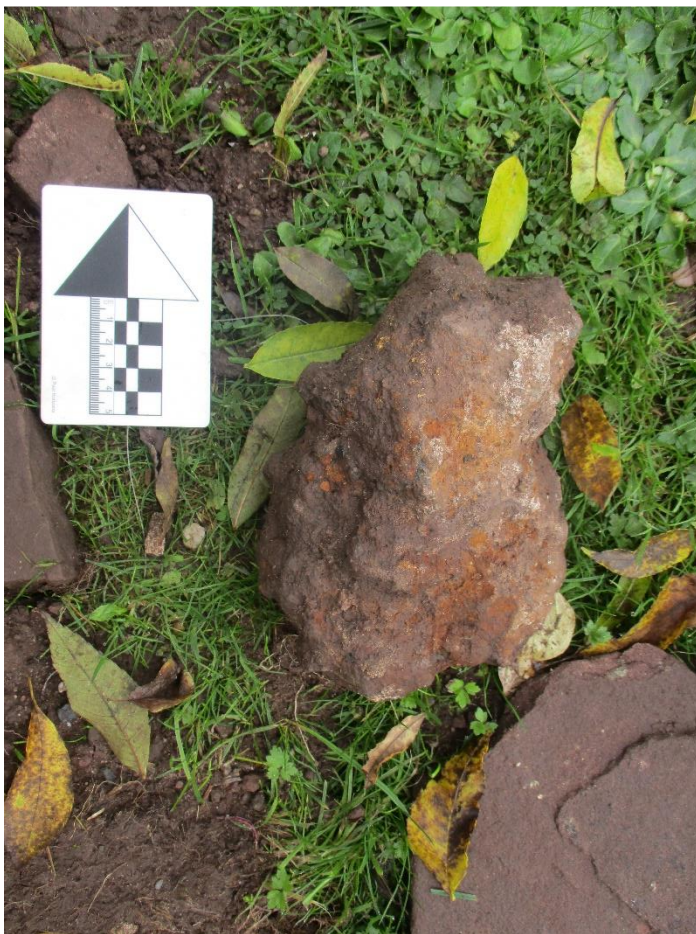
MD011 Iron Ore

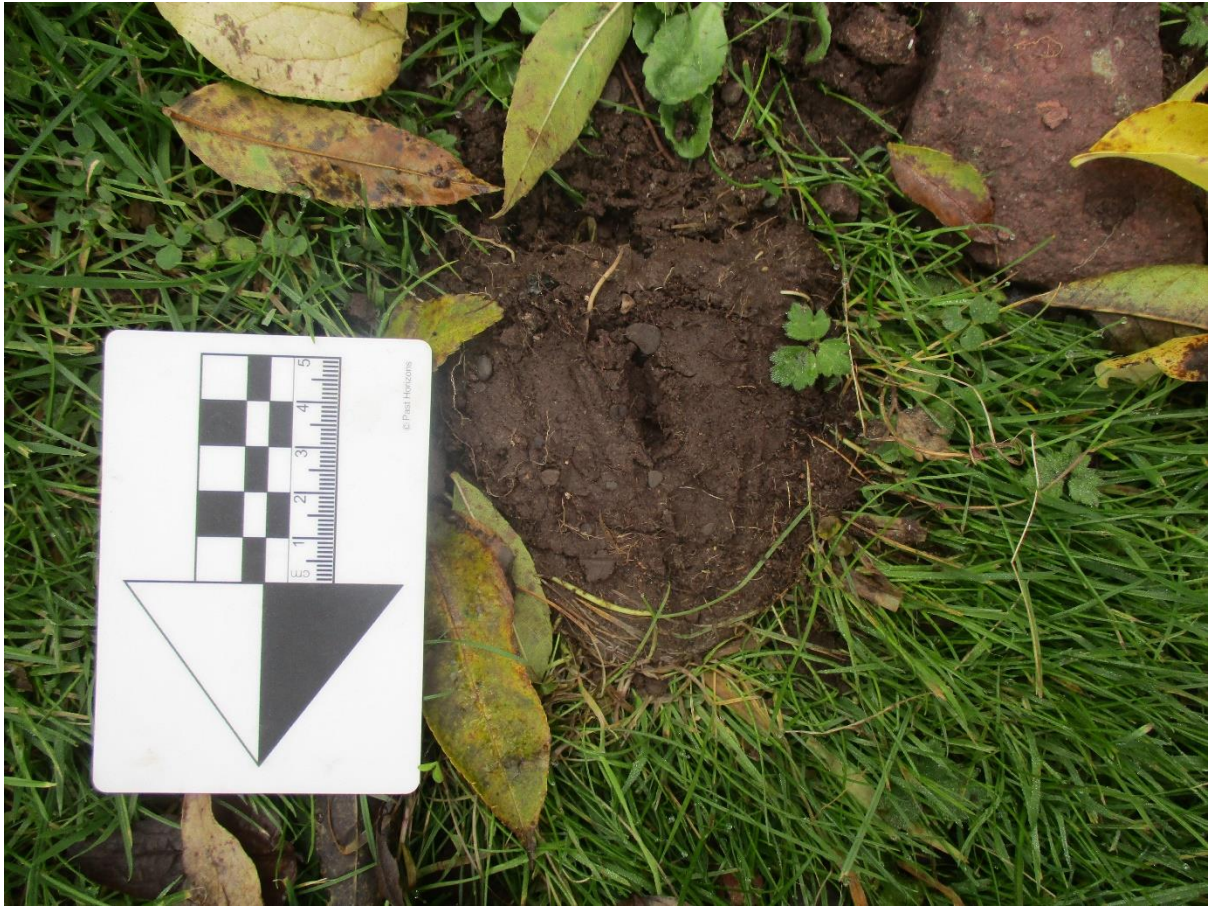
MD011 Footprint
