DB 7/2/8

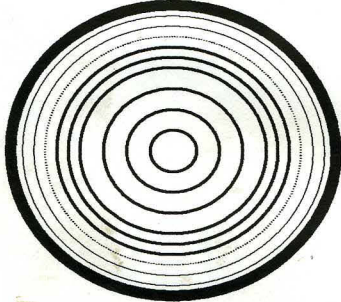
Cow Tag 109		Function Code S 5.2A
Brief Description: [timber element, p/s, condition, fragments] GOOD CONDITION, TRUNCATED AT AFT END		
Notable Features: [tool marks, scribed lines, decoration, repairs] POINTS TO LOOK OUT FOR WHEN RECORDING ufos INSIDE:- 1 LINE, VERTICAL, ACROSS MIDDLE OF PLANK C. 40cm FROM AFT END. Type 3 (←) to crack at forward end. Outboard: Dimples on tree nails.		
Wood Science: [rings, ARW, knots, sapwood, conversion] Radial - 804. Pith beyond upper edge? ARW = 185/80.

Recommended action: [samples, additional photos, moulding, queries and problems] Thickness problem with lower forward edge of plank. Drawing is thicker than actual plank... very thin scarf. Plank 1-2 mm thick. Drawing 10 mm thick.		
Cleaned: LB/BJ/VT 30/05/06	Recorded: TNJ 14.06.06	Photos:
Checked: [corrections needed] ✓	Initials & Date: NN 14/6/6	
Corrections Done [desktop, Faro Arm?]:	Initials & Date:
