Cow Tag **001** Function Code **Beam**

Brief Description: [timber element, p/s, condition, fragments]
Original Wood # 106a Part of 001/002/003
OAZ Beam + Knee Complex

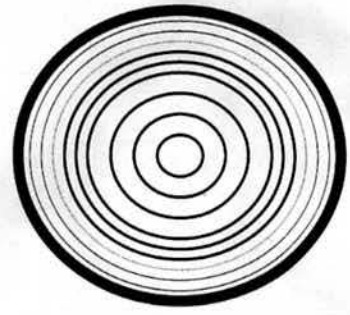
Notable Features: [tool marks, scribed lines, decoration, repairs] POINTS TO LOOK OUT FOR WHEN RECORDING
2 Iron Bolts - Corroded Heads - One recessed
Iron spike Nails - ~~Recessed~~ "outboard"
Hacked w/ axe on end in antiquity
Rebate on 'out'/'o' faces
Two large pieces missing → possibly find a match in the dried out timbers?

Dried out timber - numerous surface cracks, some warping + deep cracks
