Cow Tag 222		Function Code P 6.4
Brief Description: [timber element, p/s, condition, fragments] <i>planking (portside), good condition, lower edge consists of 0.02m thick (unde) sapwood along entire plank. some damage (saw marks) at 0.45m forward of aft edge and at 1m aft of forward edge.</i>		
Notable Features: [tool marks, scribed lines, decoration, repairs] POINTS TO LOOK OUT FOR WHEN RECORDING ufos <i>Lower edge: 2 repair nails, 0.42 &amp; 0.52m forward of aft edge, both with visible imprints of nail heads.          iB: Add. nail in sapwood, next to scarf 0.38m forward of aft edge.          Add. nails on face of plank at 0.40m and 0.60m forward of aft edge.          2 in situ wooden pegs (additional) at 0.06m and 1.86m, both go through.          Double wooden pegs all along. 2 circular features that seem to cut square cut features at 0.40m forward of aft edge. Between these, an axe mark cutting a small rectangular feature (1cm-0.5cm). Inscribed lines, one def. "diamond" at 1.45m aft of forward edge, also at 1.55m aft of forward edge, 3 inscribed lines from wooden peg and down towards sapwood, possibly fourth line at 1.65m aft of forward edge. Small holes, poss. insect disturban

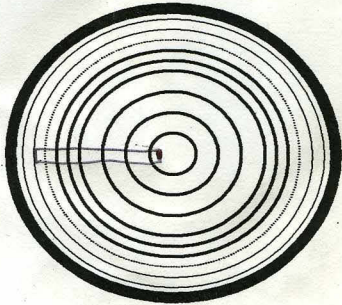
Goes under rove

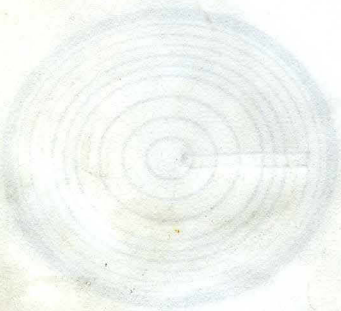
Number double treenail

Part of well core

This could  
be incomplete  
- angle hole  
- ancient?  
modern?

incomplete angle hole  
of P 6.3  
- nothing seen on P 6.3 off scarf.
