Cow Tag 223		Function Code 54.3
Brief Description: [timber element, p/s, condition, fragments] VERY WELL PRESERVED PLANK		
Notable Features: [tool marks, scribed lines, decoration, repairs] POINTS TO LOOK OUT FOR WHEN RECORDING ufos 2 PLUGGED HOLES FORW. OF AFT END (UPPER + LOWER EDGE) 1 PLUGGED HOLE FORW. OF AFT END (UPPER EDGE) 2 ADDITIONAL NAILS FORW. OF AFTEND, RIGHT NEXT TO AFT-EDGE OF PLANK ✓ 2 ADDITIONAL NAILS AFT OF FORW. END (^{found} OUTBD. SCARF) ✓ LOWER EDGE OF PLANK HAS GOT A STEP

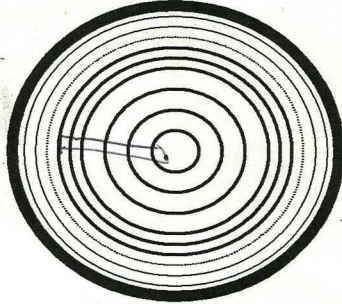
Heavy wear upper inner edge.		
Wood Science: [rings, ARW, knots, sapwood, conversion] Radial at aft scarf c 120H ARW=225/120. Pth beyond lower edge.

Recommended action: [samples, additional photos, moulding, queries and problems] NOTE: THE DRAWING SHOWS THE PLANK THICKER THAN IT IS, IN THE AFTER-UPPER CORNER (DRAWING - THICKNESS: 7mm; PLANK - THICKNESS: 7.5mm) ^{ACTUALLY} _{ACTUAL} - need to experiment with hand to detect this? NN.
