DB 19/2/8

237 S4_1 Vassilis Tsakiris 15 May 2006

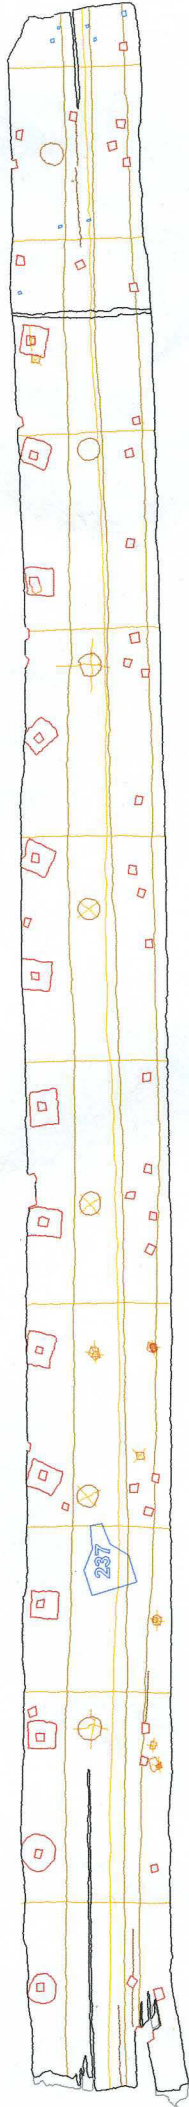
Cow Tag 237		Function Code 54.1
Brief Description: [timber element, p/s, condition, fragments] WELL PRESERVED PLANK, DAMAGED ON FORW. END		
Notable Features: [tool marks, scribed lines, decoration, repairs] POINTS TO LOOK OUT FOR WHEN RECORDING ufos		
<p>Type 2</p> <p>6 INSCRIBED LINES OUTBD. FACE, AFT OF FORW. END 3 ROVES ON LOWER EDGE OF OUTBD. FACE 1 WOODEN SPIKE, UPPER EDGE, OUTBD., FORW. OF AFTEND SEVERAL ADDITIONAL NAILS FORW. OF AFT END 3 PLUGGED HOLES, LOWER EDGE, AFT OF FORW. END 2 Nail heads on inboard face, upper edge, " " "</p> <p>Type 3 damaged</p>		
Wood Science: [rings, ARW, knots, sapwood, conversion]		
<p>c85H. Tangential at aft scarf. → near radial at damaged forward end. ARW = 190/85</p>

Recommended action: [samples, additional photos, moulding, queries and problems]		
<p>PHOTOS of outboard as indicated on plot</p>		
Cleaned:	Recorded:	Photos:
