DB 19/2/8

Cow Tag 238 Function Code 52.1

This plank have two fragments 238 52.1a and 238 52.1b

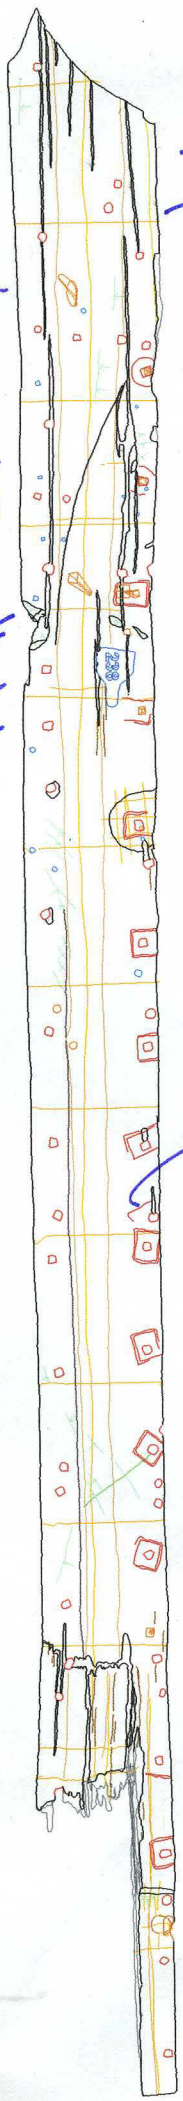
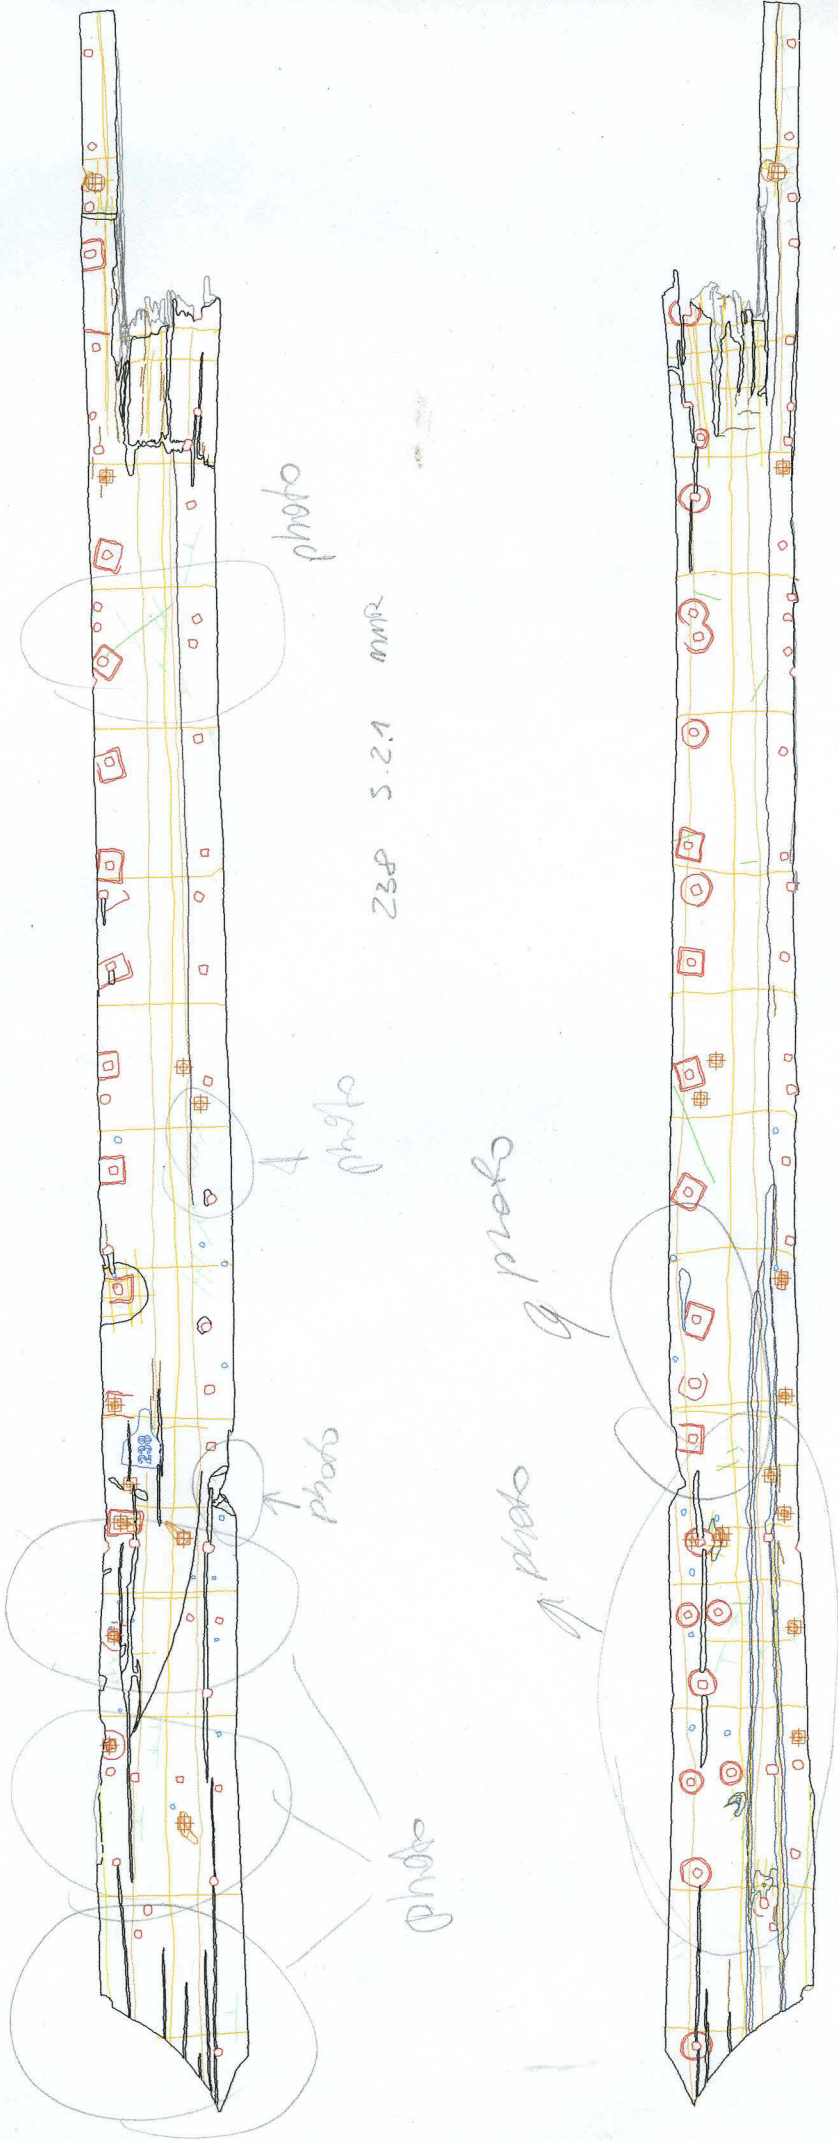
238 S2\_14 Monika Melzer-Richter 30.09.2005

Brief Description: [timber element, p/s, condition, fragments]  
DAMAGED GENERALLY GOOD CONDITION, HOWEVER BADLY DAMAGED BY CONCRETE POST (?) ON THE AFT END. END OF THE PLANK - BOW SITE - IS CURVED \* MANY CRACKS WHICH HAVE BEEN FILLED WITH COULMING MATERIAL (ANIMAL HAIR & PLANT MATERIAL) OUTBOARD FACE →

REMAINED WOODEN NAILS, SOME <sup>IMBEDDED</sup> WITH 45° ANGLE PLANK LACKING TREENAILS / EX: ONE ON THE AFT END  
OUTBOARD FACE - LOOK LIKE HAVE 2 LANDS (?)  
INBOARD: MANY TOOL MARKS - MOSTLY <sup>ON</sup> UNDER SCARP + INSCRIBED LINE

HOOD END 7 ROVES ON OUTBOARD ~~lower~~ edge

wooden nail?  
 Fe small nail?  
 smaller iron nails.  
 irregular rows? and pairs?

Only Fe nail

DENDRO BUT prime sample location in sensitive area close to hood end.
