DB 19/2/8

271 823_4 Angeln Karsten 04 August 2006

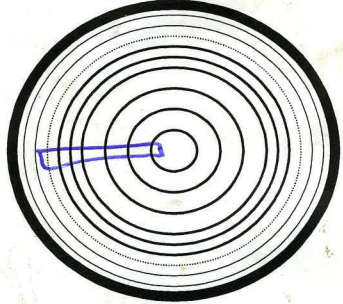
Cow Tag 271	Function Code S 23 4	
Brief Description: [timber element, p/s, condition, fragments] <p>THIS IS LOWER HALF</p> <p>edge of plank missing - covering in all of cracks, lots of wooden plugs</p>		
Notable Features: [tool marks, scribed lines, decoration, repairs] POINTS TO LOOK OUT FOR WHEN RECORDING ufos <p>INS. LINE 10cm off of cow tag</p> <p>" " 15cm for " "</p> <p>" " 70cm " "</p> <p>" " 1.5m off of for edge</p> <p>" " 5m off of and T.N from for edge</p> <p>Type ③ Line off of Forw. end</p> <p>Out. Att out - tool marks across whole s. de 3 additional nails approx 1m aft of forward edge cooking on fracture that runs whole length on upper edge - POSSIBLE "STAPLE-MARK" - ADD. NAIL-HOLES FILLED WITH CAULKING → NO CORROSION PRODUCTS</p> <p>ASSOCIATED TINGLE: 272</p>		
Wood Science: [rings, ARW, knots, sapwood, conversion] <p>NB. This ring cut etc applies to 271 + 1713 combined</p> <p>Radial. Pith uncertain as no clear growth trend. c75H</p> <p>ARW =</p>

Recommended action: [samples, additional photos, moulding, queries and problems] <p>- NICE NICE FACETTES + TOOL SIGNATURES OUTBD. → <u>MOULDING</u></p> <p>- TOOL SIGNATURES ARE VERY DIFFERENT TO THE ONES ON PLANKS ⇒ USE OF DIFF. TOOL (e.g.: AD2E)</p>		
Cleaned: ms/vi 3/10/6	Recorded: 04.08.06 AK	Photos:
Checked: [corrections needed] ✓		Initials & Date: NN 16/8/6
Corrections Done [desktop, Faro Arm?]:		Initials & Date:
