Oak, Orig runber 214, Disabel 11/5/10

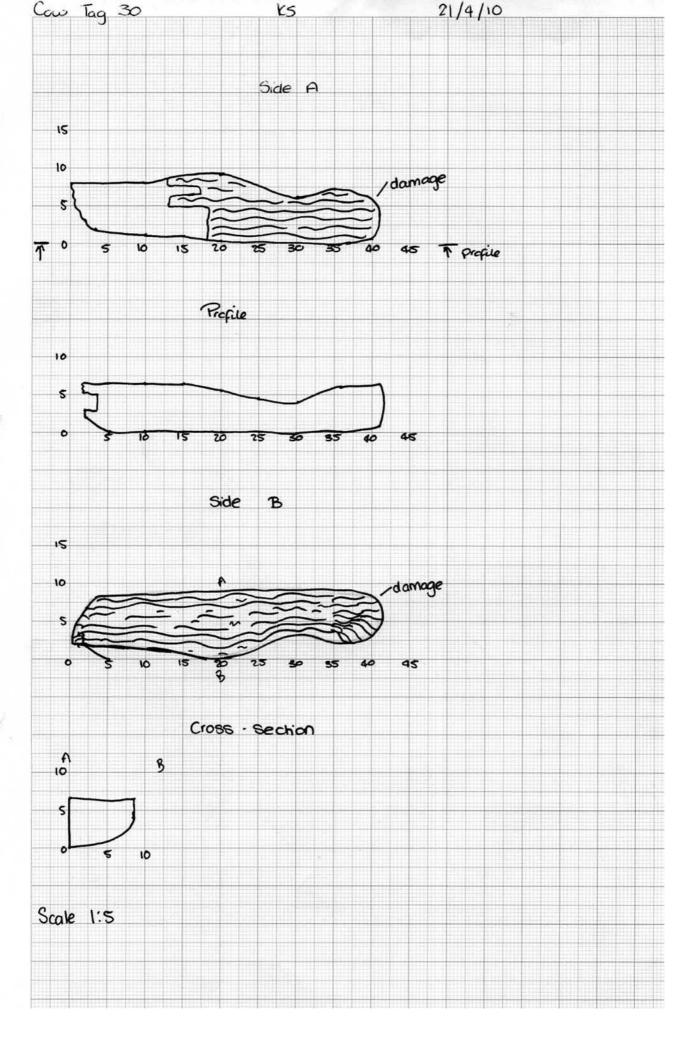
Cow Tag 30		Type function unknown Resside Pesr.	
Description		result rest.	al
length 42cm width	8.5cm depth bom	38 19/05/2	•
Colour.		The surface has parches of 10	Sr
Side A is very cracked a damaged Surface is ?	nd damaged. Possible 8 cm long.	aliginal surface has been remove	d.
Side B's suiface is ve	ry damaged, possibly	no original Surface Left.	
No visable treenail ho	ios or metal houss	ner fasteness.	
Wood Science:	very bod Surface clama	age.	
Bart Van (1)	9		
Bark Yes (No)			
Sapwood Yes No	*

•			
52			
Knotty Yes No			
Knotty Yes No			18
Knotty Yes No			16
Knotty Yes No	mples, additional photos	s, moulding, queries and problems]	16
Knotty Yes No	mples, additional photos	s, moulding, queries and problems]	16
Knotty Yes No	mples, additional photos	s, moulding, queries and problems]	18
Knotty Yes No	mples, additional photos	s, moulding, queries and problems]	H
Knotty Yes No	mples, additional photos	s, moulding, queries and problems]	14
Knotty Yes No	mples, additional photos	s, moulding, queries and problems]	
Knotty Yes No	mples, additional photos	s, moulding, queries and problems]	
Knotty Yes No Straight grained Yes No Recommended action: [sar		s, moulding, queries and problems]	
Knotty Yes No Straight grained Yes No Recommended action: [sar		s, moulding, queries and problems]	
Knotty Yes No Straight grained Yes No Recommended action: [sar		s, moulding, queries and problems]	
Knotty Yes No Straight grained Yes No Recommended action: [sar	ded]
