Cow Tag	313	Function Code	523.3
---------	-----	---------------	-------

313 S23_3 Yardeni Vorst 18 August 2006

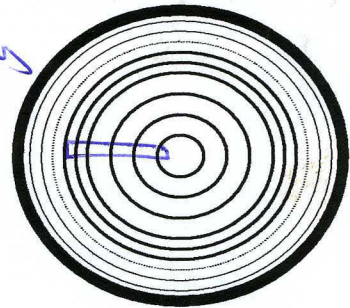
Radial 100% ARW 2:15. Slightly wavy grain. Pith beyond upper edge in growth trend.

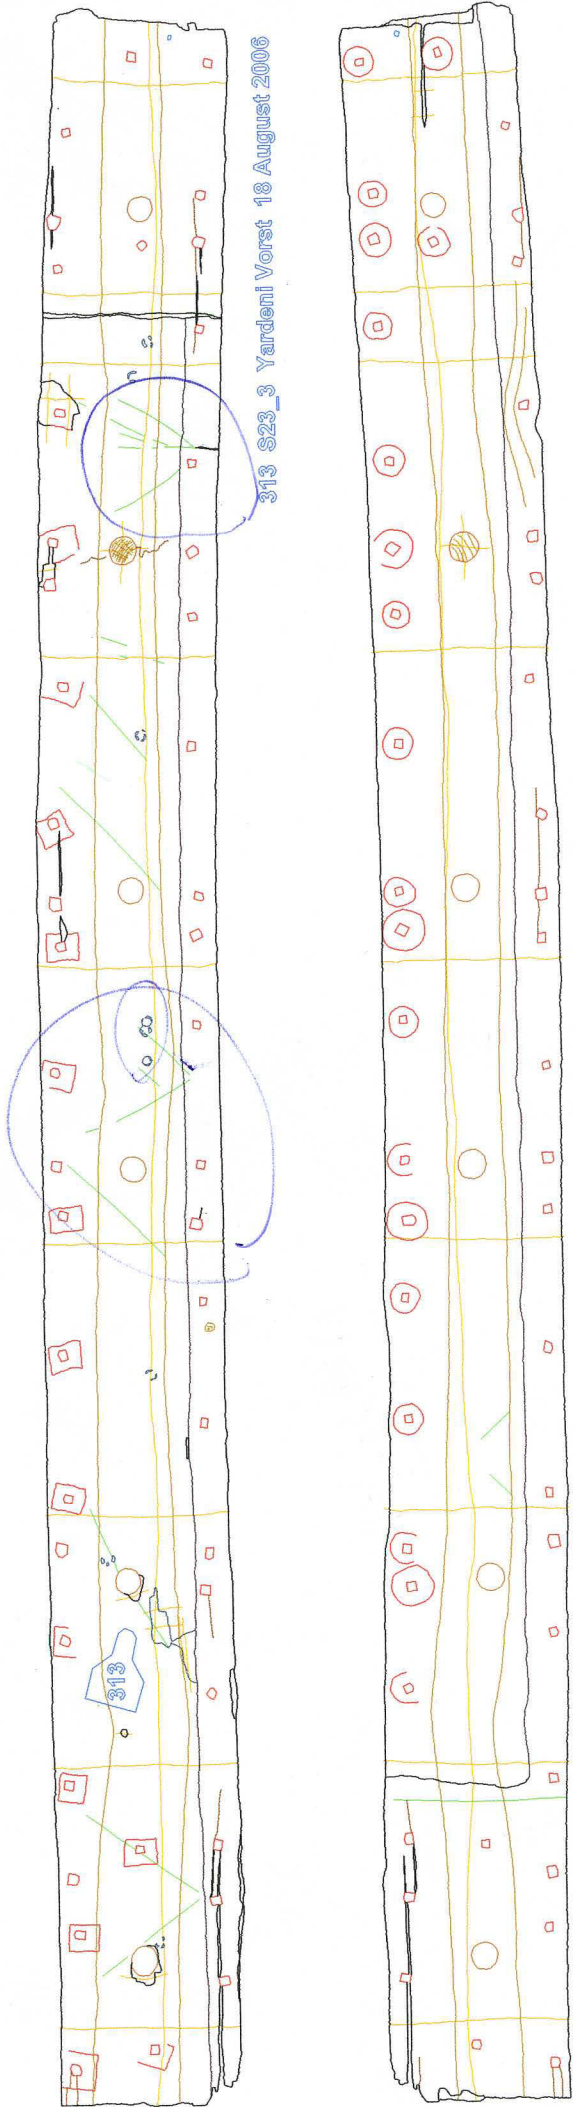
INBOARD:- Type 1 lines, also non converging lines, c 1m from aft end

outboard:- line med for of for scarf line - see plot. possible line for of aft T.N from aft end

inboard:- 8 clamp marks. (Between 3rd & 4th keel nail it looks like the clamp has been moved because two of them overlap!)
 - between 2nd & 3rd keel nail wide rectangular deep hole on edge of land. (as limits)
 - type 2 lines near scarf: there's always a vertical line going down to the small step on the land. (seen on other planks)

Photos of 'step' on land for scarf on S22 and associated inscribed lines. Other inscribed lines and clamp marks.
