Cow Tag 314	Function Code S18.5 S18,5	
Brief Description: [timber element, p/s, condition, fragments] Very tough corrosion. Bendy/crivy plank otherwise solid.		
Notable Features: [tool marks, scribed lines, decoration, repairs] POINTS TO LOOK OUT FOR WHEN RECORDING ufos IB several lines Type 1, some vague. OB, Type 3, vague - just aft of scarf (crack end) > 3 in a row Lines diagonal (toolmarks) / / / just on edge of scarf. several lines Type 1 scraper, parallel with land, 1m. aft of scarf. forward: < shape, crack of edge and on other side of 1st nail head in the middle of face. several lines around large crack alternate large # small nail heads, OB Add. nail, 0.20m forw. of aft edge (see other side →)		
Wood Science: [rings, ARW, knots, sapwood, conversion] Radial = 70H+5S. Pith beyond upper edge ARW = 230/75

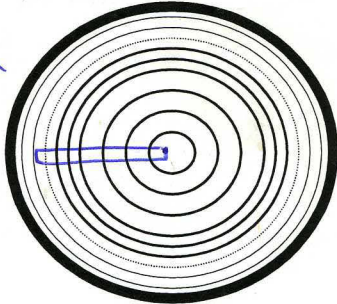
- Inboard: - type 2 lines (well, everything else which isn't type 2, 3, 4)
- small step on land
 - big knot

Outboard: - forward end type 2 diamond → the crack has caulking material in it! 2526 sample nr.

- possible type 2 lines (grouped) on aft end of plank

- crack at aft end caulked sample nr 2527
