Cow Tag 035 Type plank fragment

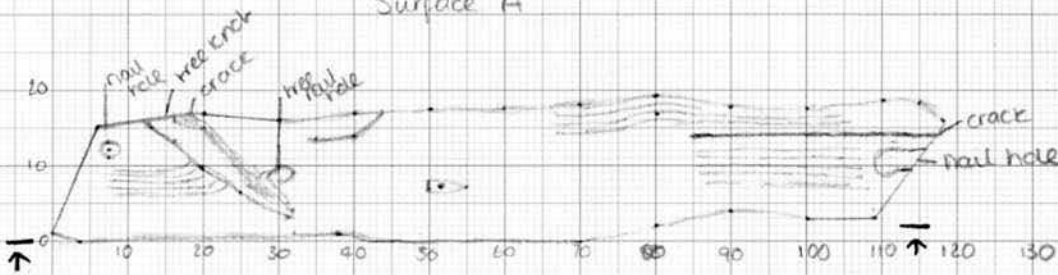
Surface A

Description
length 117cm
width 18cm
depth 4cm
Side A has a metal nail hole, the head impression is 3cm in diameter, shaft is 1.4cm in diameter. Crack runs diagonally 22cm in length, runs through treenail hole. Nail is not present. treenail hole is 3cm in diameter.
Another metal nail hole is present which has been discoloured by the nail. The nail head impression is 3.7cm in diameter and the shaft is 1.5cm in diameter.
Section of original damage which may have been caused during the creation of the ship. Crack 30.5cm in length alongside the second nail hole.
Side B has the bottom section of the nail shaft 1cm in diameter. The diagonal crack is 14.6cm in length and 2cm wide in the centre. The treenail hole is 3.5cm in diameter. The second metal nail shaft is 1.4cm in diameter. Side B is very cracked. There is a small hole located in the centre of the timber 8.1cm in diameter on side B and 1cm on side A, on side A located in a groove 4.5cm long.

Recommended action: [samples, additional photos, moulding, queries and problems]
Must be sawn with number of large knots.
Nail heads related with square shafts.
DISCARDED Possible wood end??
