DB 11/3/8

Cow Tag 383 Function Code P79A

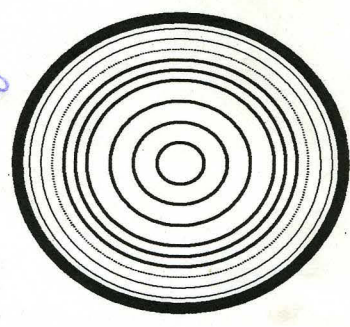
Brief Description: [timber element, p/s, condition, fragments]
section of Plank fairly good condition
Bow end of Plank - Forward scarf, damaged aft.

Notable Features: [tool marks, scribed lines, decoration, repairs] POINTS TO LOOK OUT FOR WHEN RECORDING ufos
Tool marks (possible) on out board side near on land edge and scarf - Diagonal
possible scribed line Aft of Forward edge on inboard running through treenail hole

Wood Science: [rings, ARW, knots, sapwood, conversion]
Radial. ~ 60H ARW = 205/60
Pith uncertain

Recommended action: [samples, additional photos, moulding, queries and problems]
Add additional nail inboard upper edge?
