Cow Tag 003 Function Code Beam

Brief Description: [timber element, p/s, condition, fragments]  
 Original Wood # 1064 OA3  
Dried out crossbeam - was attached to standing knee complex

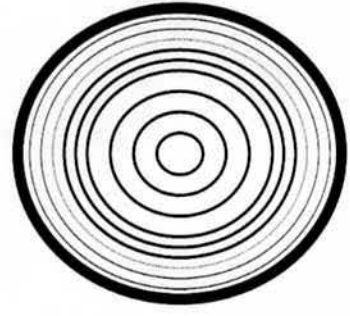
Large cracks and splits - Difficult to discern edges in certain areas.  
- Original edges are notional in places.  
idealised  
Iron Bolts  
Treenails  
Blind Treenail on outboard face?  
5 additional spike nails on 'O' face  
2 pairs seem to be related - similar depths + spacings along a line.  
Bevel on edge of O/Inboard face  
Chamber  
1 End cut on site for dendro analysis  
1 End hacked off in antiquity w/ axe.

Interesting 'Tab' on Iron Bolt Head  
Rebates - Inboard/x face, Out face,

Laser Scan Axe marks on end of crossbeam
