Cow Tag 471	Function Code P3.4	
Brief Description: [timber element, p/s, condition, fragments] VERY WELL PRESERVED PLANK		
Notable Features: [tool marks, scribed lines, decoration, repairs] POINTS TO LOOK OUT FOR WHEN RECORDING ufos <ul style="list-style-type: none"> <li>- 5 NOTCHES ON OUTBD. LAND</li> <li>- possible BORER DAMAGE ON INBD. FACE</li> <li>- VERY SIGNIFICANT COMPRESSION MARKS FROM FRAMES</li> </ul> <p>Good stop marks - stop on aft scarf. Short, but clean stop mark with signature on forward scarf.</p>		
Wood Science: [rings, ARW, knots, sapwood, conversion]  66H ARW = 210/66 Near radial, quite fast growth centre beyond lower edge. <del>short but</del>

411 P3\_4 Monika Maliszka-Richta 20.10.2005

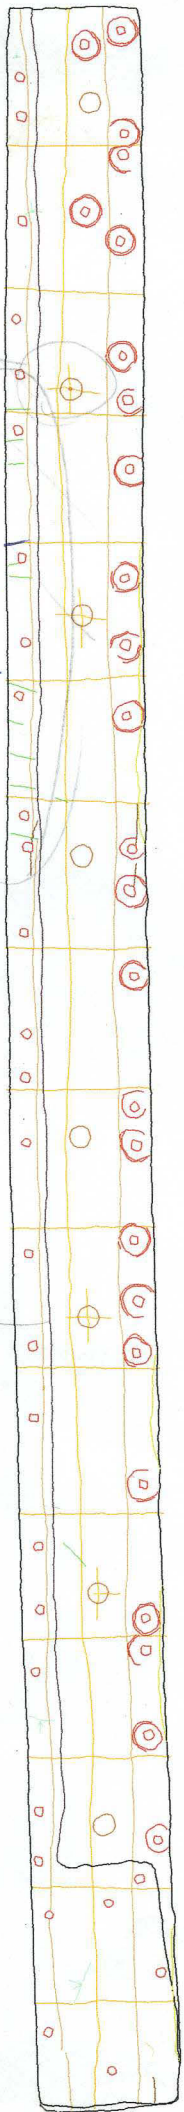
open  
five scored  
lines, less  
clear.

deeper under  
c. 2mm under 1mm deep  
'Kraipen'.

open

ring?  
hole?

modern  
damage / wear?

level of wood continues.
