Cow Tag	1118 415	Function Code	P6.7
---------	---------------------	---------------	------

Brief Description: [timber element, p/s, condition, fragments]
 portside plank, fairly knotty, both aft and forward edge thin, aft edge = 2 splits, otherwise good condition.

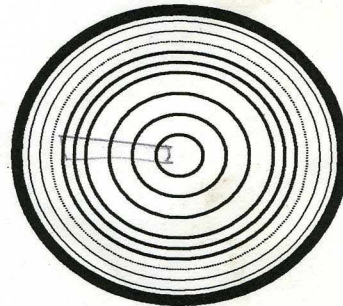
Numerous pin knots Radial
 c80 H. Pith beyond lower edge
 ARW = 190/80
