Cow Tag

48

ship component - plank

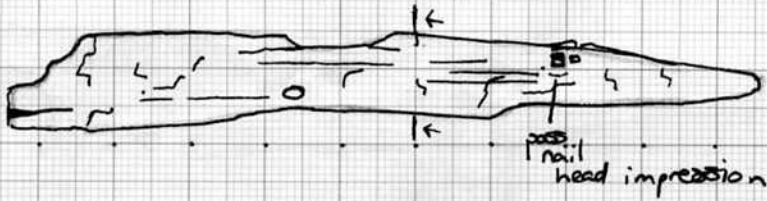
Description One metre long plank fragment, 14cm wide, 3cm thick. Three iron nail fasteners → Two holes and one nail shaft remain. Nail has been driven into the edge of the plank. Other two driven through the thickness of the plank. One treenail hole, oval in shape (possibly due to dried out wood) 3cm in diameter. One surface has covering of what appears to be animal hair. This may be the area of overlap - inboard, bottom edge. Approx 5cm wide. does appear to taper in thickness towards the bottom edge from 3.5cm to 1.5cm. No visible tool marks. Nail holes 1cm x 1cm. Nail driven into edge is small, measuring 0.6cm x 0.6cm. SURFACES are extremely dry and cracked
