Cow Tag 52 Type PLANK FRAGMENT?
purpose unknown

COW TAG S2 EMC 1414/10

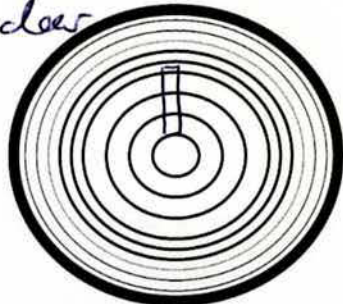
Description Poor condition, dried timber, modern damage,
possibly from excavation, throughout. One metal fastener, nail no
longer in situ. shaft measures approx 1.5cm x 1cm (hole is
damaged) Surface is cracked, no evidence of toolmarks. One
partial treenail hole 2.5cm in diameter. Treenail no longer in
situ. Timber itself measures 80cm in length, 12.7 cm wide
and 3.5cm thick. Purpose unknown.

Bark Yes No possibly oak
 Sapwood Yes No tree ring structure unclear
 Knotty Yes No due to condition.
 Straight grained Yes No Appears to be slow
grown.
Approx 50 tree rings.
Radially split

Disceded -
