Cow Tag 54	Type TIMBER FRAGMENT unknown
-------------------	--

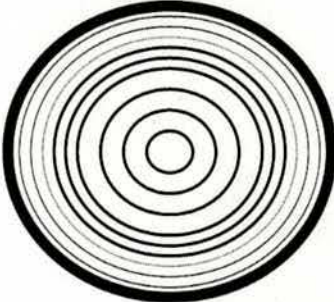
Description
 Length 70cm width 10cm depth 4.5cm
 Side A's Surface is very cracked with one large crack 38cm long. There is also a section of damage. There are a few possible tool marks. Possible treenail distorted by crack approx 3cm in diameter with crack running through. Also distorted by damage to surface.
 Side B has a large crack 42cm long. Has a smaller amount of damage to the surface. Treenail hole is distorted by large crack approx. 3cm in diameter. Slight rust colour within crack. Possible nail hole 1cm in diameter.
 Timber very dry and damaged.
 Original 218.

Wood Science:	approx 28 tree rings. <i>oak</i>

Recommended action: [samples, additional photos, moulding, queries and problems]
Discarded
