Cow Tag 563		Function Code Pd. 5	
Brief Description: [timber element, p/s, condition, fragments] very thick and fairly short plank			
Notable Features: [tool marks, scribed lines, decoration, repairs] POINTS TO LOOK OUT FOR WHEN RECORDING ufos <ul style="list-style-type: none"> - significant bevel on inboard land - <u>straight notches on outboard land</u> - 1 plugged hole 			
Wood Science: [rings, ARW, knots, sapwood, conversion]

563 P2_5 Toby N. Jones 27 August 2005

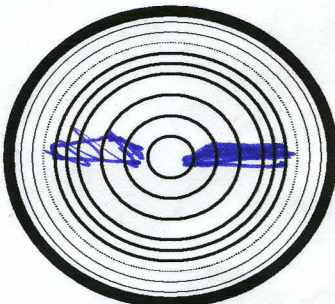
<p>93 H at scarf (off)</p> <p>Radial straight grained. Main inboard face approx in line with med. rays. (see ground)</p> <p>Age band suggests lower edge nearest centre</p> <p>ARW = 2.0</p>			
Recommended action: [samples, additional photos, moulding, queries and problems]			
Cleaned: 25.08.05 AK	Recorded: TNT 27. Aug 2005	Photos: 28/02/06 MMR IN PLUGGED HOLE INS. LINES.	BD
Checked: [corrections needed] Photos of group of scribed lines on outboard land.		Initials & Date: NN 4/10/05

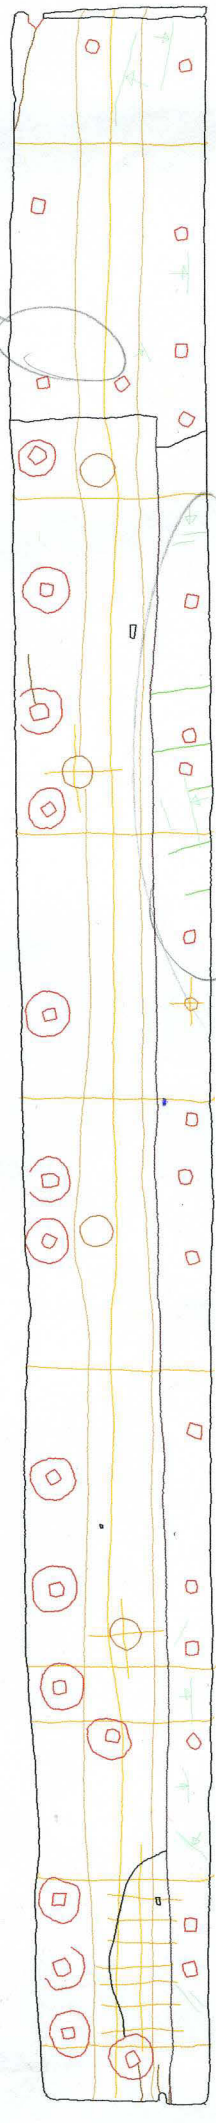
width (~2mm) photo
 scribed lines
 'group of five'
 bracket damage.
