DB 13/318

Cow Tag 570		Function Code 53.1
Brief Description: [timber element, p/s, condition, fragments] DAMAGED ON <del>EITHER</del> ENDS + SEVERAL CRACKS <i>both</i>		
Notable Features: [tool marks, scribed lines, decoration, repairs] POINTS TO LOOK OUT FOR WHEN RECORDING ufos ASSOCIATED OUTBOARD TINGLE: COW 245 (TANK3) 1 ADDITIONAL NAIL ON <sup>UPPER</sup> LAND 1 TREENAIL SEEM TO HAVE HAD A WEDGE, WHICH IS GONE NOW SOME WOODEN SPIKES (2) AT AREA OF TINGLE NICE TOOL MARKS + SIGNATURES ON OUTBD. FACE UNDER TINGLE Incomplete lower forward edge.		
Wood Science: [rings, ARW, knots, sapwood, conversion] Radial at aft scarf (to level). Pith beyond lower edge ~ 70% ARW = 175/70

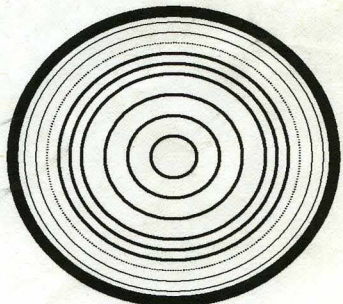
NB: line above land, outboard face = recorded as original damage (=line from tingle)		
Cleaned: 02.02.06 AK MM	Recorded: Demi 12-05-2006	Photos: 1/08/06 VT (cont 12)
Checked: [corrections needed] ✓	Initials & Date: NN 16/5/6	
Corrections Done [desktop, Faro Arm?]:	Initials & Date:

Recommended action: [samples, additional photos, moulding, queries and problems] <del>Not sure if the "saw" marks on the inboard forward end, are ours or theirs? Are they are marks -&gt; than drawn on wrong layer.</del> photos: - - - Round nailheads on inboard, forward end. ✓ 3x stars on nailheads, outboard aft end ✓ Two overlapping nailheads, outboard face, aft end (195) + as indicated on print out photo of tool-marks under tingle, outboard, forward end. ✓
