DB 13/3/8

Cow Tag	571	Function Code	52-5
---------	-----	---------------	------

Brief Description: [timber element, p/s, condition, fragments]
 Very good condition, however aft end damaged

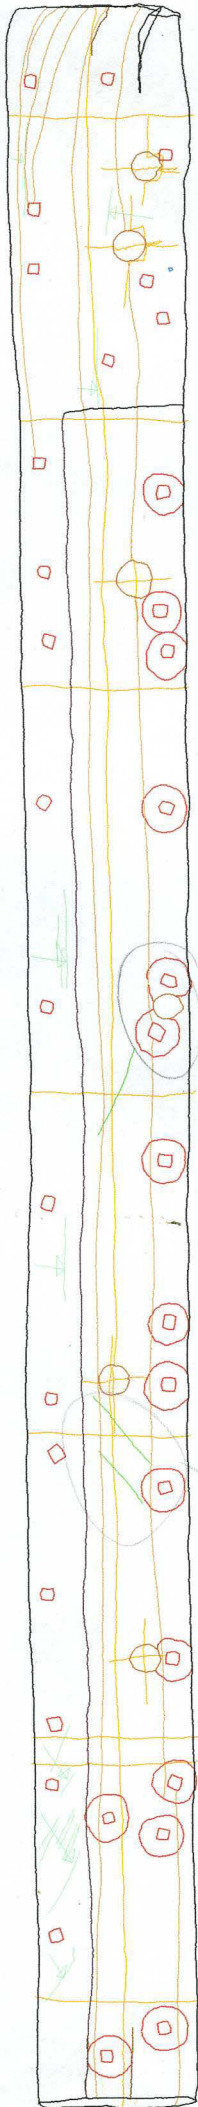
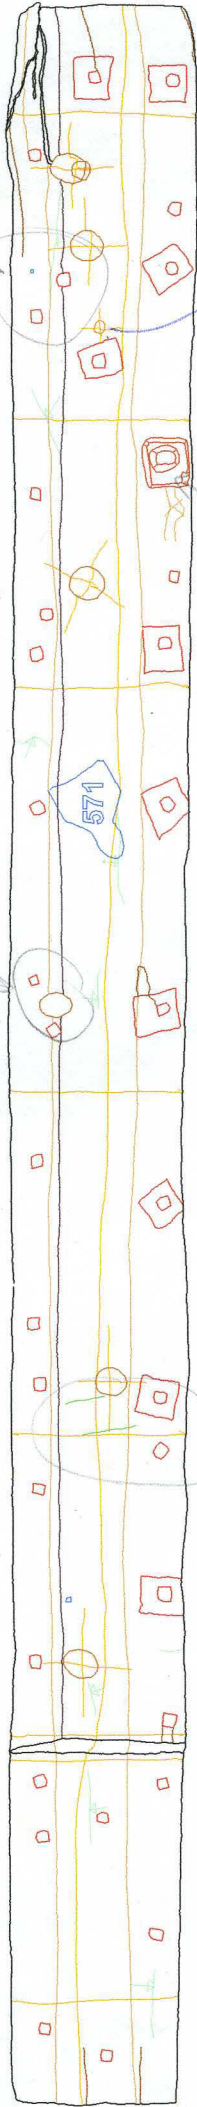
571-22, corner N. 4th St. of 22 N. 4th St. Tolby St. Jones 12.10.08

Inboard Land Strongly beveled, towards aft end there is a concreted rove with nail end. Very small additional nail close to aft end of plank.

Smaller than normal treenail on aft end of plank. - Also on outboard face

Outboard: scribed lines near the middle of the plank.

Radial, c75H, ARW = 170/75.
 Pith beyond upper edge? Straight around except at forward end where grain curves away

Photo of in situ rove
