DB 13/3/8

Cow Tag <b>577</b>		Function Code <b>P2.7</b>	
Brief Description: [timber element, p/s, condition, fragments]			
Notable Features: [tool marks, scribed lines, decoration, repairs] POINTS TO LOOK OUT FOR WHEN RECORDING ufos <b>BLIND</b> - NO TREENAILS, ONLY 1 <del>BLIND</del> TREENAIL HOLE AT FORWARD END / INBOARD FACE <b>+1 dips edge of scarf</b> - 1 PLUGGED HOLE NEXT TO NAIL HOLE OUTBOARD FACE - 2 ADDITIONAL NAILS AT EDGE OF SCARF OUTBD. FACE - 2 BLIND LITTLE NAIL HOLES AT FORW. END / INBD. FACE, 1 on LAND, 1 AT EDGE OF LAND ↳ next to <b>1317</b>			
Wood Science: [rings, ARW, knots, sapwood, conversion]

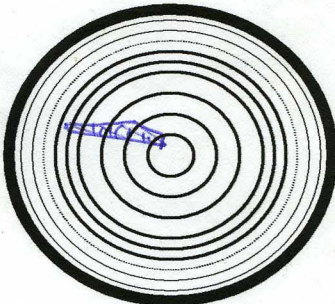
577 8.2.7

<b>c 90H ARW = 140/90</b> Slightly off radial at stop for off scarf (see drawing). lower edge nearest centre Two knotty areas inboard with chip marks.			
Recommended action: [samples, additional photos, moulding, queries and problems]			
Photo blind treenail near forward scarf. Check for <del>plugged</del> plugged nail hole in P3 (see drawing) Photo of 3 deeper scribed lines on lower outboard edge.

3 2mm wide 1mm deep, curved fibre lines, One not recorded.
