Cow Tag <u>586</u>		Function Code <u>53.2</u>
Brief Description: [timber element, p/s, condition, fragments] <u>WELL PRESERVED PLANK</u> <u>SLIGHTLY DAMAGED ON FORW. END</u>		
Notable Features: [tool marks, scribed lines, decoration, repairs] POINTS TO LOOK OUT FOR WHEN RECORDING ufos <u>SMALL ADDITIONAL NAILS ON EITHER END</u> <u>SOME TREENAILS WITH DIMPLES OR CUT-MARKS</u> <u>2 WOODEN SPIKES - LAND INBD.</u> <u>1 BLIND TREENAIL HOLE - INBD. - STRANGE IMPRESSION</u> ✓ <u>NEXT TO IT</u>

586 S3_2 Toby N. Jones 05 February 2006

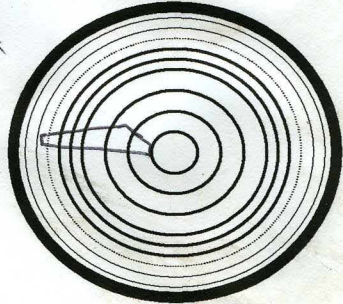
<u>BLIND TREENAIL</u> → IMPRESSION		
<u>SMALL ADDITIONAL NAIL</u>

<u>INBD. SCARF - HAD NO FE - CORROSION PRODUCTS</u>		
Wood Science: [rings, ARW, knots, sapwood, conversion] <u>Supposed radial - straight grained except at forward scarf: P.H. beyond lower edge</u> <u>At step in aft scarf: 86 H + 45. ARW = 195/90</u>

Recommended action: [samples, additional photos, moulding, queries and problems] <u>Photograph central treenail outboard face - perspective + plan view</u> <u>" impression + blind treenail on inboard face</u>
