DB 13/3/8

Cow Tag 590		Function Code 54.8
Brief Description: [timber element, p/s, condition, fragments] WELL PRESERVED PLANK, APART FROM SOME DAMAGE-FORW. OF AFT END		
Notable Features: [tool marks, scribed lines, decoration, repairs] POINTS TO LOOK OUT FOR WHEN RECORDING ufos		
<p>4 ADDITIONAL NAILS AT AFT END (RIGHT BY THE EDGE)</p> <p>2 ADDITIONAL NAILS, AFT OF FORW. END (AFT END OF OUTBD. SCARF)</p> <p>1 PLUGGED HOLE, _____ " _____</p> <p>1 PLUGGED HOLE, FORW. OF AFT END, LOWER EDGE (INBD. SCARF)</p> <p>4. TREENAIL FROM AFT END, HAS SOME KIND OF DIMPLE, INBD. ???</p> <p>- <u>Drilled Out treenail</u> - appears to be under a frame.</p> <p>⇒ 2-3 mm DEFLECTION ON EITHER SIDE ←</p>		
Wood Science: [rings, ARW, knots, sapwood, conversion]		deflection
NA v. clear. Just off radial FOR ARW = 255/70

590 S4_8 Angela Karsten 22 March 2006

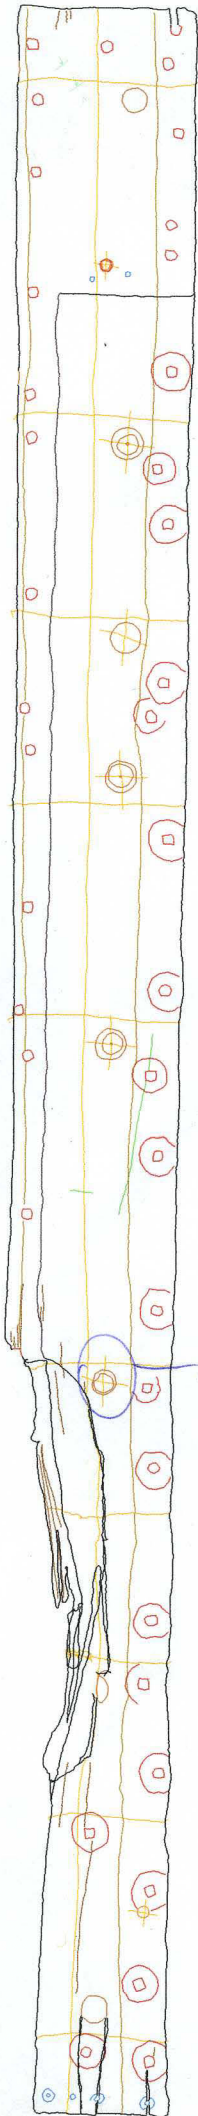
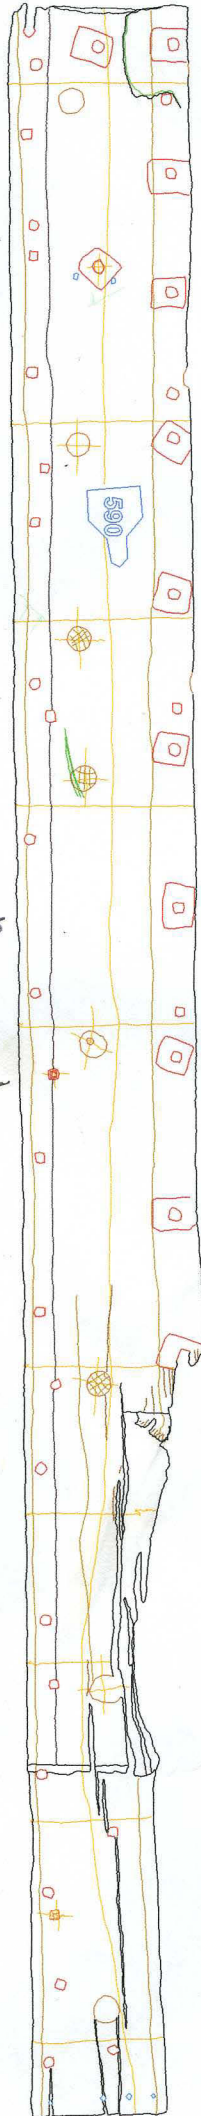
Fe nail removed (mm)
