Cow Tag 005 Type possible beam.

Cow TAG 005 EMC 22/4/10

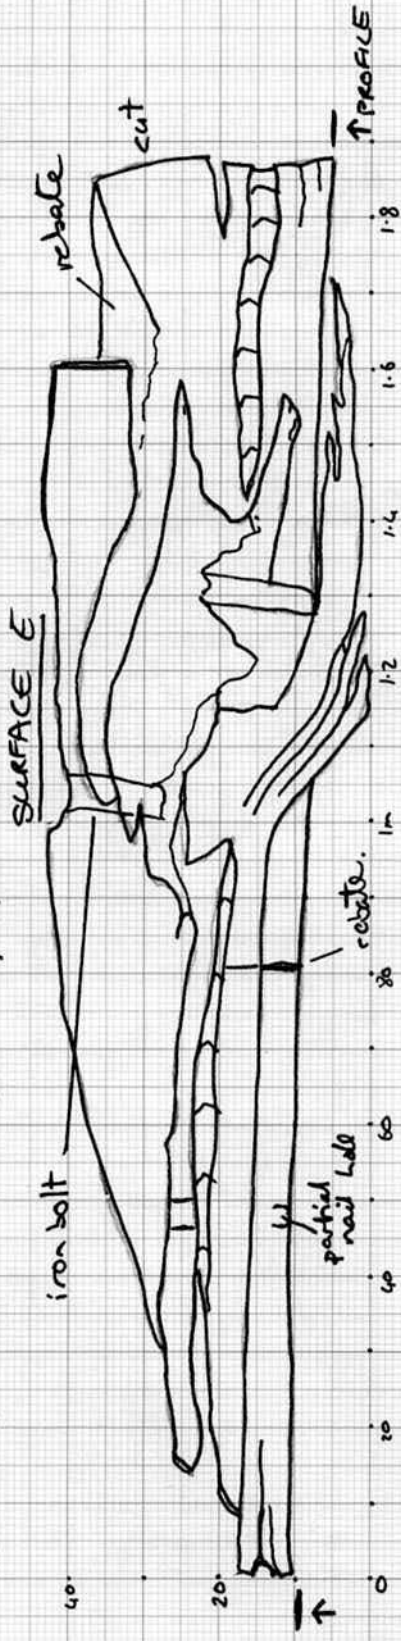
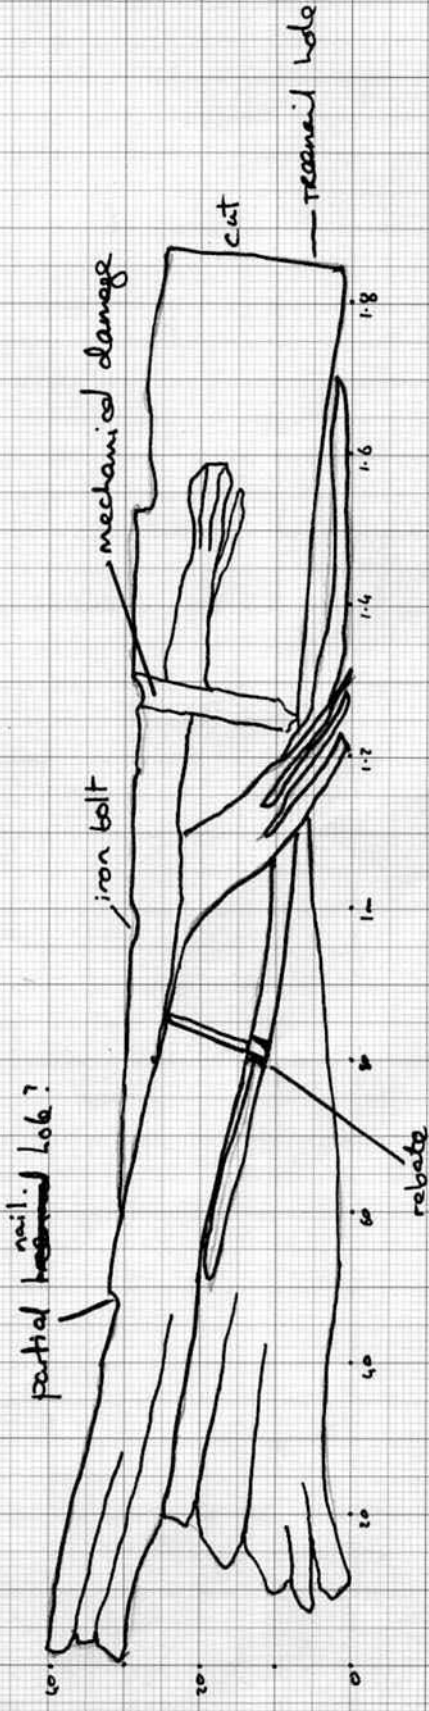
Description 1.86m in length, Approx 37cm wide x 21cm thick. Extremely damaged, possibly by a pile. End 'B' is cut, possibly done on site. Some evidence of fasteners, however all is extremely distorted. One toenail hole, 3.3cm in diameter. One iron bolt partial hole Approx 4cm wide x 22cm in length. Second partial metal fastener 3.3cm in diameter

Another beam element damaged by piling within the ship. End is joint to beam self.

Checked: [corrections needed]  
NN Selective faro-cam record of fastenings & relatives.
