Cow Tag <b>614</b>		Function Code <b>P 15.4</b>
Brief Description: [timber element, p/s, condition, fragments] <b>FAIRLY WELL PRESERVED PLANK, BUT FRAGILE DUE TO DENDRO SAMPLE TAKEN A CENTRE</b>		
Notable Features: [tool marks, scribed lines, decoration, repairs] POINTS TO LOOK OUT FOR WHEN RECORDING ufos <ul style="list-style-type: none"> <li>* INBOARD * ON THE <b>BOU</b> SIDE OF THE PLANK - <sup>BLIND</sup> <del>BLIND</del> TREEMARK</li> <li>* ON THE <b>AFT</b> SIDE END ADDITIONAL NAILS</li> <li>* INSCRIBED LINES - ON THE <b>BOU</b> SIDE</li> <li style="padding-left: 150px;">- ON THE <b>AFT</b> SIDE → X</li> </ul> <p><u>OUTBOARD</u>: - INSCRIBED LINES TOWARDS AFT END</p>		
Wood Science: [rings, ARW, knots, sapwood, conversion]

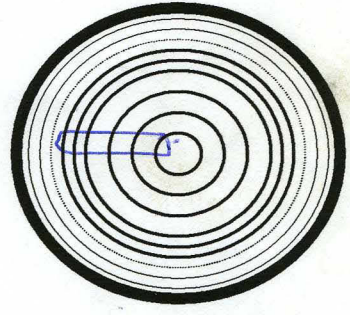
<p>Radial c 80 H ARW = 230/80.          Sampled for dendro during excavations          - need to</p>		
Recommended action: [samples, additional photos, moulding, queries and problems]

<p>Check for delts (NN) - find and return sample.</p>		
Cleaned:	Recorded:	Photos: 11/01/06 mm <sup>D</sup>
TNJ, AK, MM 09.11.05	TNJ 09.11.05	IN: INS. LINES + ADD NAILS OUT: INS. LINES + ADD NAILS + DOUBLE NAILS + TOOL SIGNATURE
Checked: [corrections needed]		Initials & Date:
Corrections Done [desktop, Faro Arm?]:		Initials & Date:
