Cow Tag 630 Function Code F 20.3

Brief Description: [timber element, p/s, condition, fragments]  
FRAME DAMAGED ON BOTH ENDS; 1 SIDE VERY FIBROUS

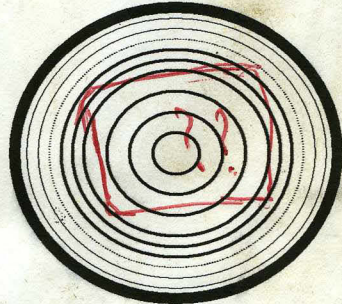
Notable Features: [tool marks, scribed lines, decoration, repairs] POINTS TO LOOK OUT FOR WHEN RECORDING ufos  
CENTRE TREENAIL HAS STRAIGHT CUT-LINE AT THE TOP → LATHE? ALSO CHECK TOPS OF TREENAILS, THERE ARE WEIRD MARKS / IMPRESSIONS  
SOME NAILS (IRON) ARE NOT VERY EVIDENT ANY MORE (AFTER CLEANING) - THEY WERE MARKED WITH TYVEK-LABELS  
→ Timber redrawn as on original drawing (orientation) Not recorded same detail as original drawing especially in damaged areas.

Wood Science: [rings, ARW, knots, sapwood, conversion]  
ON THE FORWARD FACE? SAPWOOD.  
AFT FACE  
DISCUSSION ON GRAIN + CONVERSION: AS MANY OPINIONS AS VOICES. Much variance in grain, branch? + stem. Medium growth rate.  
NB some no sapwood

Recommended action: [samples, additional photos, moulding, queries and problems]  
→ yet another time: 23/11/08 USB
