Cow Tag

631

Function Code

F 62-0

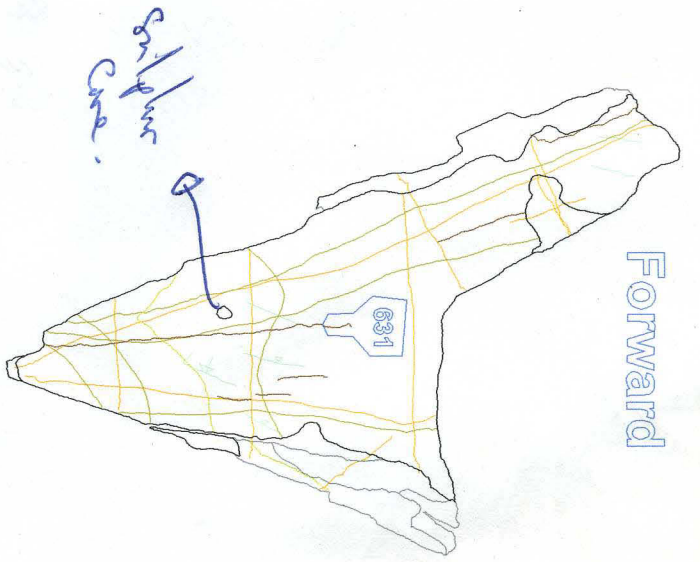
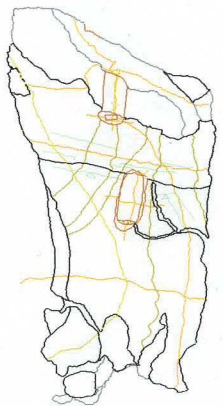
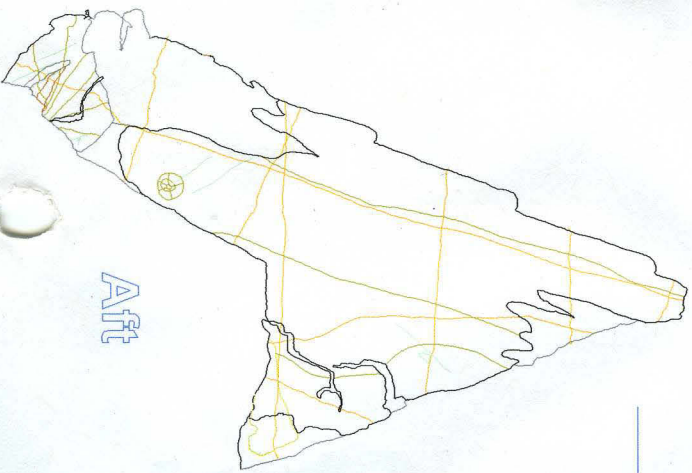
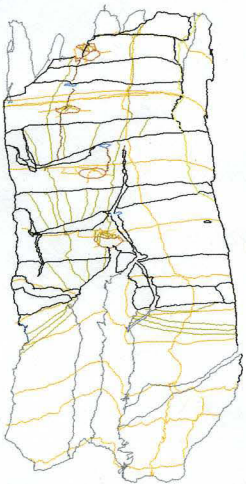
631 F62\_0 Matt Simmonds 25 January 2007

v. damaged floor element 'v' shaped, sliced in half by sheet piling

For - lots of see marks Pile damaged on port side  
I.B - see marks Hacked in antiquity on upper end of starboard arm.

Small round impression on 2nd Joggle outboard - starboard. - not sure what this is

>5, c70H + 10S + Be. on starboard side. Timber is from crown of tree

Core for deids after photos?
