Cow Tag 032 Function Code F2-0

Brief Description: [timber element, p/s, condition, fragments]
floor timber, slight damage to extremities
very soft.

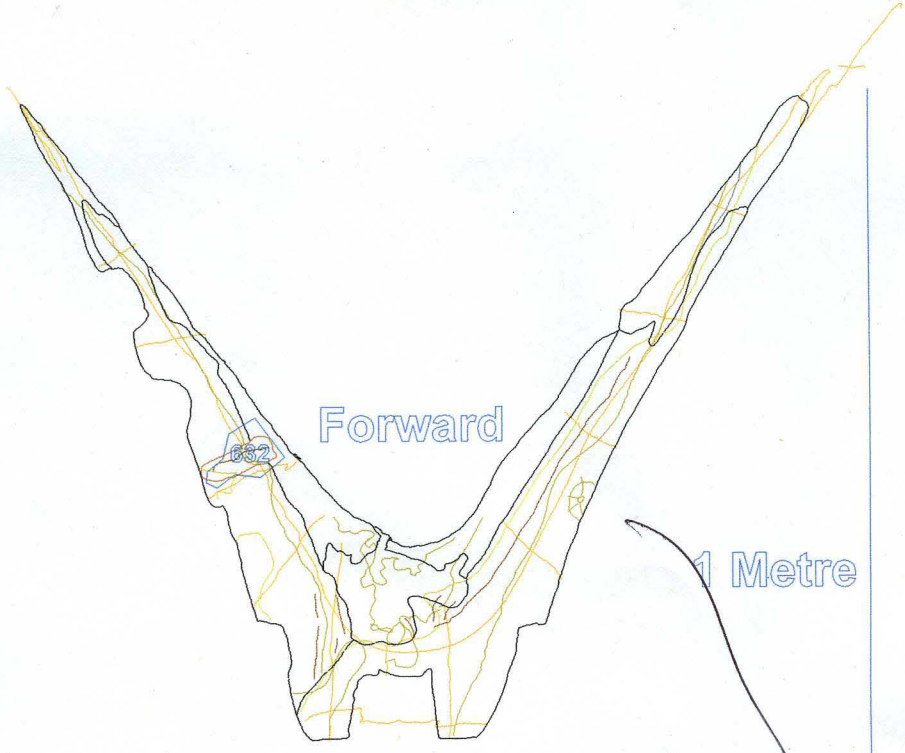
632 F2_0 Ben R. Jennings 09 February 2007

Notable Features: [tool marks, scribed lines, decoration, repairs] POINTS TO LOOK OUT FOR WHEN RECORDING
Starboard side - Scarf joint on O.B. sole,
∴ F2-2 was put in place first,
groin V. Swirly - 1.3 - Saddle - back edge almost
groin quite difficult to see
low top on aft
sole) Scarfed over F2.1? ☺

Recommended action: [samples, additional photos, moulding, queries and problems]
Photos: angled 'feet' and timber hole showing from
floor is not coated. + Near horizontal Trunnel on aft
face

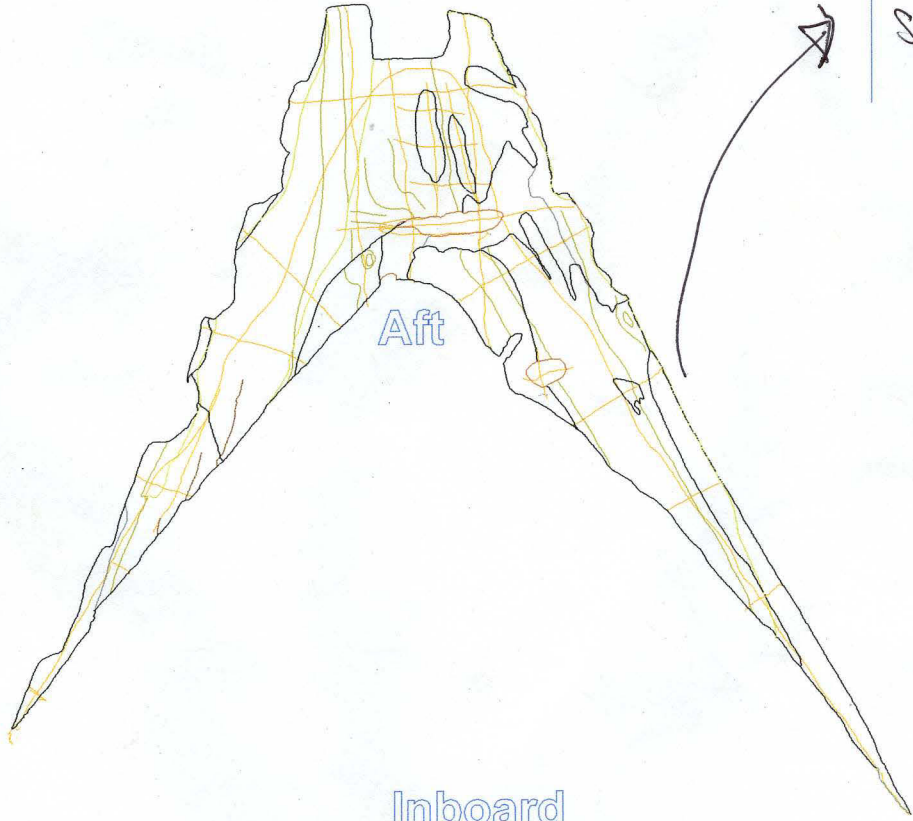
Searched over F2.1
