Cow Tag <p style="text-align: center; font-size: 1.2em;">633</p>	Function Code <p style="text-align: center; font-size: 1.2em;">F 60.0</p>
---	--

Brief Description: [timber element, p/s, condition, fragments]
Part of floor. large crack in middle.

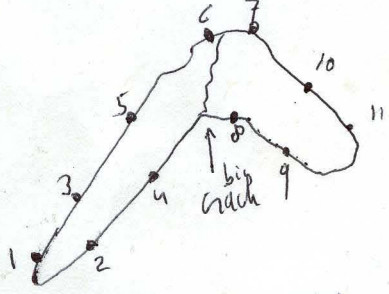
Type 4 on forward (vague)

inboard: calibration difficult (even with leap fogging)

Sapwood on x-face not drawn with Faro arm (initially forgotten) but reconstructed with poly lines, using lines already drawn on x-face surface and by looking at the sapwood on the x-face of the timber.

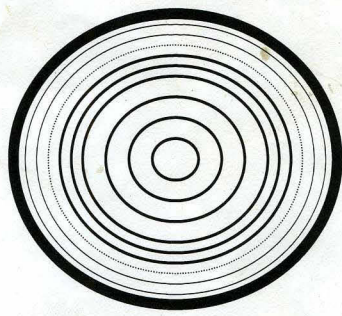
Core of tree

C + 50 H + 15 S + Be

ARW = 160/65

↓ photos of these please plus some general photos
