Cow Tag 636 Function Code F 50-0

Brief Description: [timber element, p/s, condition, fragments]  
floor timber, slight damage to ends

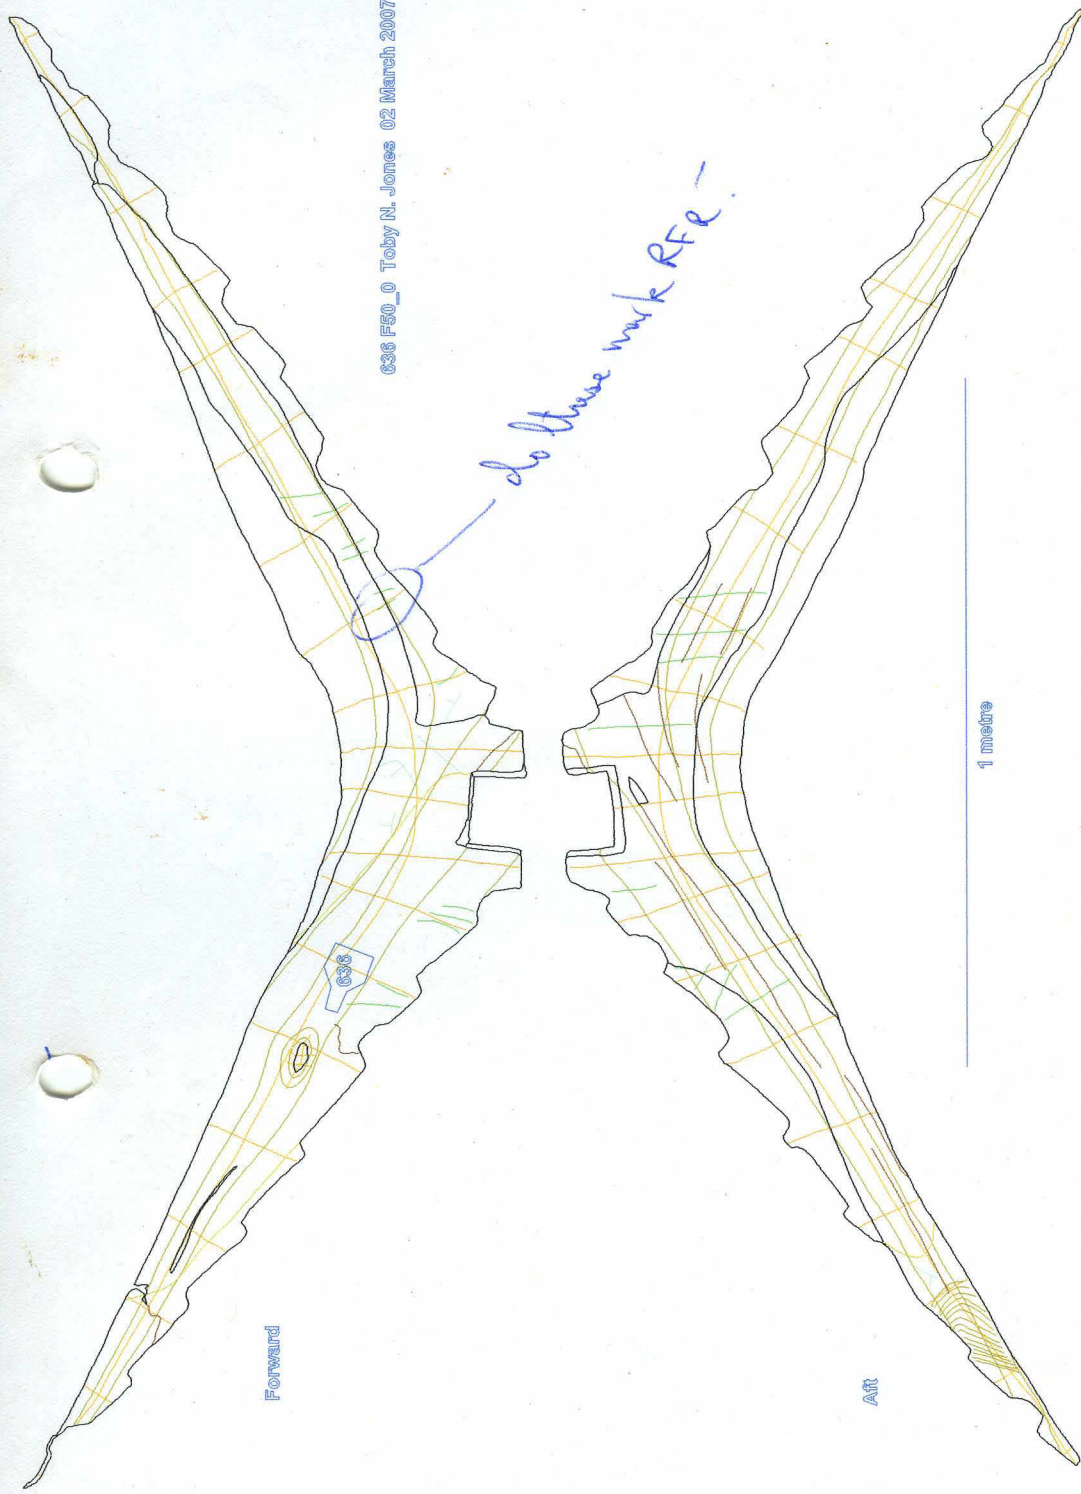
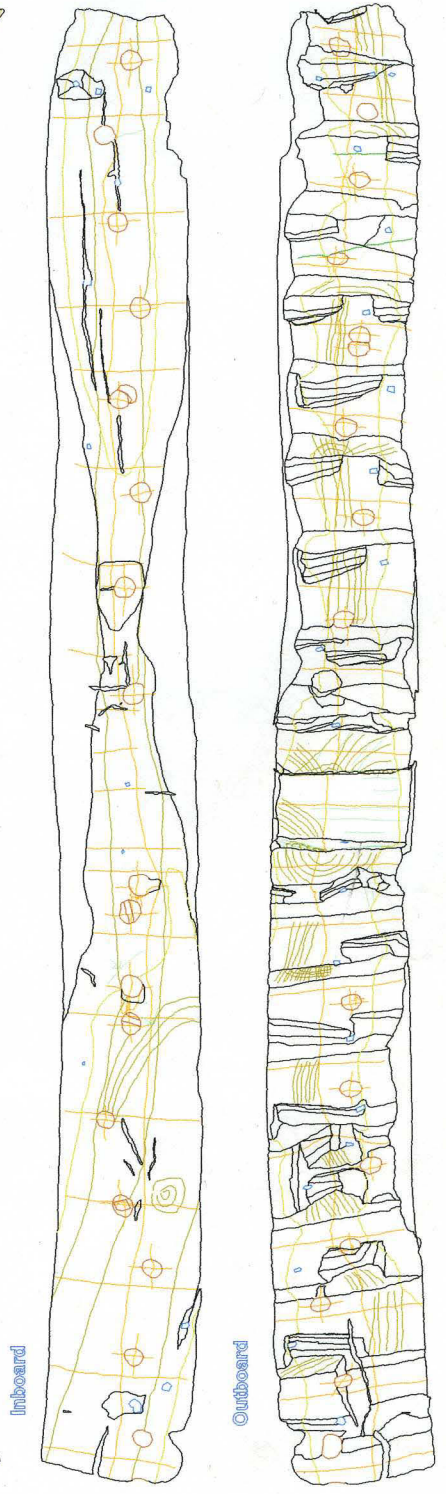
636 F50\_0 Toby N. Jones 02 March 2007

NUMEROUS T4, some double + triple marks. It is possible that some of these mark RFR's as well as joggle portions  
Rebated Fe nails (1 each) on both sides, saw marks - 1B.  
Deep Axe marks on outboard face in the timber hole.  
Nail Angles + Depth on outboard: Suspect - not cleaned out well.

Starboard arm = bole of tree, port arm = branch

Reclean nail? Had 2nd clean 12/11/7 but could be more to do on this timber.
