Cow Tag 637	Function Code FSI-0
-------------	---------------------

Brief Description: [timber element, p/s, condition, fragments]
 Intact, good condition

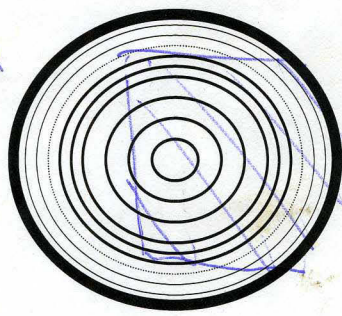
Wood Science: [rings, ARW, knots, sapwood, conversion]

Be on aft port arm + forward starboard arm. Starboard

$C + 3.5H + 10S + Be = 130 / 45$
