Cow Tag 63 Type function- unknown

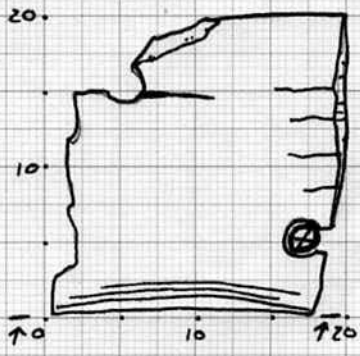
OUTBOARD

Description 20cm x 20cm x 3cm. One treenail - 2.7cm in diameter, still in situ. Second treenail hole (partial) appears to have diameter of 2.7cm also but is damaged. Some metal staining on outboard surface. However no metal fasteners. Inboard surface is in poor condition. No landmarks remain. original wood number 230.

Recommended action: [samples, additional photos, moulding, queries and problems]  
Discarded ✓
