Cow Tag **90**

Function Code **S8-8**

Brief Description: [timber element, p/s, condition, fragments]

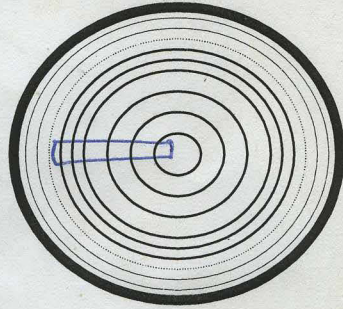
Wide distal bevel on inboard surface between land and upper edge
 4 Type 8 ^{odd use?} staple holes - possibly to hold ~~plank~~ ^{plank} up - as a sort of jig - during construction.
 wooden spikes / additional nails
 Narrow inboard land

on land
 6+ Type 5 clamp marks
 1 Type 3 outboard Aft Edge - damaged

No sapwood. Some Resin + tears -
 Radial. Pith beyond lower edge.
 95H. ARW = 190/95.

Photo clamp marks + ^{odd use?} staple holes + Type 3

on land.
